Building Envelope Remediation Site Visit Report

Building Envelope Remediation Report

REPORT DATE: June 23, 2023

Building Envelope Remediation

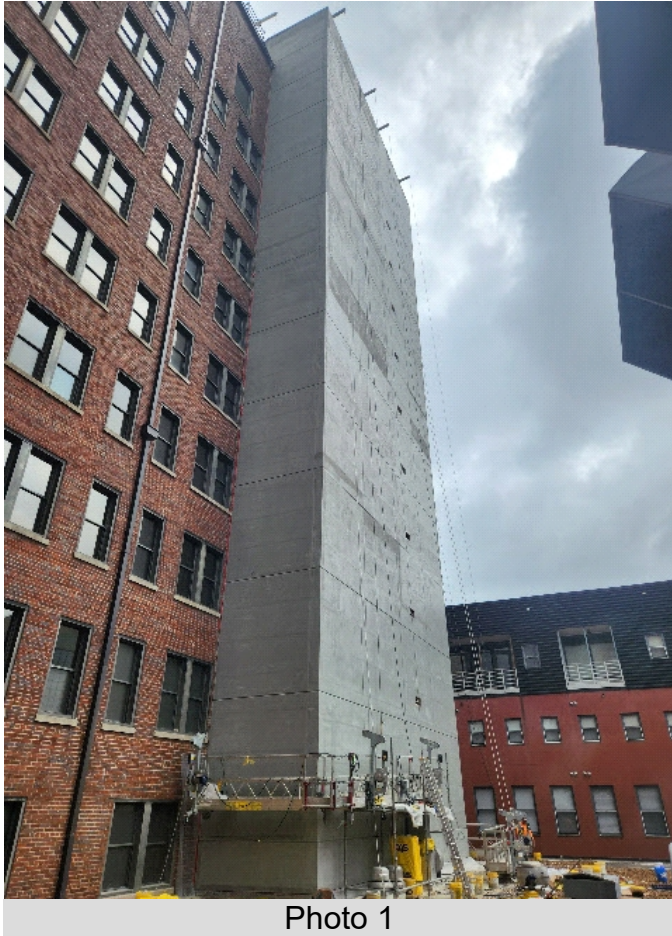
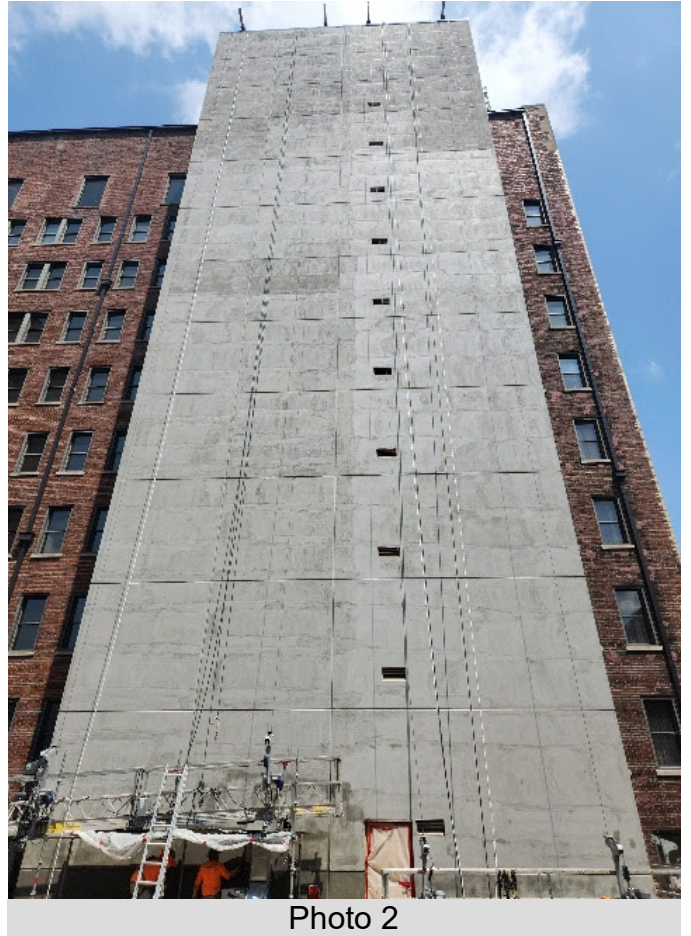
All areas ready for finish and sealants

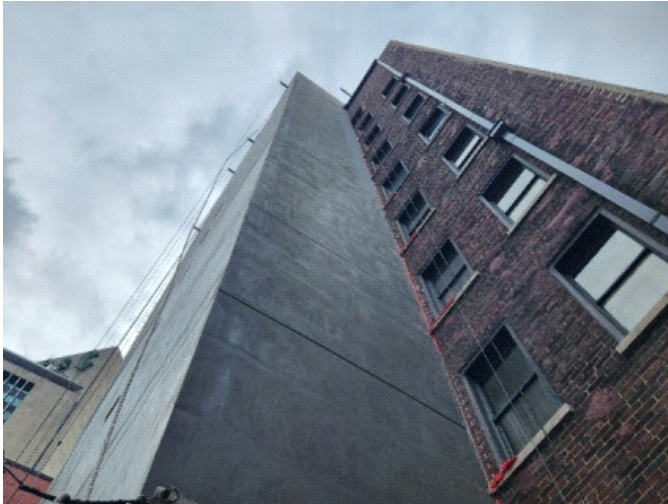
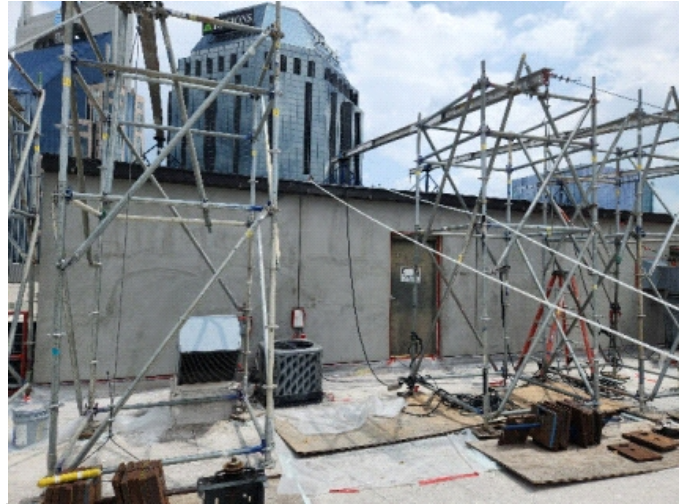
All areas ready for finish and sealants

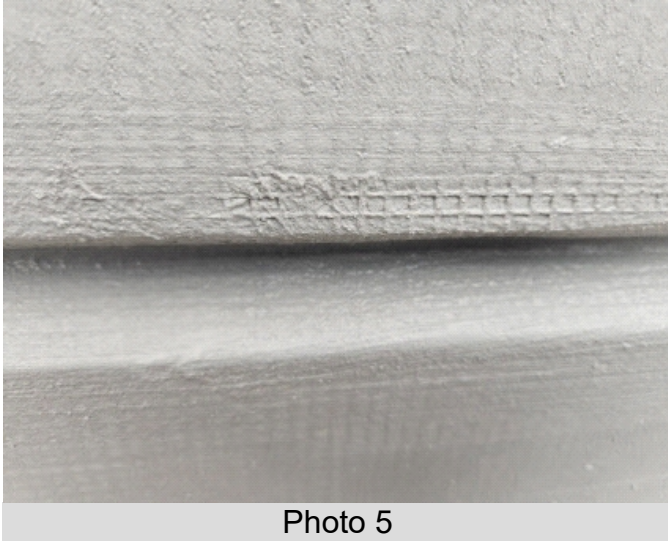
Photo 5

Initial inspection showed many areas of exposed mesh. Areas had skim coat applied and is now ready for finish and sealants

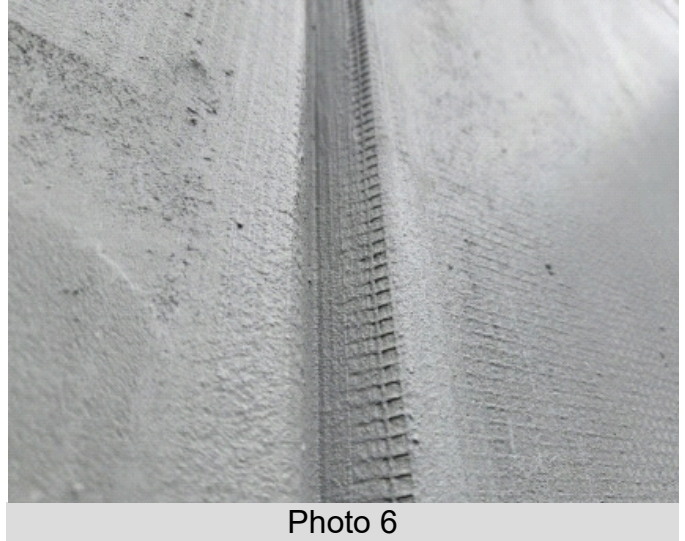
Photo 6

Example exposed mesh (initial inspection)

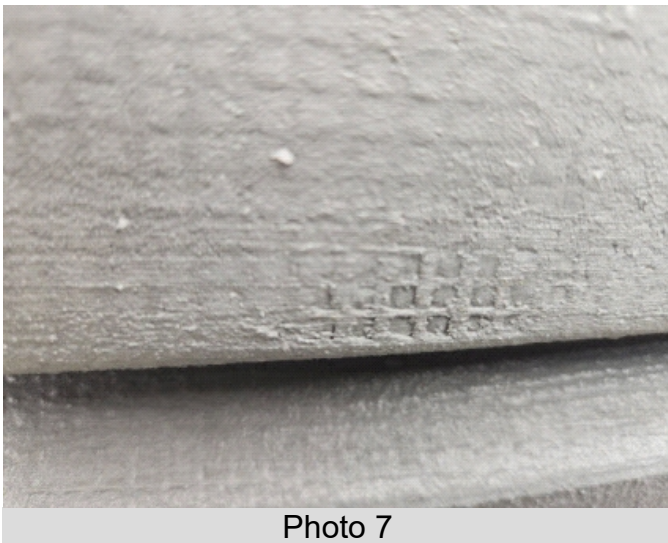
Photo 7

Example exposed mesh (initial inspection)

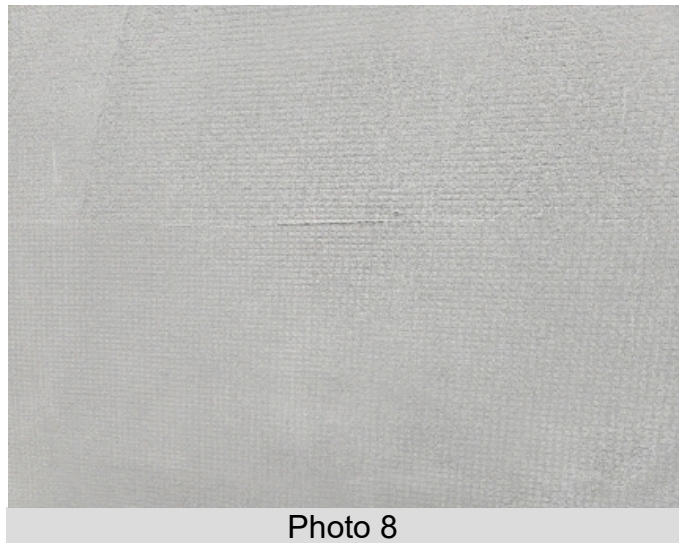
Photo 8

Example exposed mesh (initial inspection)

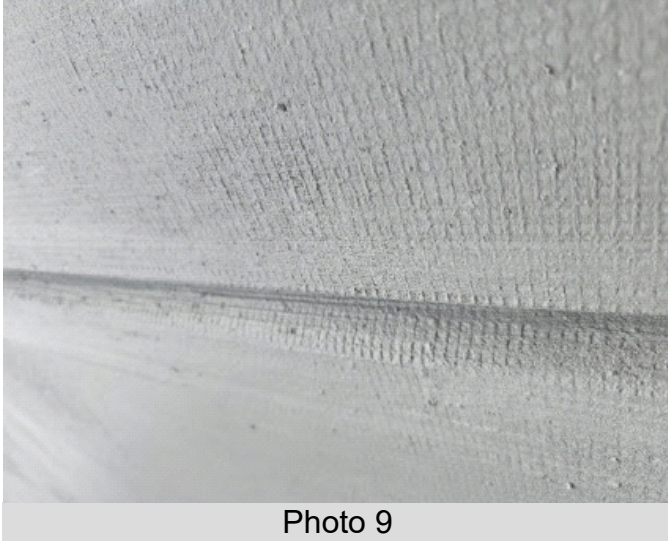
Photo 9
Example exposed mesh (initial inspection)

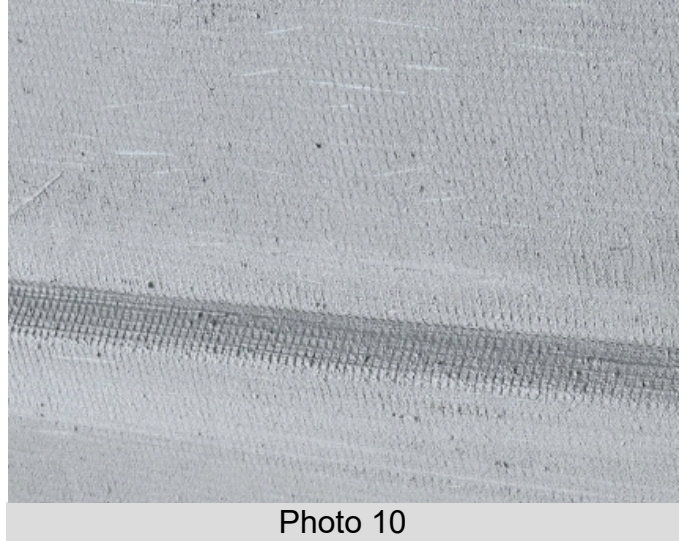
Photo 10
Example exposed mesh (initial inspection)

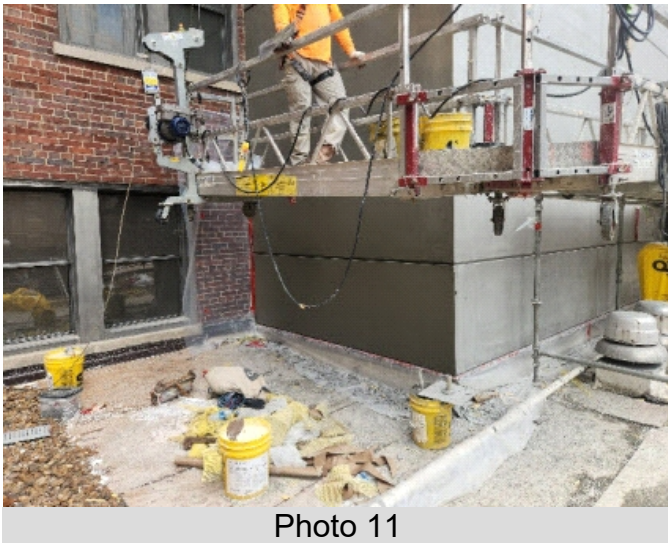
Photo 11
Areas reskimmed

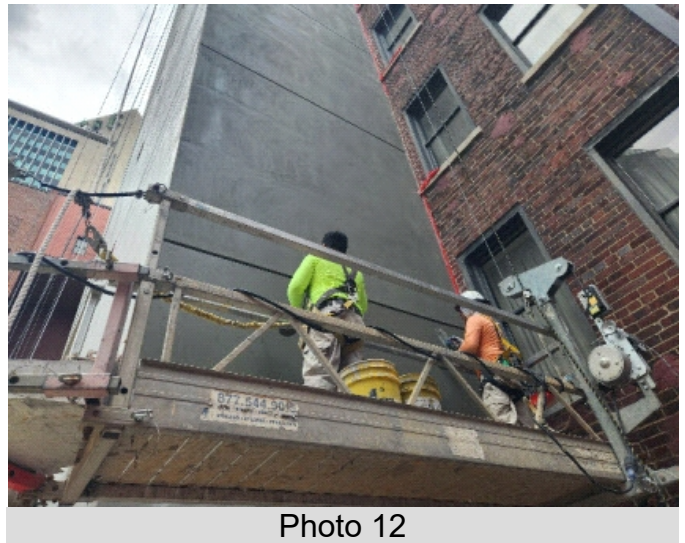
Photo 12
Areas reskimmed

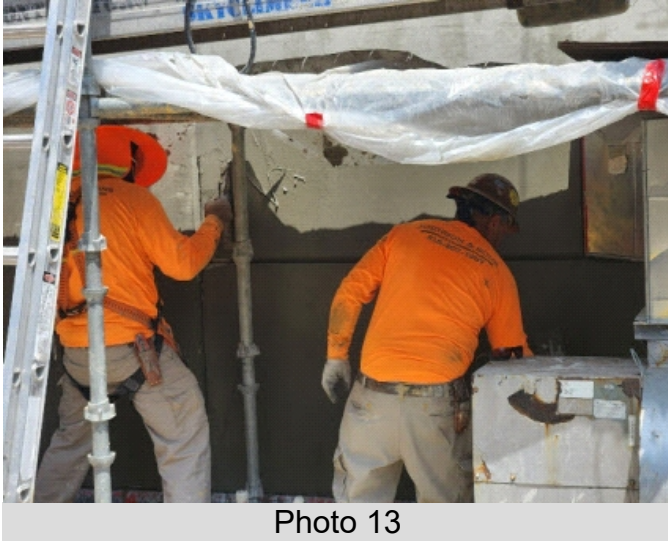
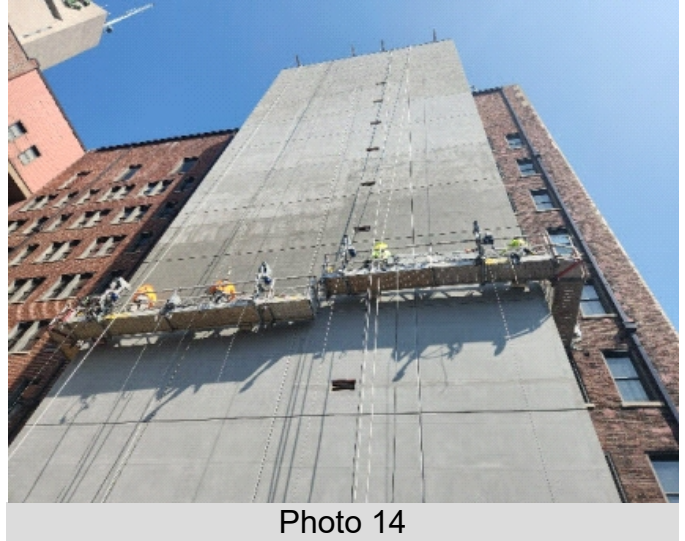
Skim coat in progress

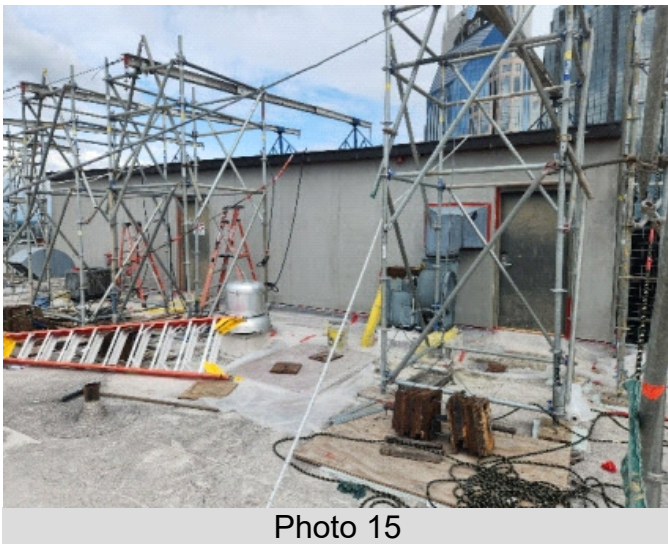
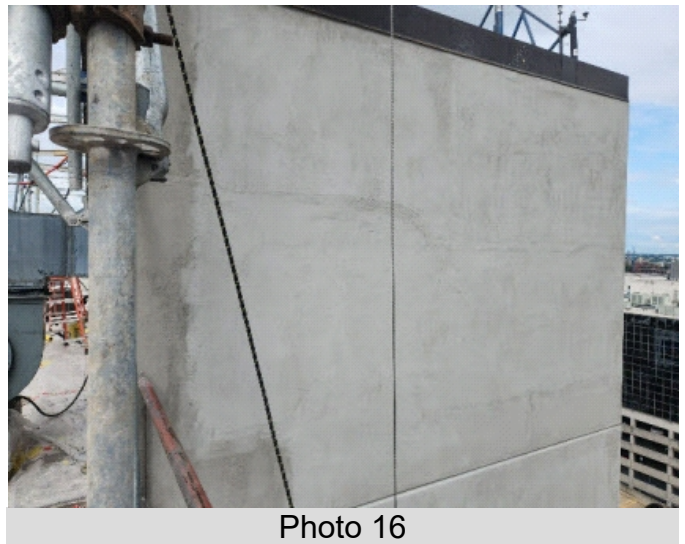
Wall surface after touch ups - no exposed mesh

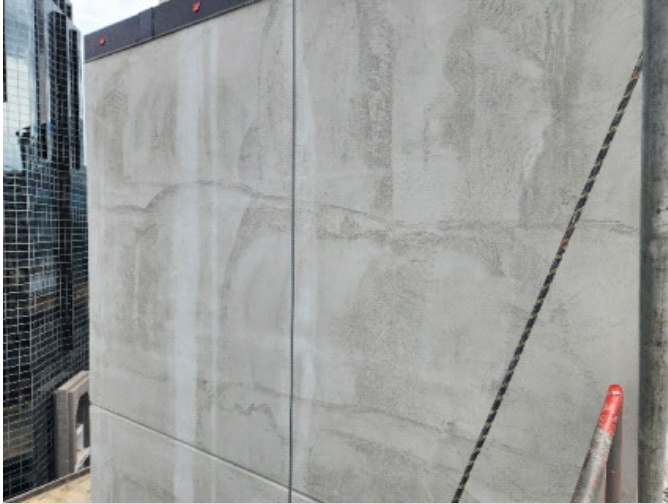
Photo 17

Wall surface after touch ups - no exposed mesh

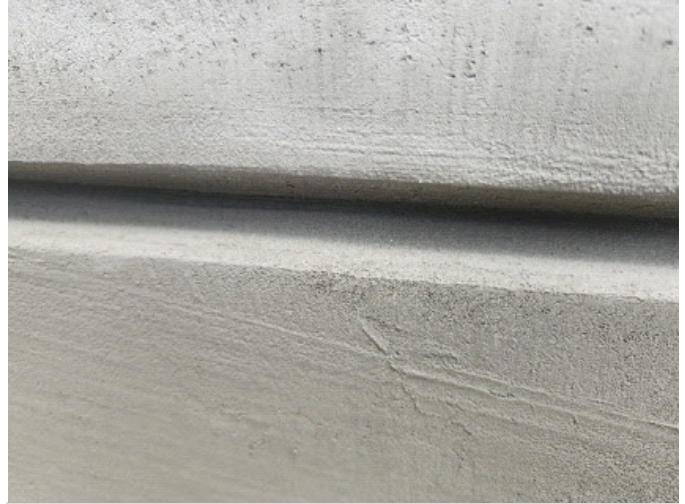
Photo 18

Typical Control joint after touch up - no visible mesh - ready for finish

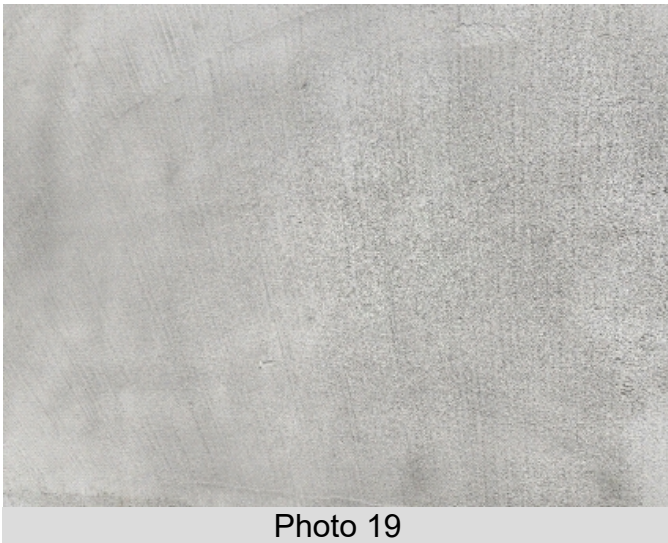
Photo 19

Typical wall after touch up - no visible mesh

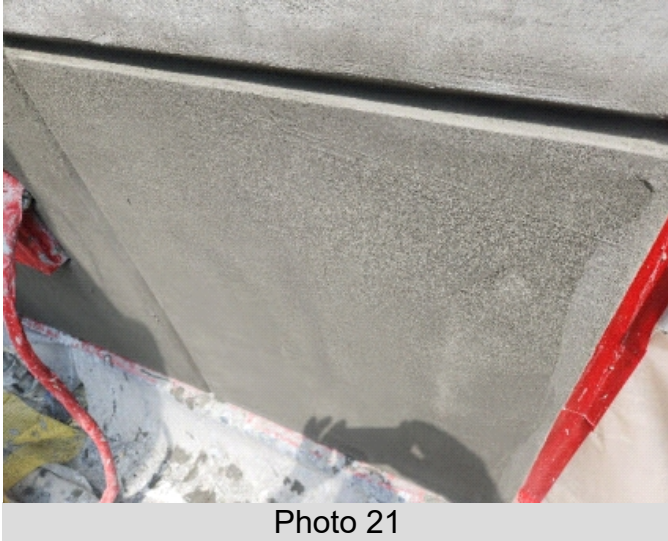
Photo 21
No visible mesh - ready for finish

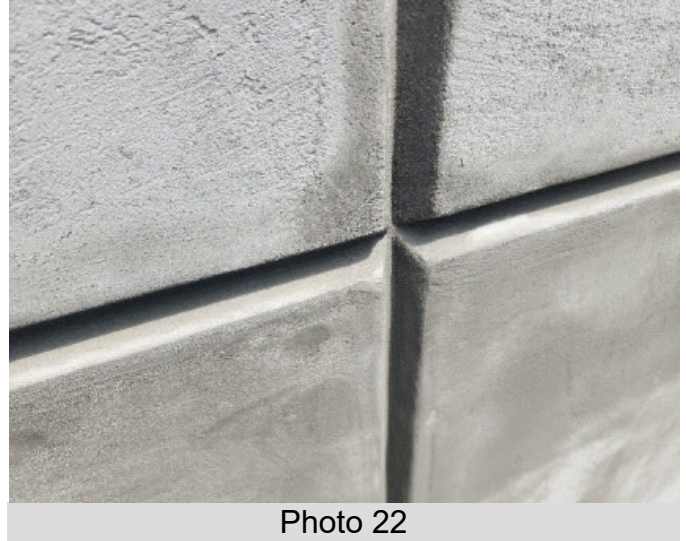
Photo 22
Control joints good base after touch up - ready for finish

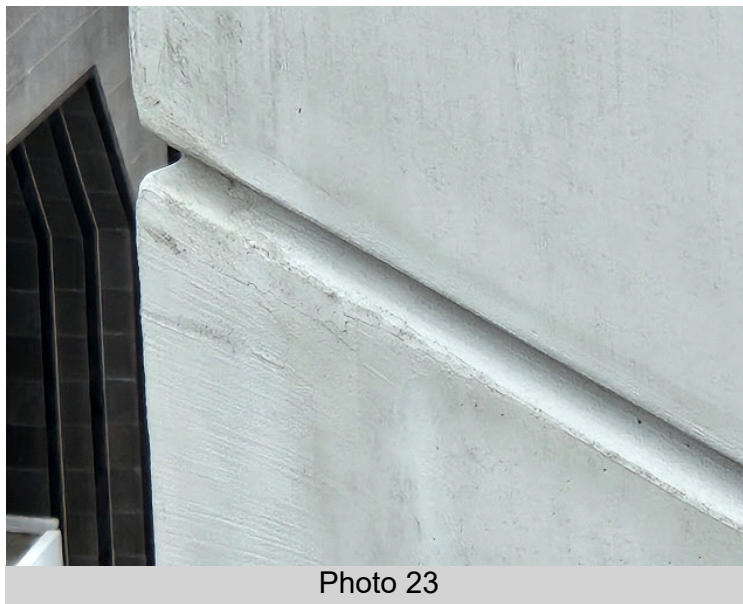
Photo 23
Good basecoat application ready for finish

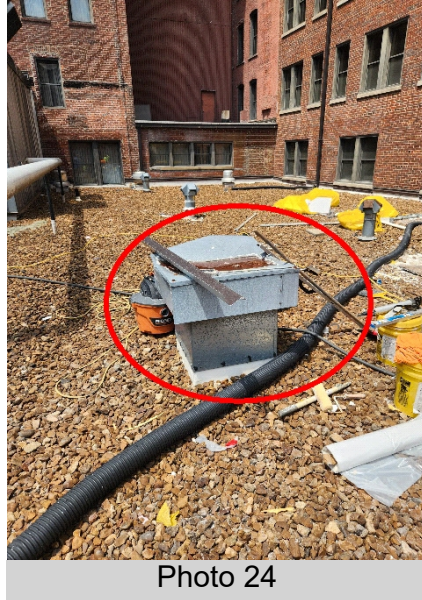
Photo 24

- We need confirmation of the intended sealant for use to verify it is a Sto approved sealant for EIFS
- There is still a damaged housing cover that needs repair (photo 24-26). This is the only remaining open water intrusion risk. We do not know whose responsibility this is but we do not believe it is on CPS's scope of work.

This cover still damaged -
needs new top piece

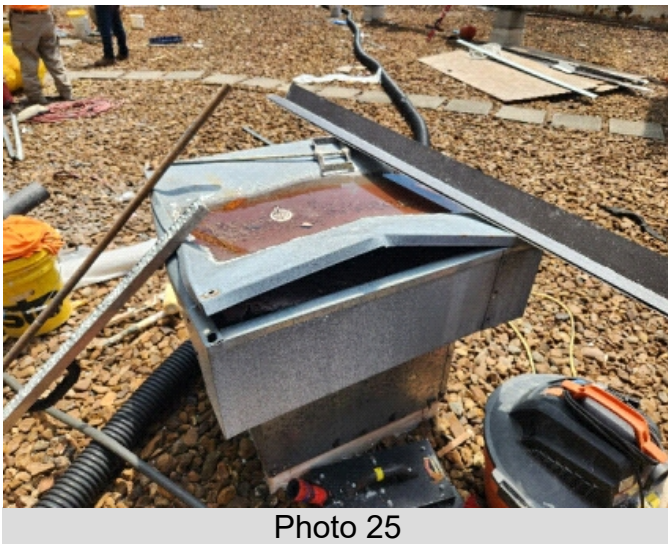
Photo 25

Close up damaged top piece to sheet metal
housing - water intrusion risk

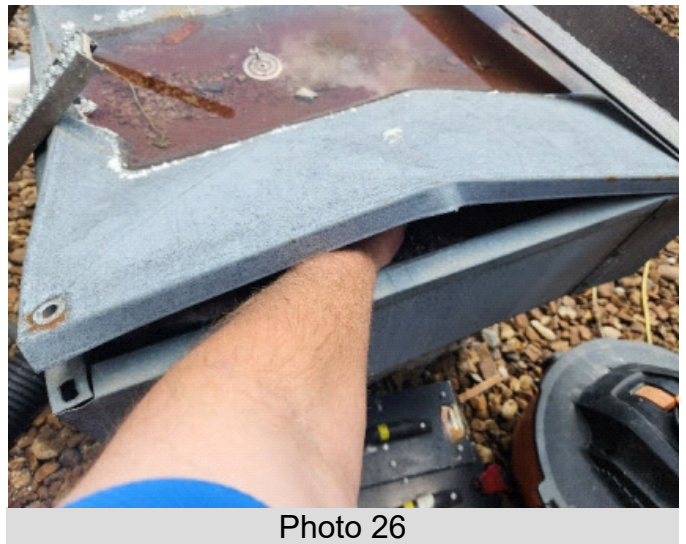
Photo 26

Large opening where damaged - water
intrusion risk
