Field Report No: 777888
Date: February 18,2025
Project: <#ProjectID#>

Project: Luxury Resort Towers
Orlando, FL 32533

Field Test Report

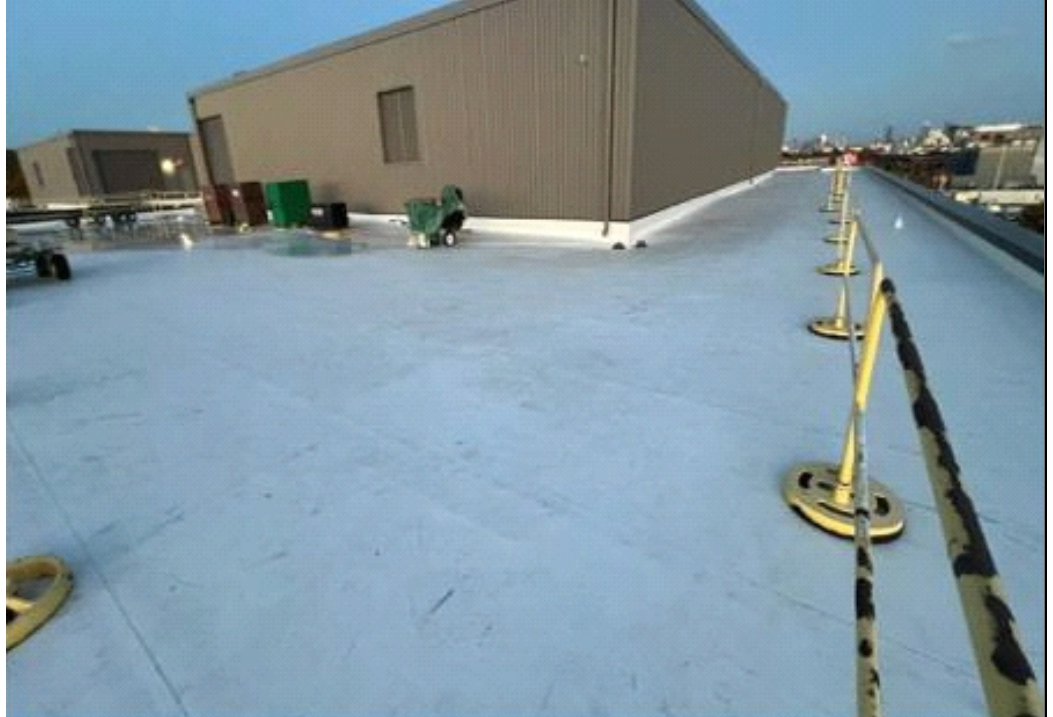
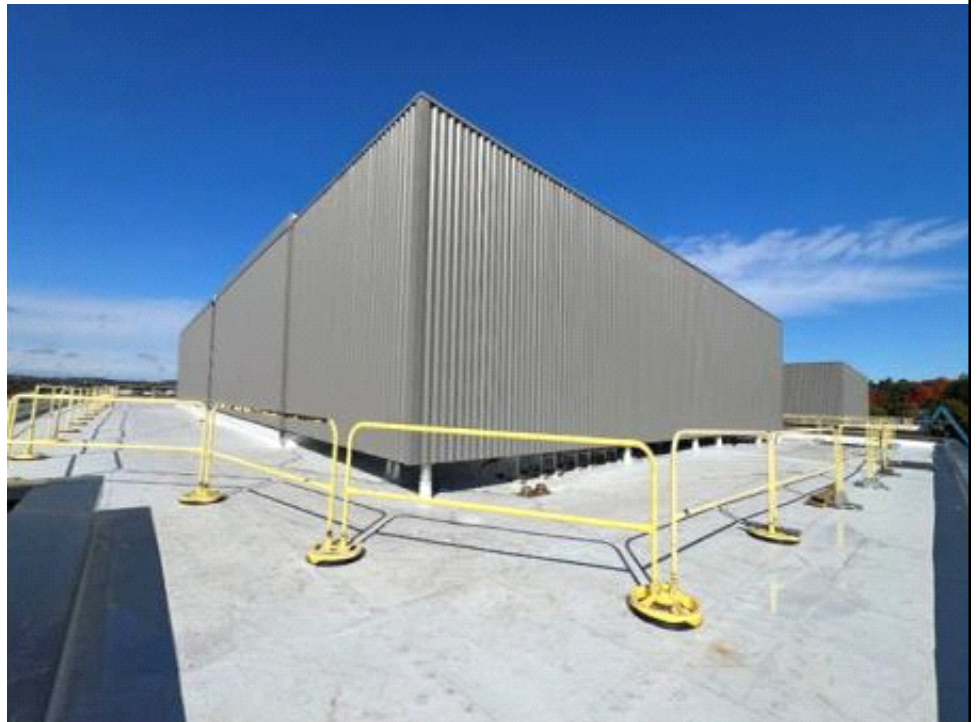
Example of TPO roofing Membrane roof areas to be tested on this date.

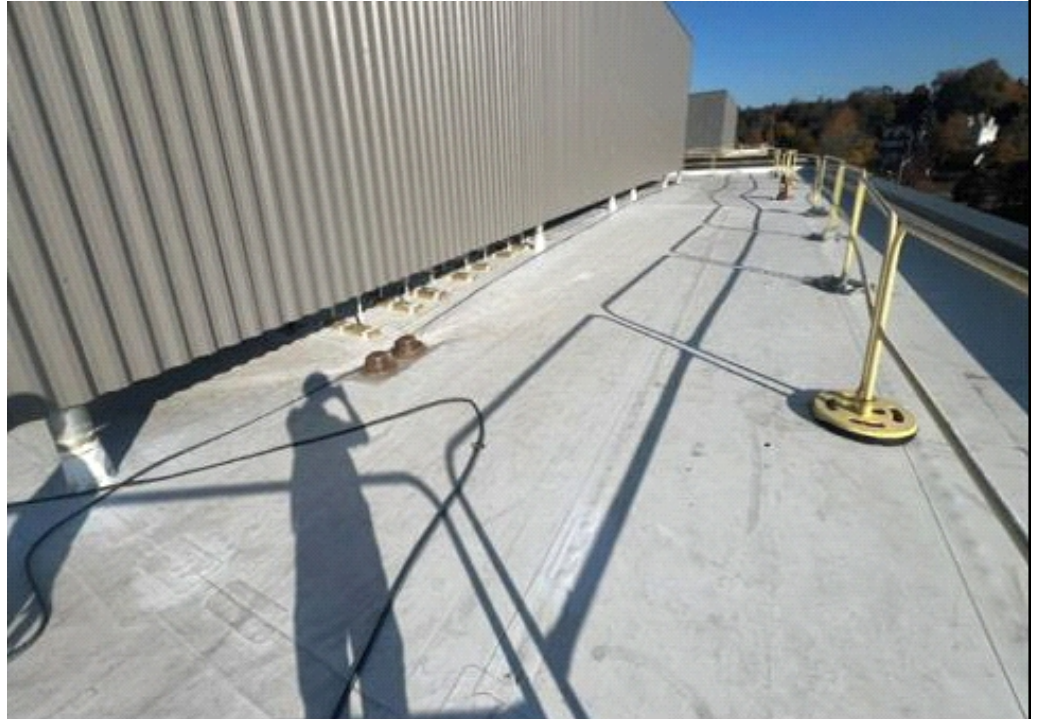
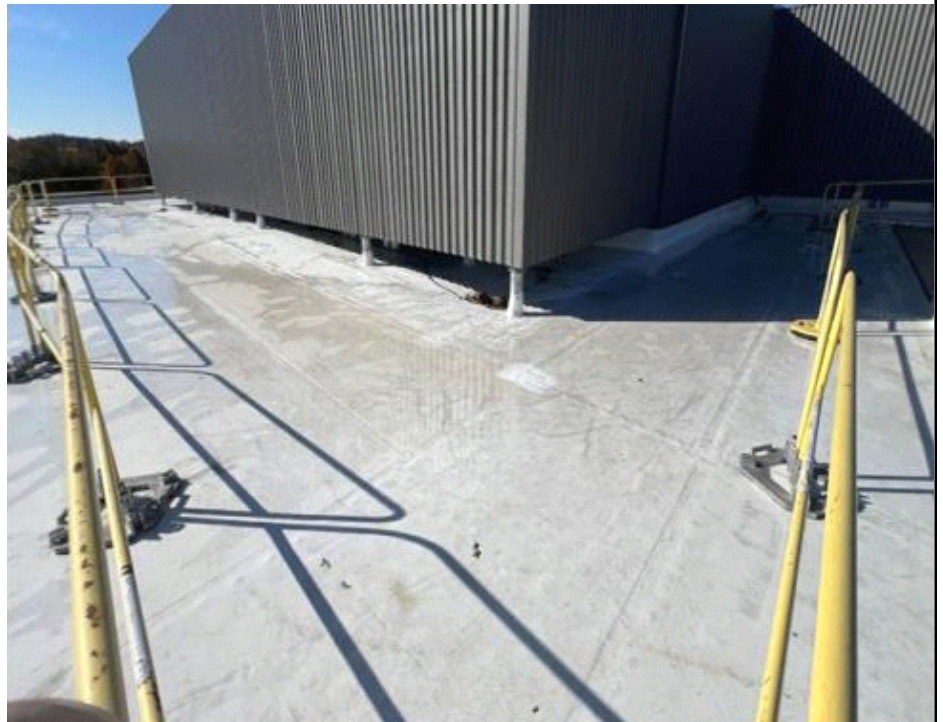
Example of TPO roofing Membrane roof areas to be tested on this date.

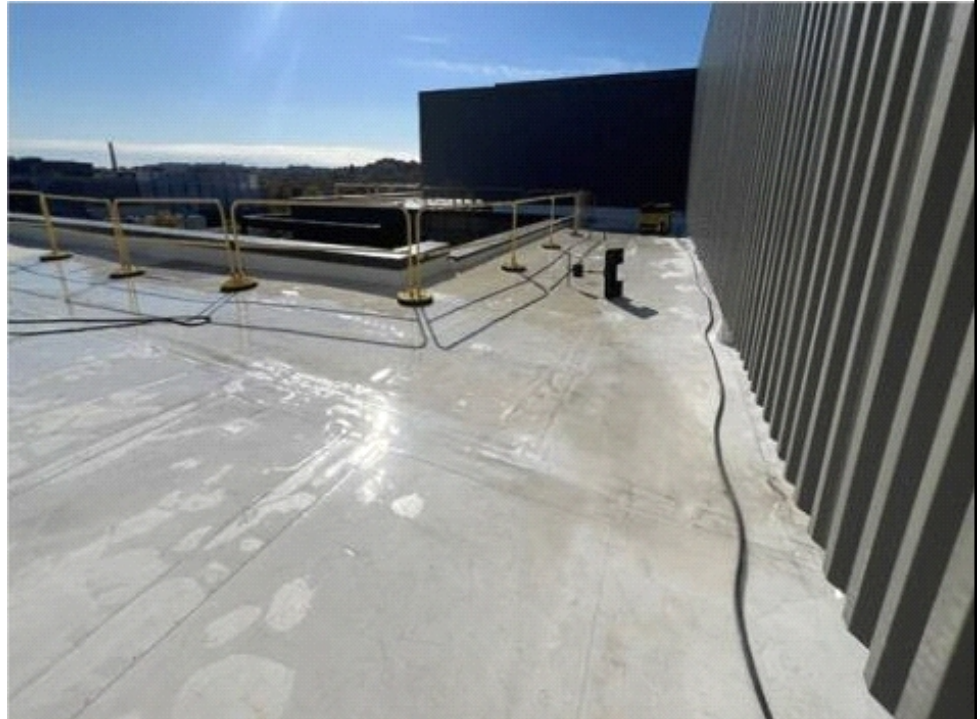
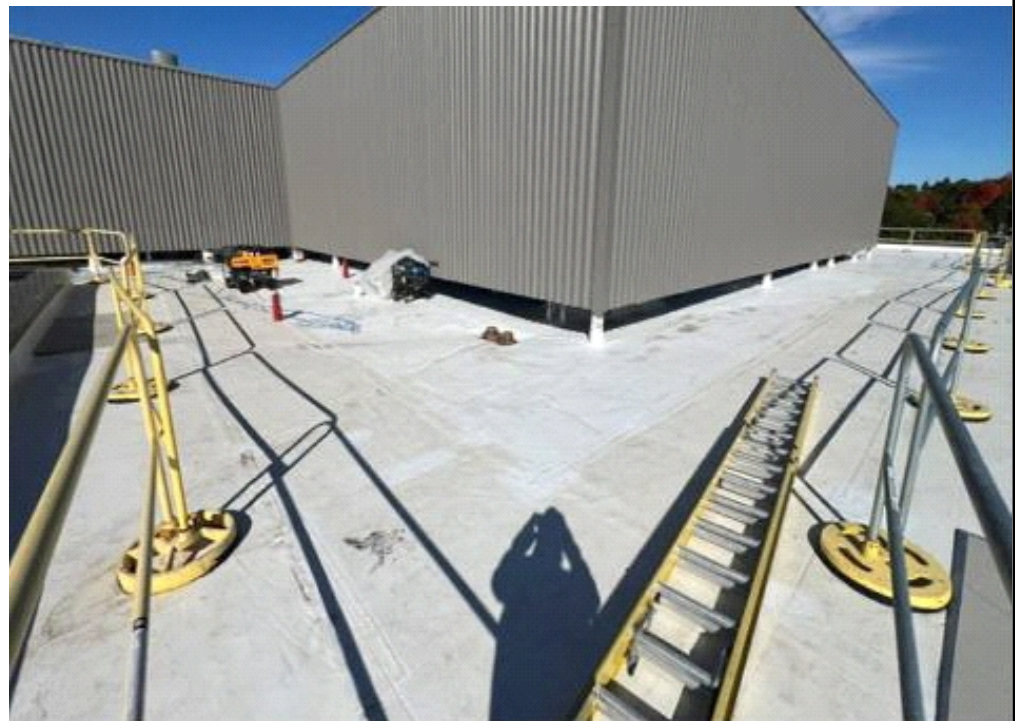
Example of TPO roofing Membrane roof areas to be tested on this date.

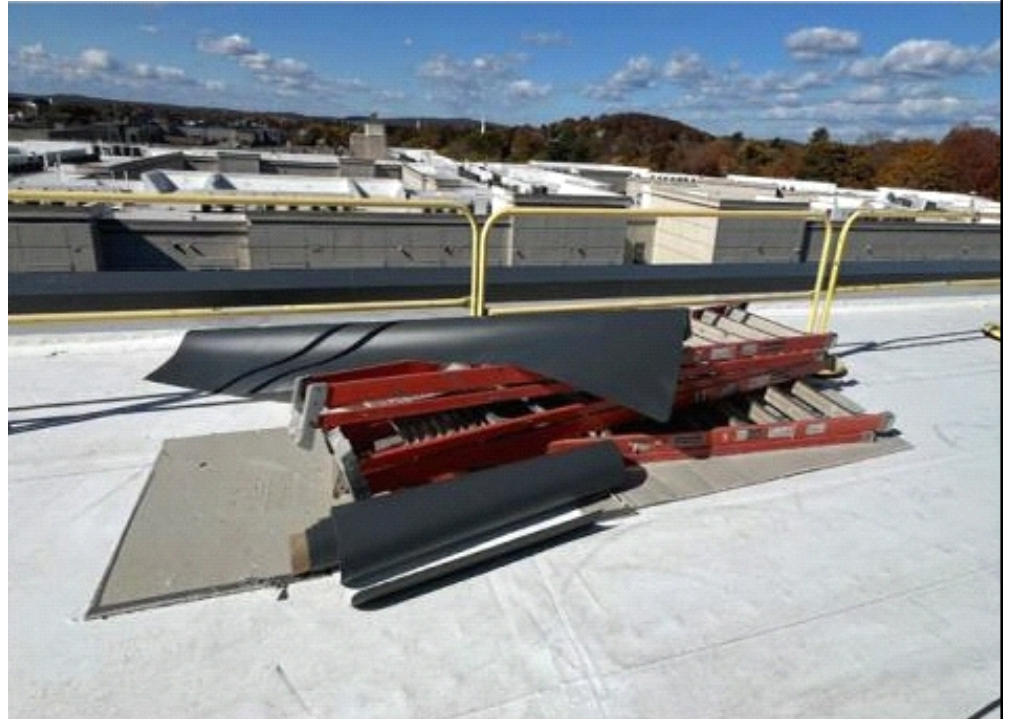
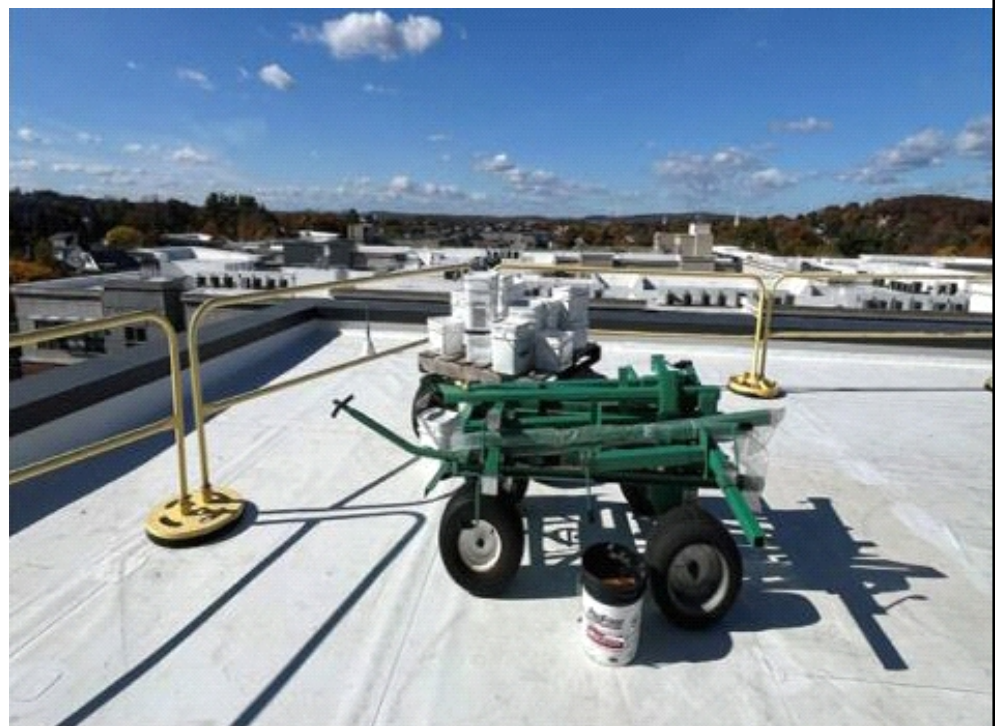
Example of inaccessible TPO roofing Membrane areas on this date.

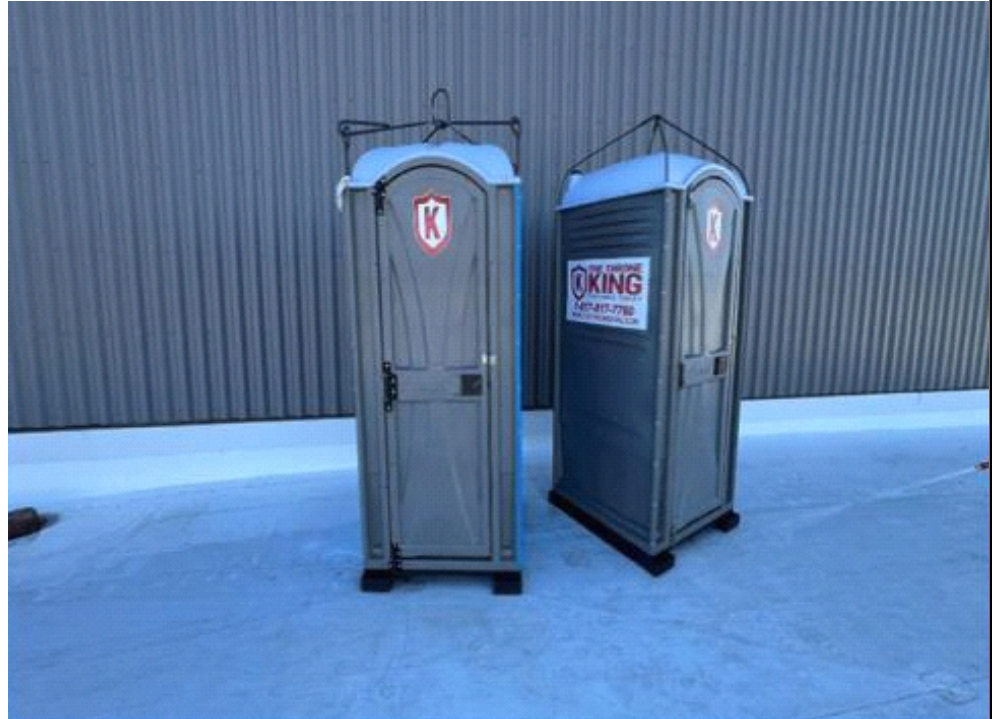
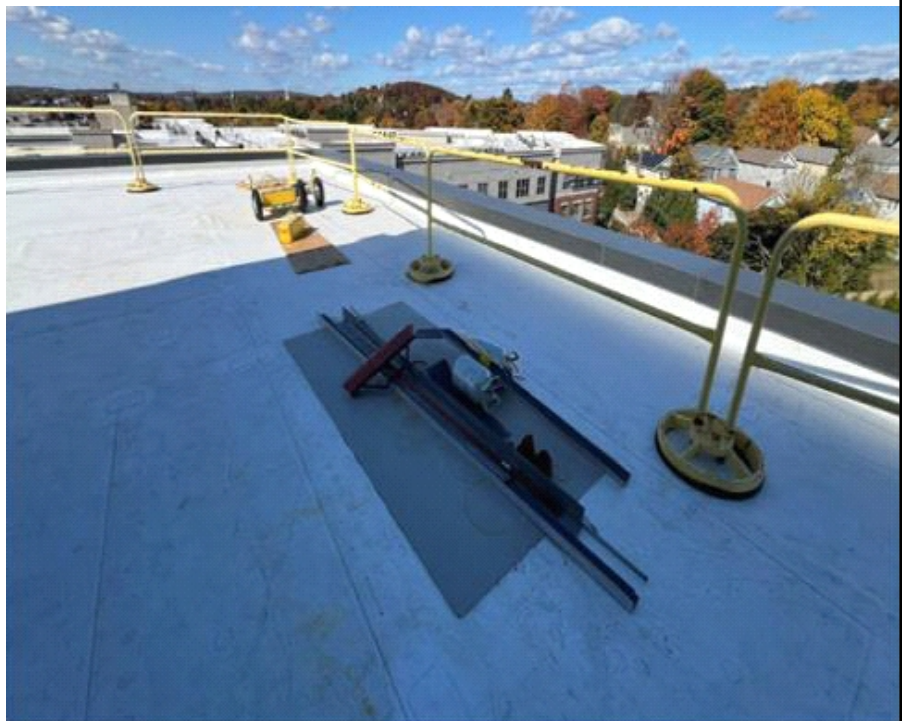
Example of inaccessible TPO roofing Membrane areas on this date.

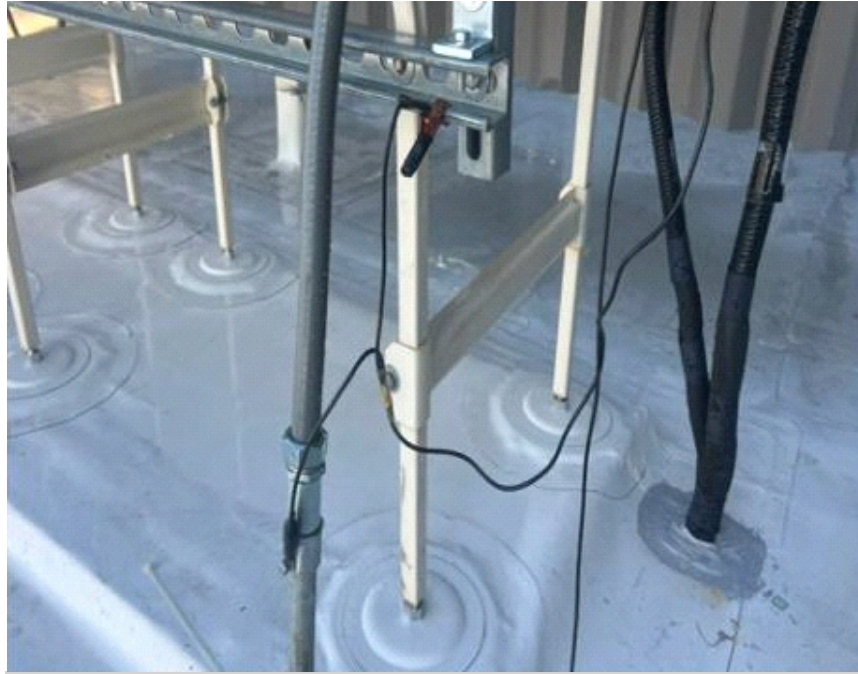
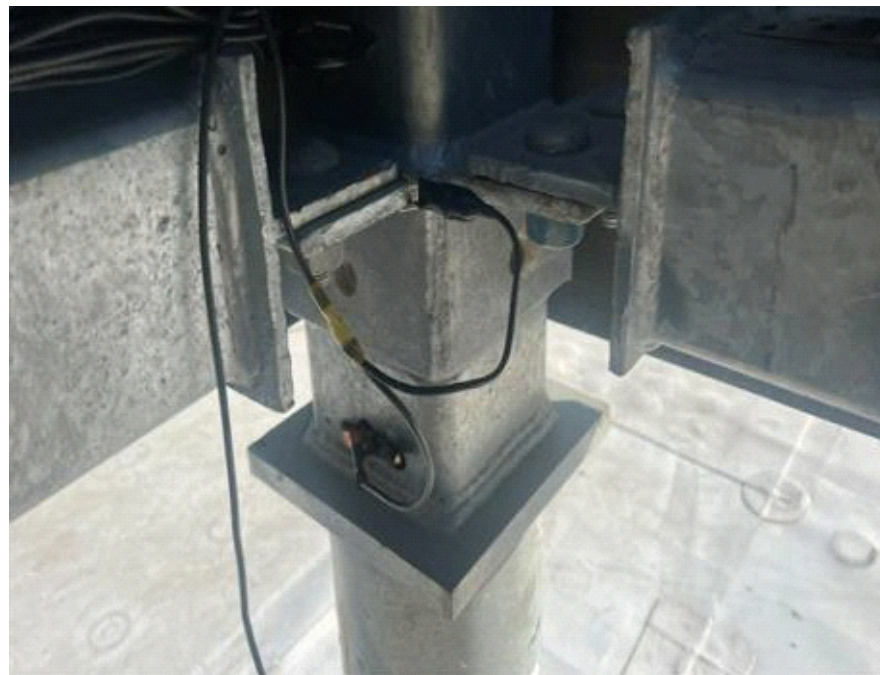
Example of Ground connection for proper and accurate testing.

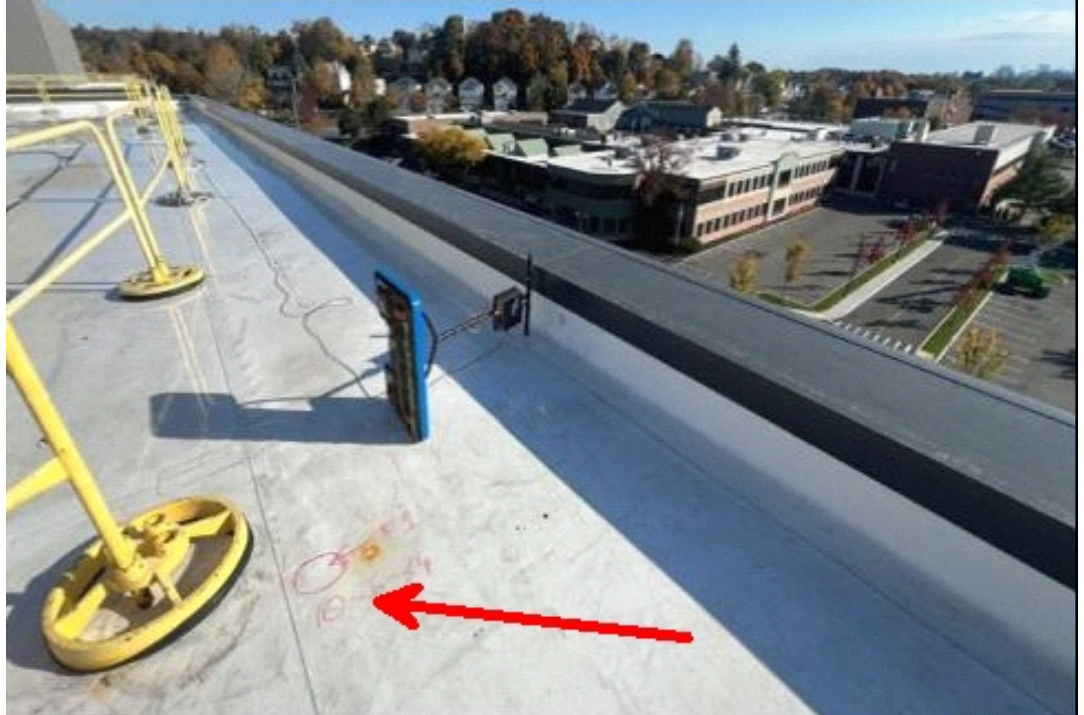
Photo 23

- On this date, our low-voltage ELD equipment detected four (4) breaches in the TPO roofing membrane installed. All detected breaches were marked with a red crayon for roof repairs. These results were communicated with Phase 3 Real Estate Partners, Inc personnel, necessary roofing repairs are required.

Example of breaches detected on this date with location.

General Area Of Breach

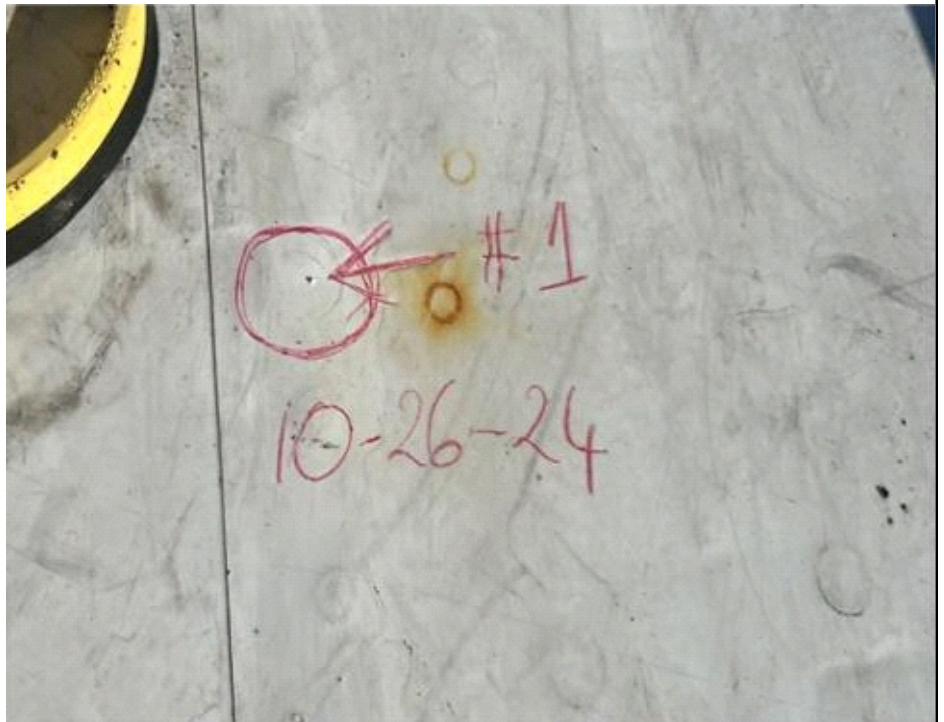
Photo 24

Close up

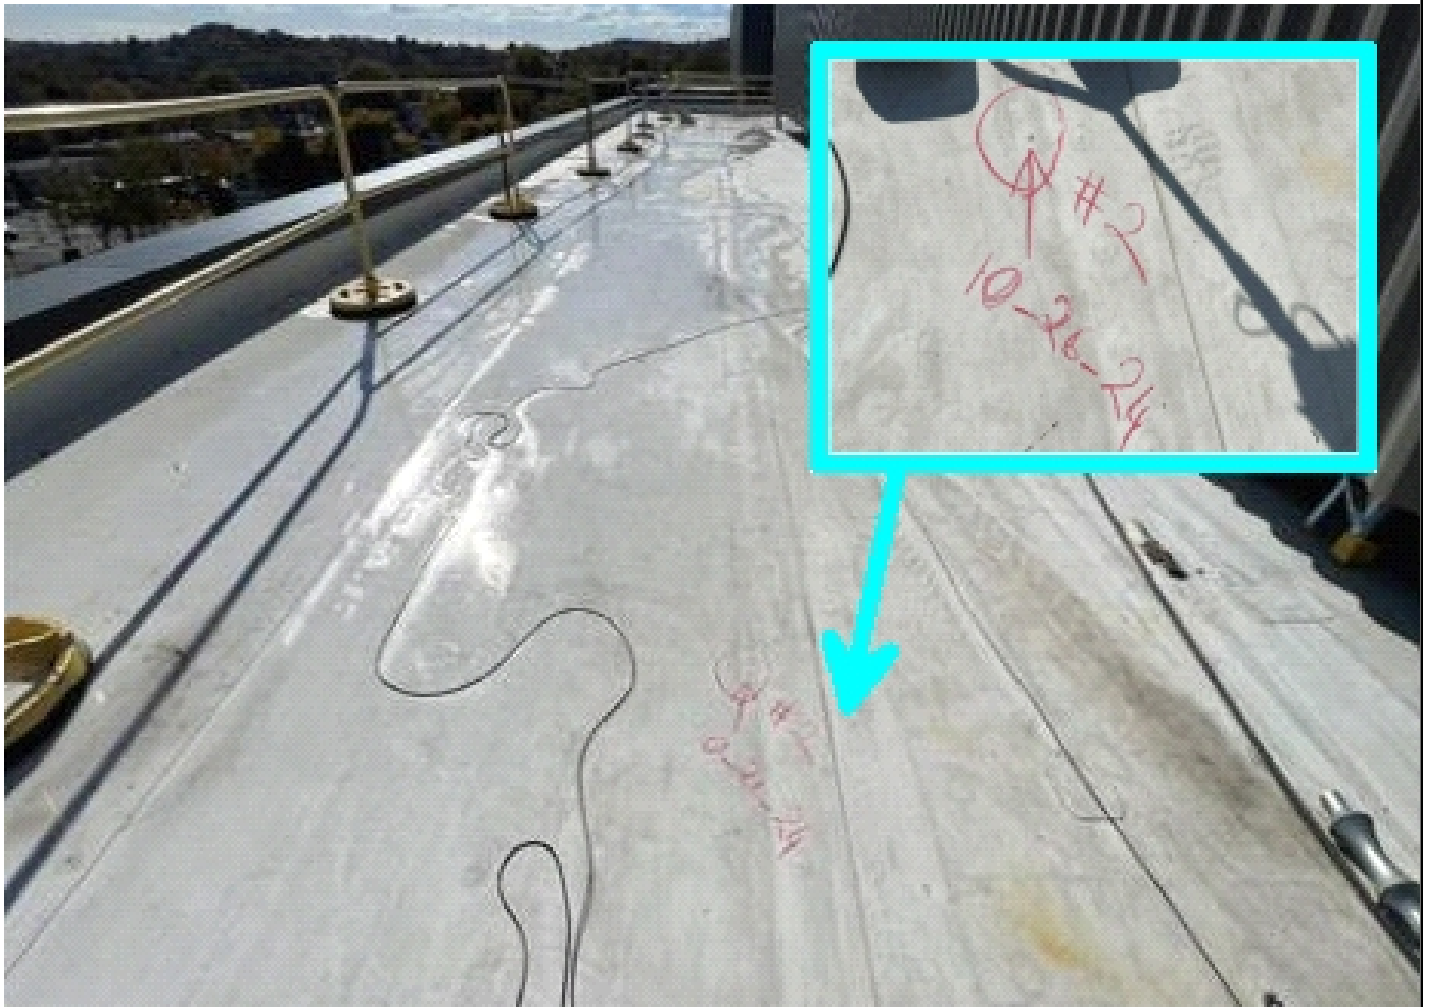
Photo 25

Example of breaches detected on this date with location.
