**Water Intrusion Assessment
Property Address
City, ST 12345**

ATTN: I. B. Client

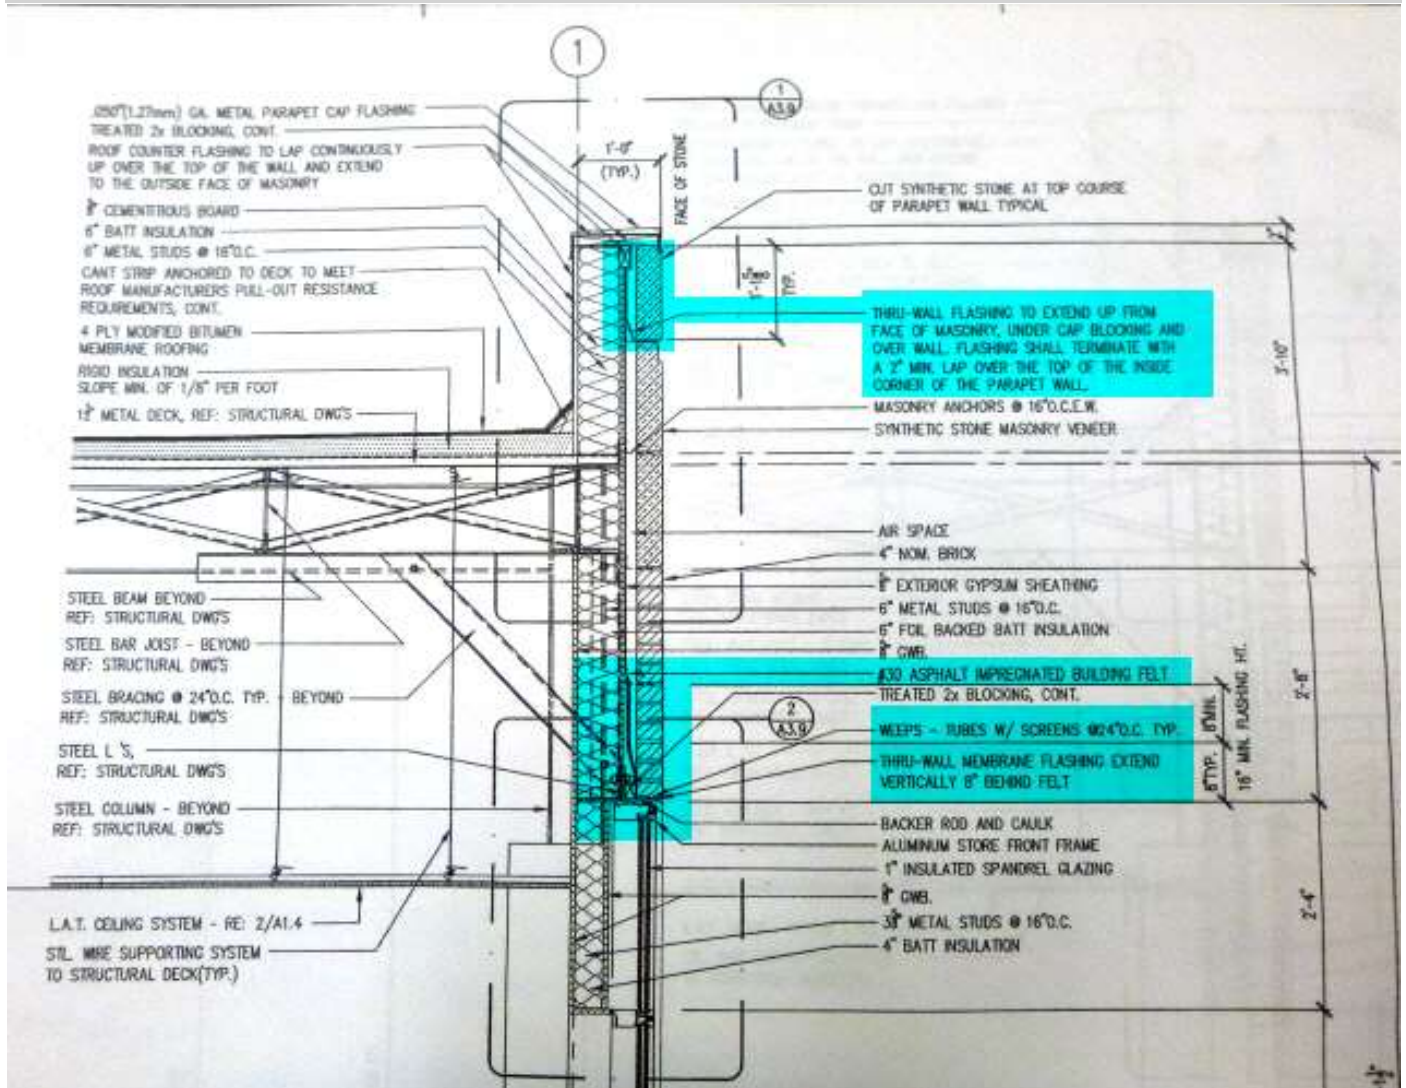
System relies on a functioning weather resistant barrier (WRB) of 30lb felt properly lapped over a thru-wall flashing system as shown in blue highlights.

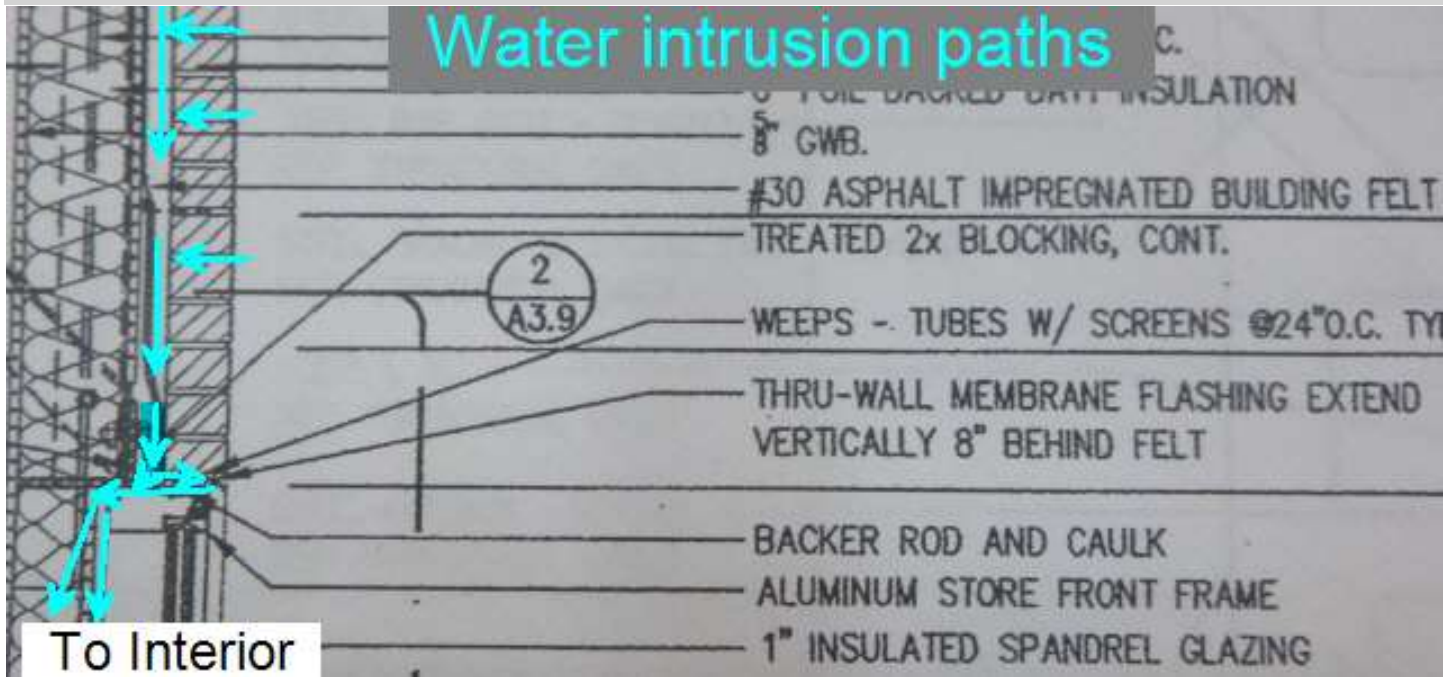
Water migrates through stone and brick and then down wall cavity. The failure of the thru-wall flashing (whether through seams, tears, damage, lack of end dams, etc) allows waterflow to enter in below the thru-wall into the angle iron metals and interior components through gaps, holes, bolts, etc.

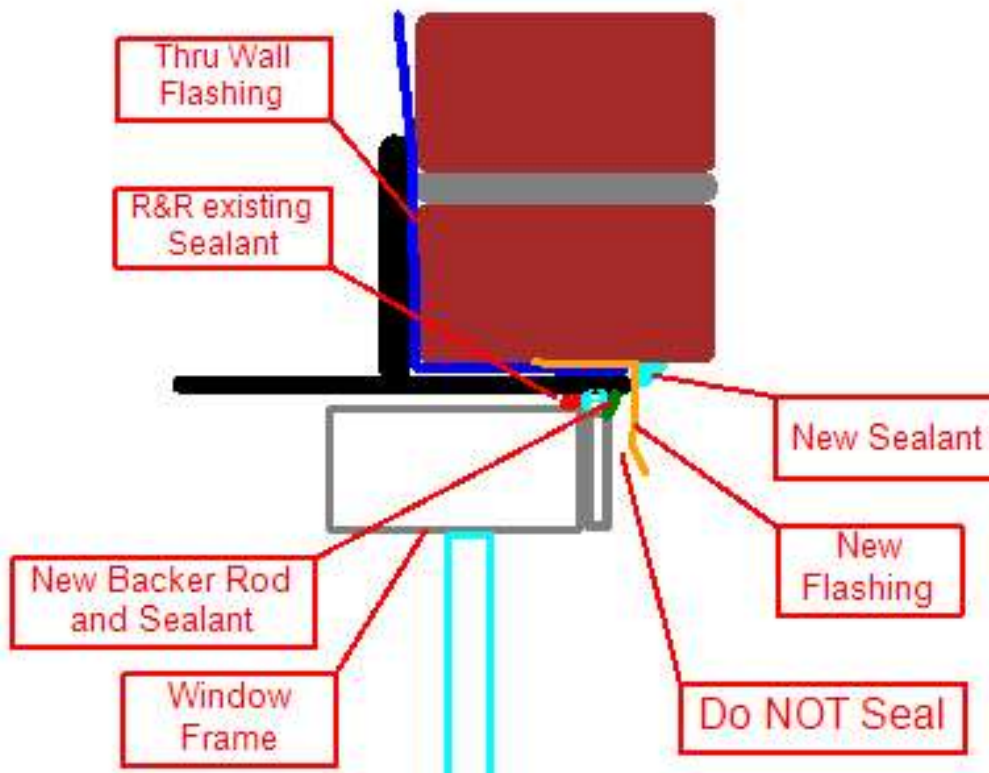
Suggested Test Repair

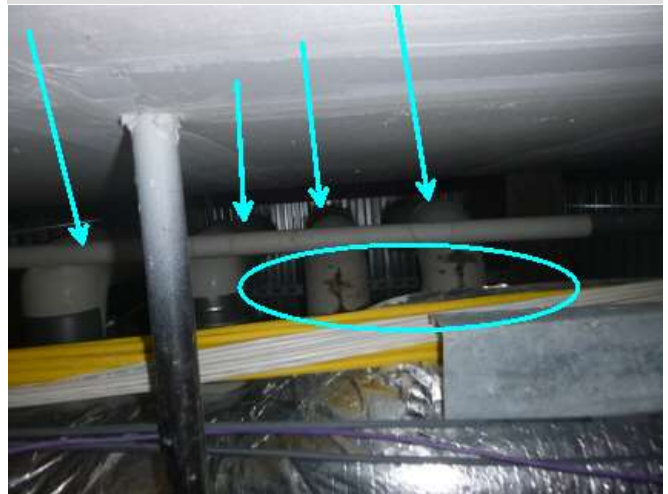
Removal of tiles showed pipe penetrations at 2nd floor (arrows). Visible leakage (circle).

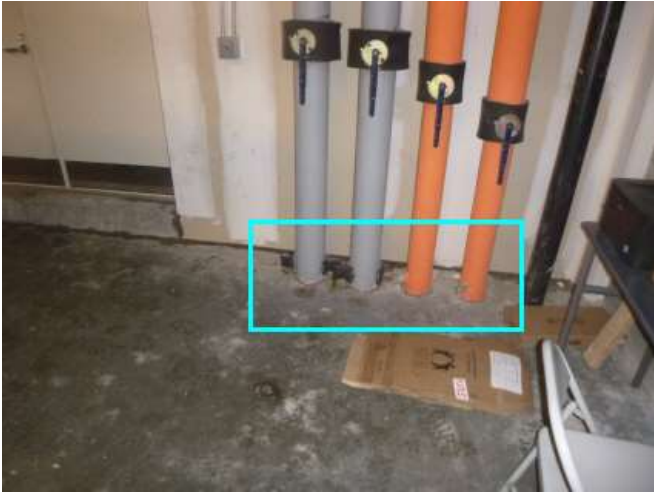
Pipe penetrations above leak area. Leakage noted through penetrations below.

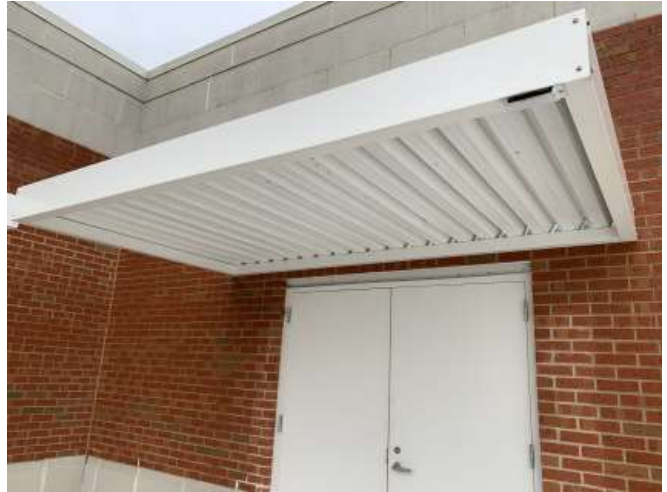
Mechanical Room directly above Leak area 1
Awning has been installed

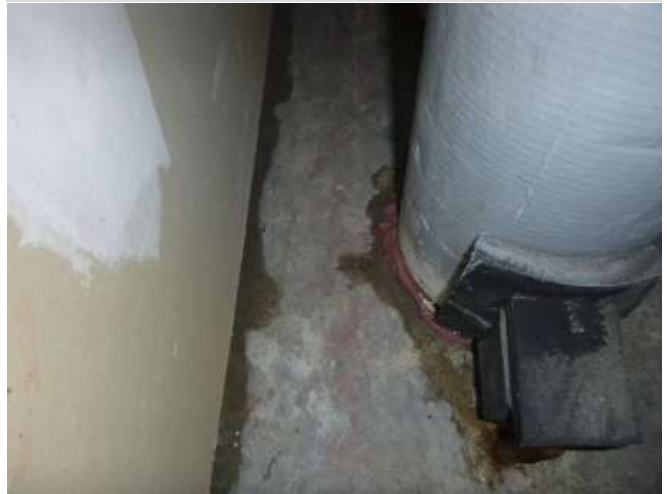
Visible leakage into mechanical room during tests

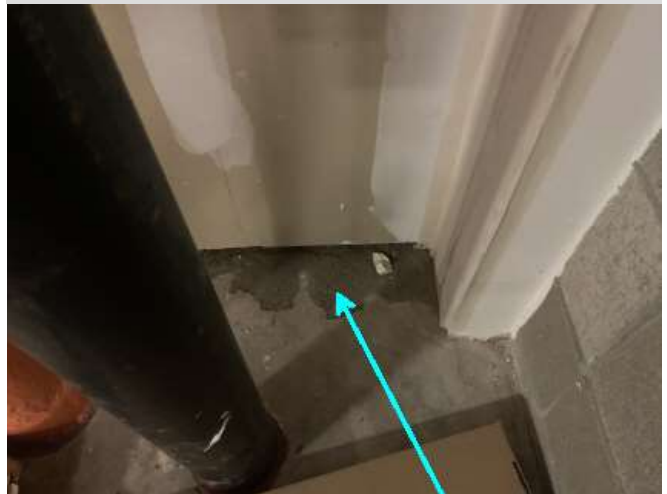
Test of through wall flashing produced leakage into the mechanical room and leak area 1 below. Through-wall flashing likely missing proper overlaps and end dams.

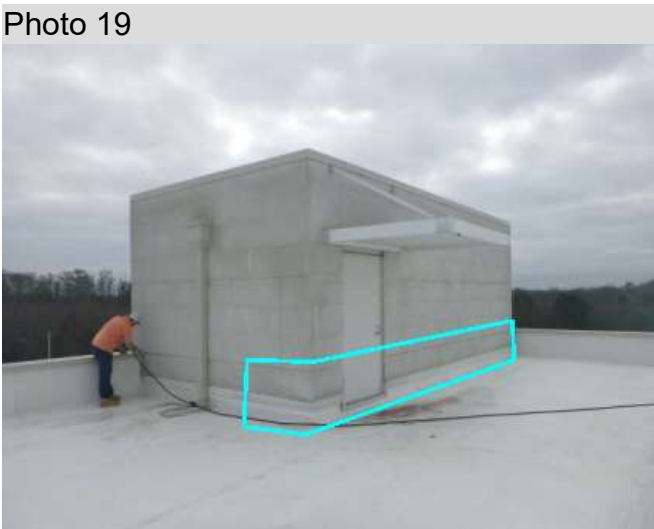
Leak area #2 at SE stairwell roof access door and administrative office stairwell entryway (also admin conference room).

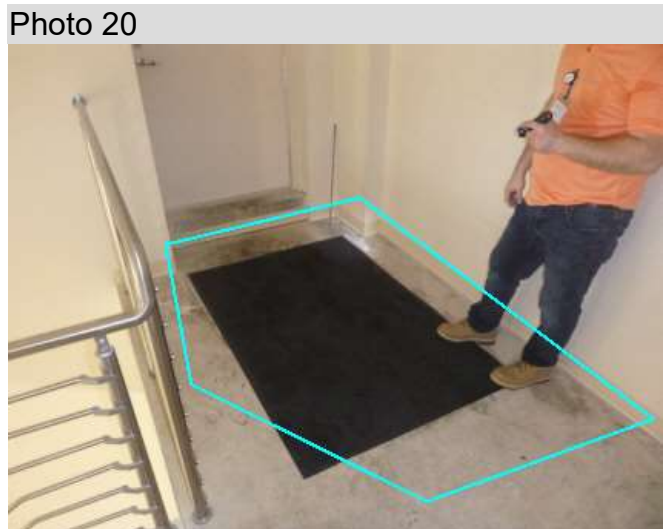
Water reportedly ponds this whole area. Evidence of ongoing leakage ie water stains and efflorescence.

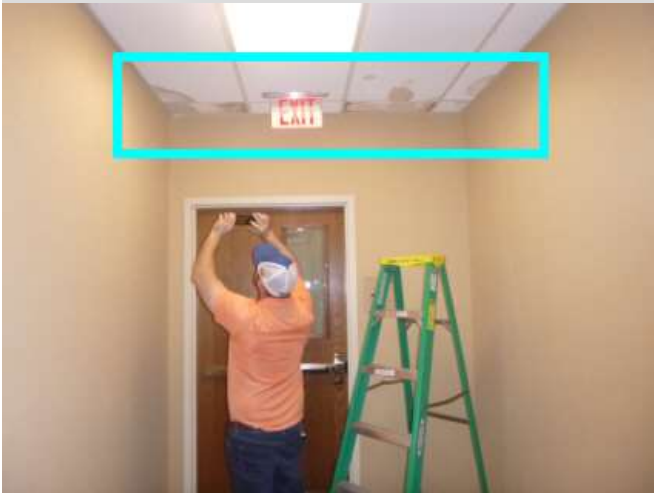
Leak area below in ceiling at admin stairwell entryway

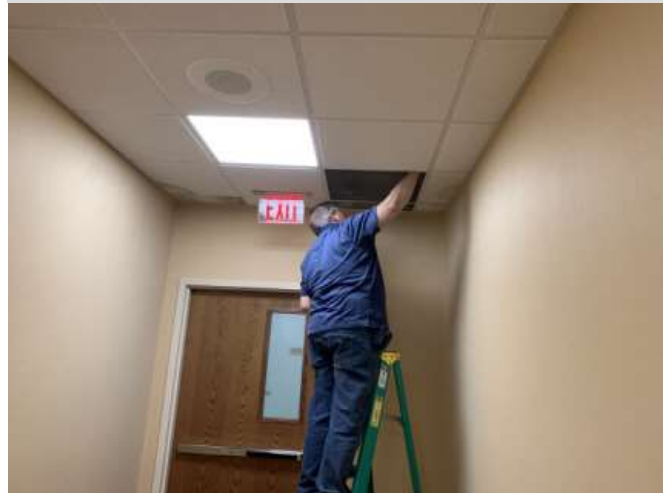
Inspection of area above ceiling shows water stains and rust stains.

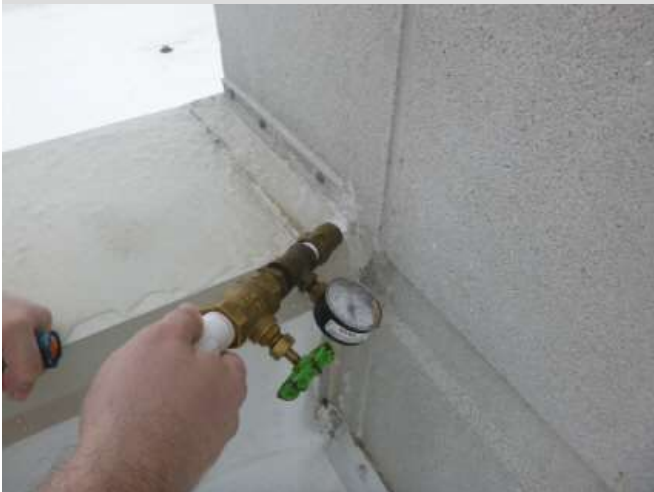
Tests of flashing terminations did not produce visible leakage

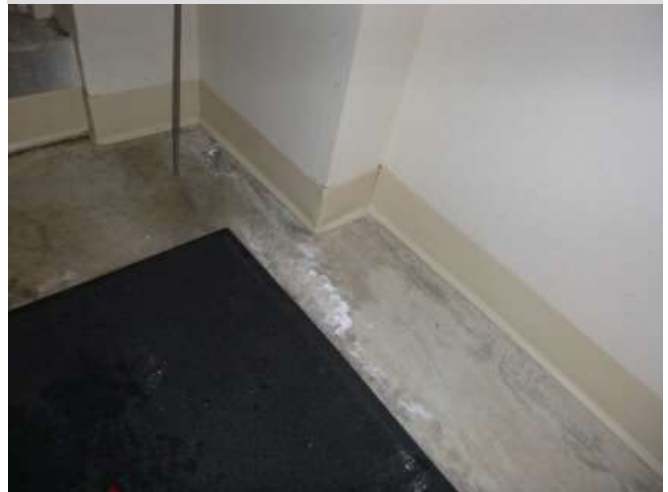
No visible leakage note with test of roof / doorway and flashings

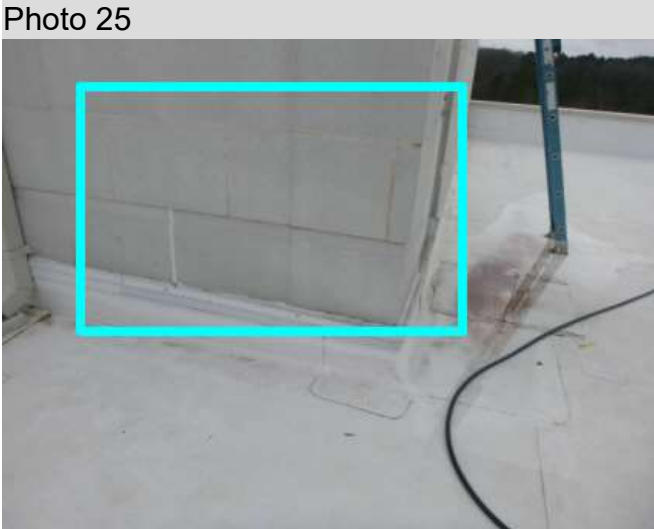
Water tests of mortar joints gaps and cracks in stone produced the reported leakage

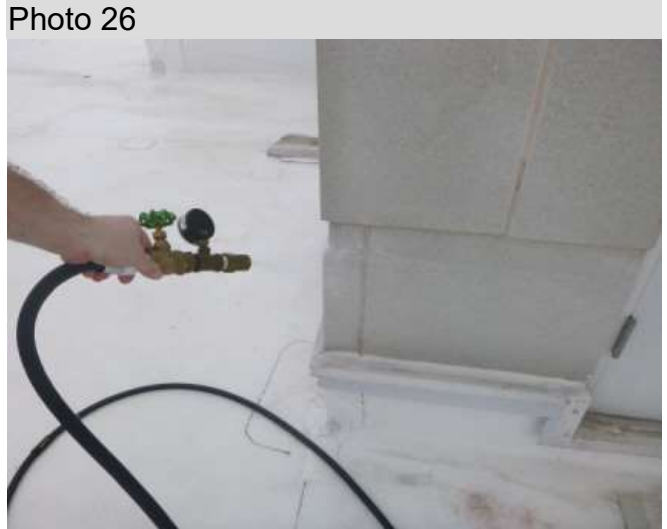
Water test of stone joints

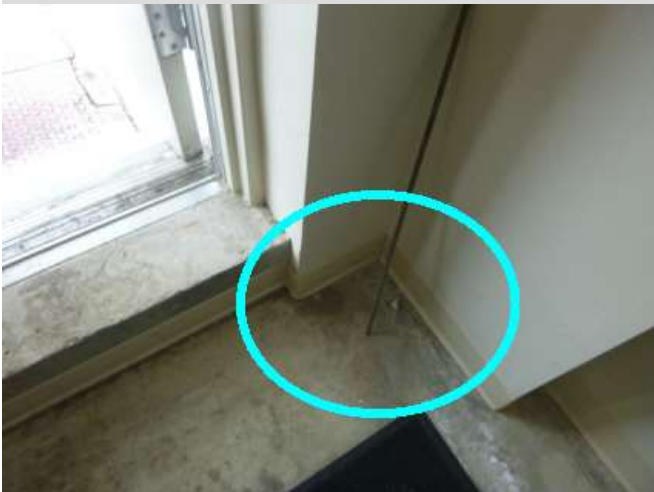
Leakage onto stairwell floor noted.

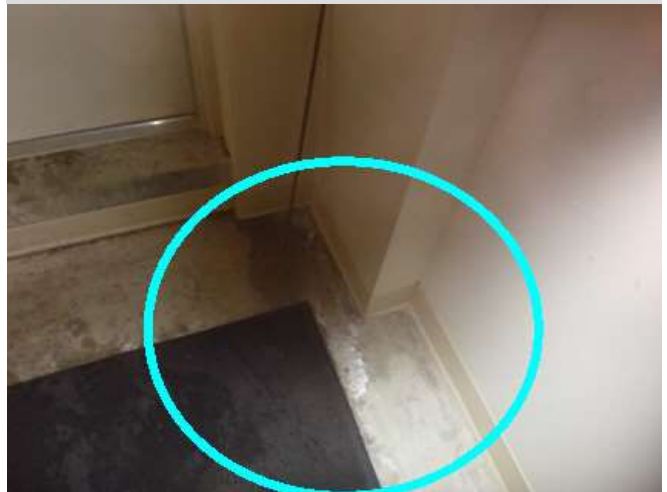
Leakage spread across floor and leaked into admin ceiling area below.

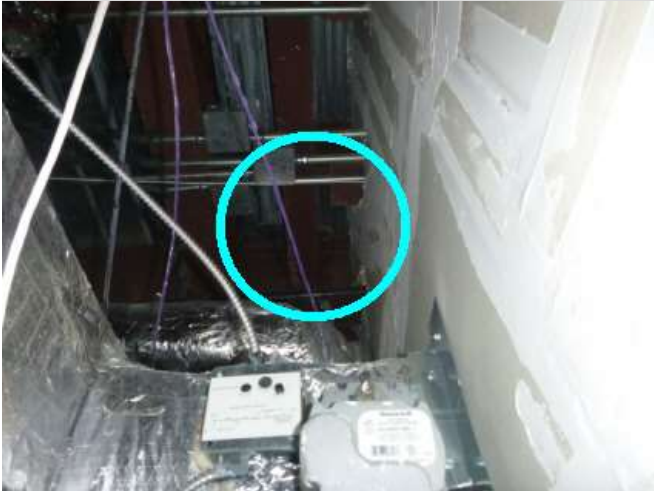
Visible leakage noted during test same area as stains and rust

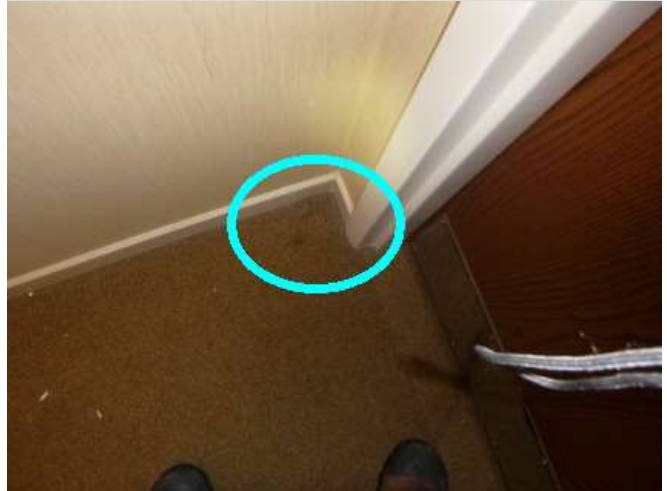
Water dripping onto carpet during test - same area as stain on ceiling tile.

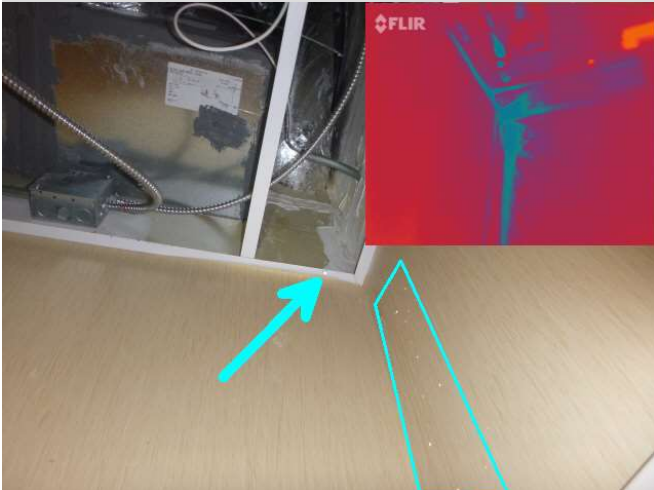
Visible leakage noted during test. IR (top right) better shows water flow.

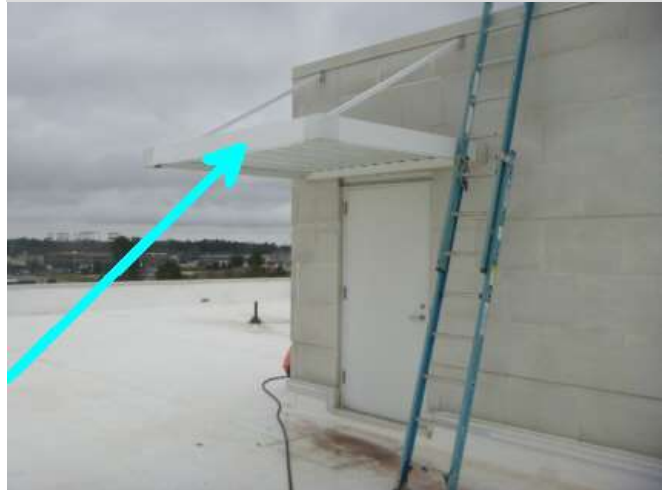
Awning has been installed to reduce door exposure to weather.

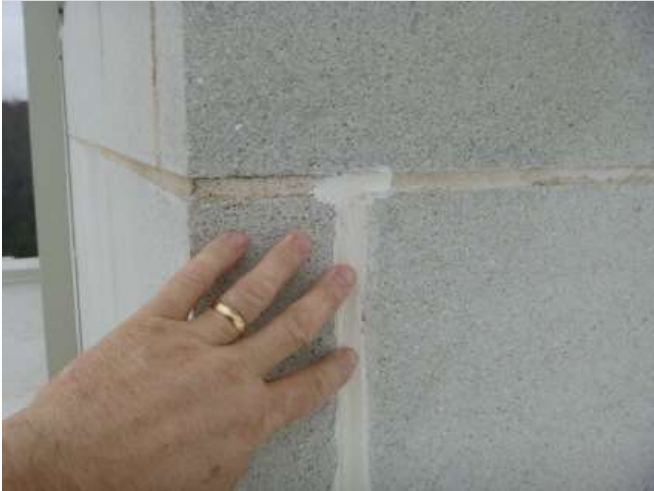
Example of sealants used in attempt to seal crack in stone mortar joint

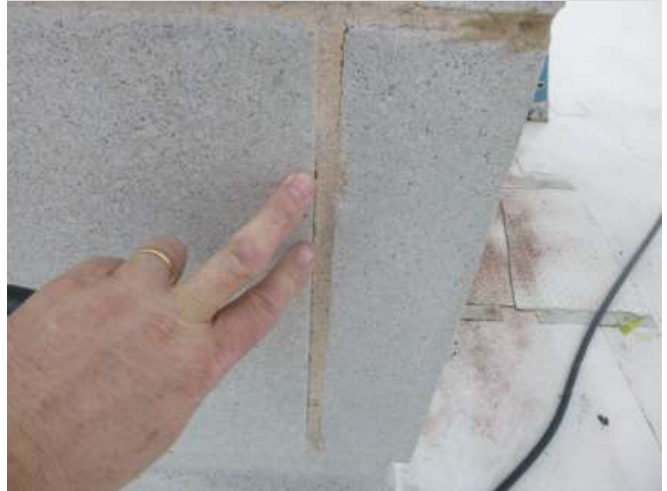
Example of crack in mortar joint - many noted like this. Can cause capillary suction into wall cavity

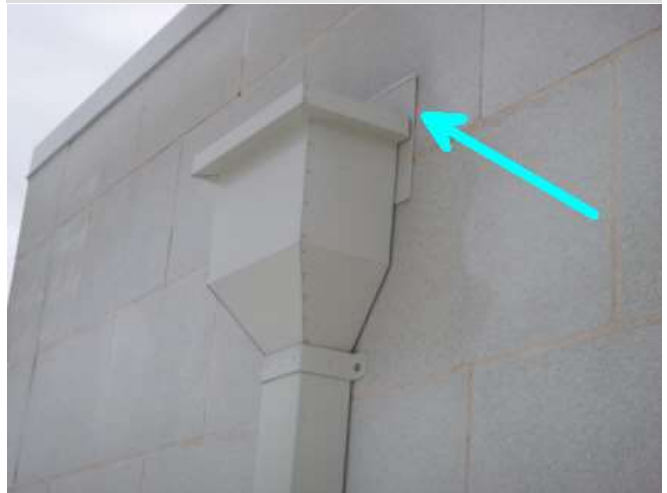
Sealants at ALL scupper catch box details and face plates should be professionally resealed to help prevent water intrusion into wall cavity.

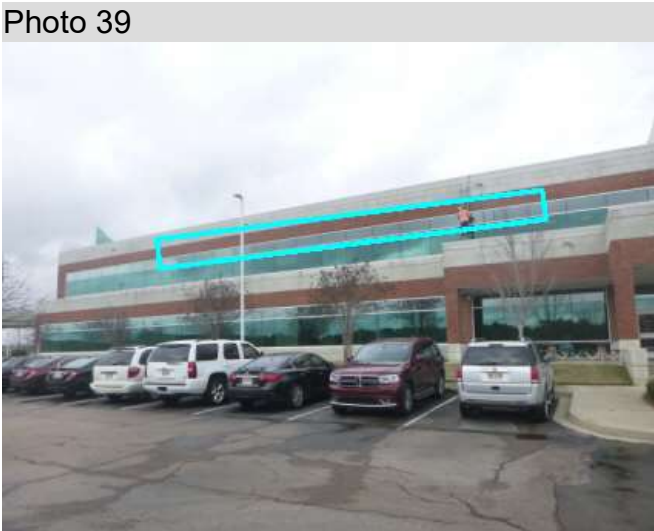
Leak area #3 - leakage at tops of various administrative office windows.

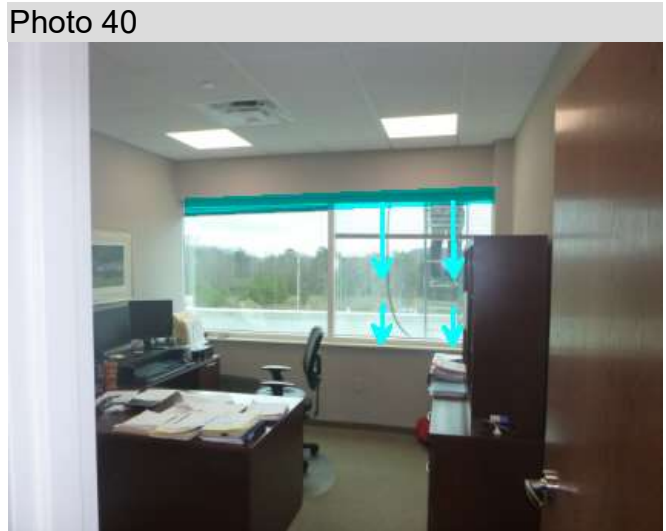
Leakage enters at tops of windows and migrates down to window sills.

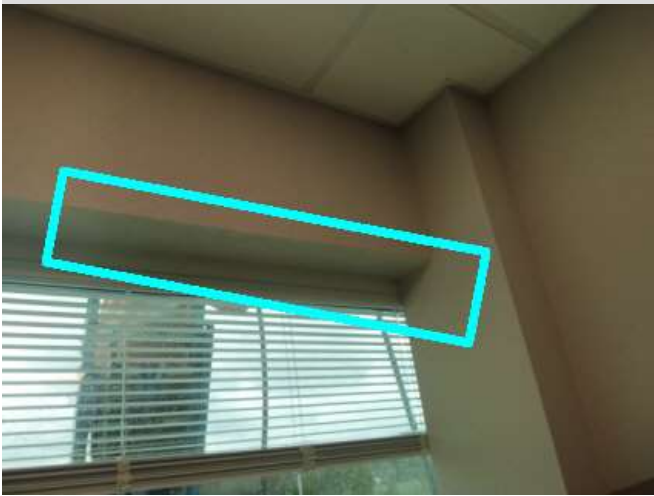
Water stains noted various areas at sheetrock at tops of windows.

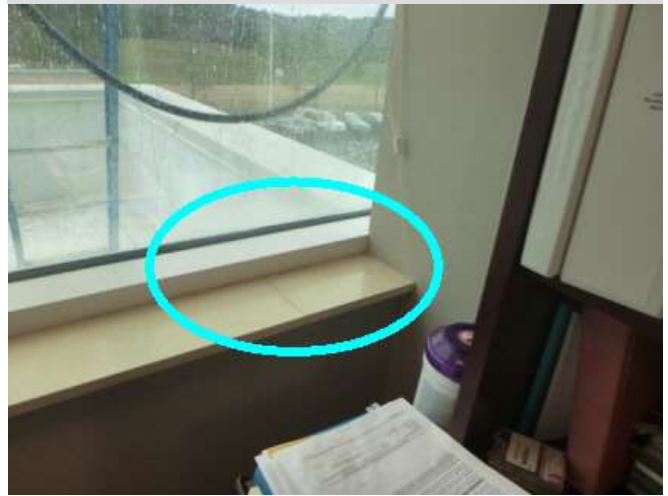
Water ponds at window sills.

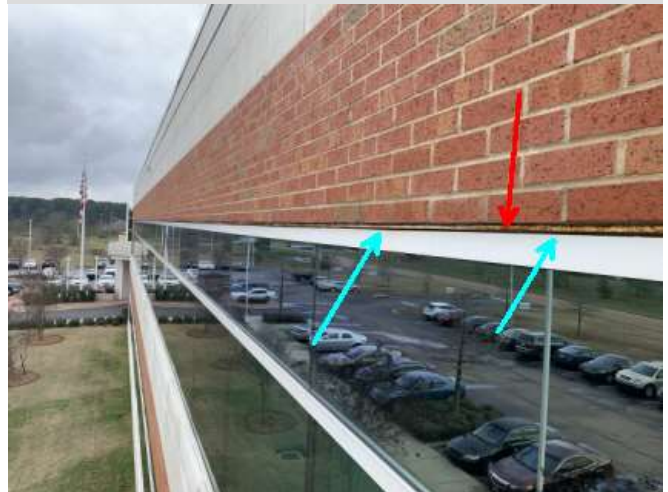
Noted missing sealants at bottom of angle ledger (blue arrows). Angle iron itself shows some rusting (red)

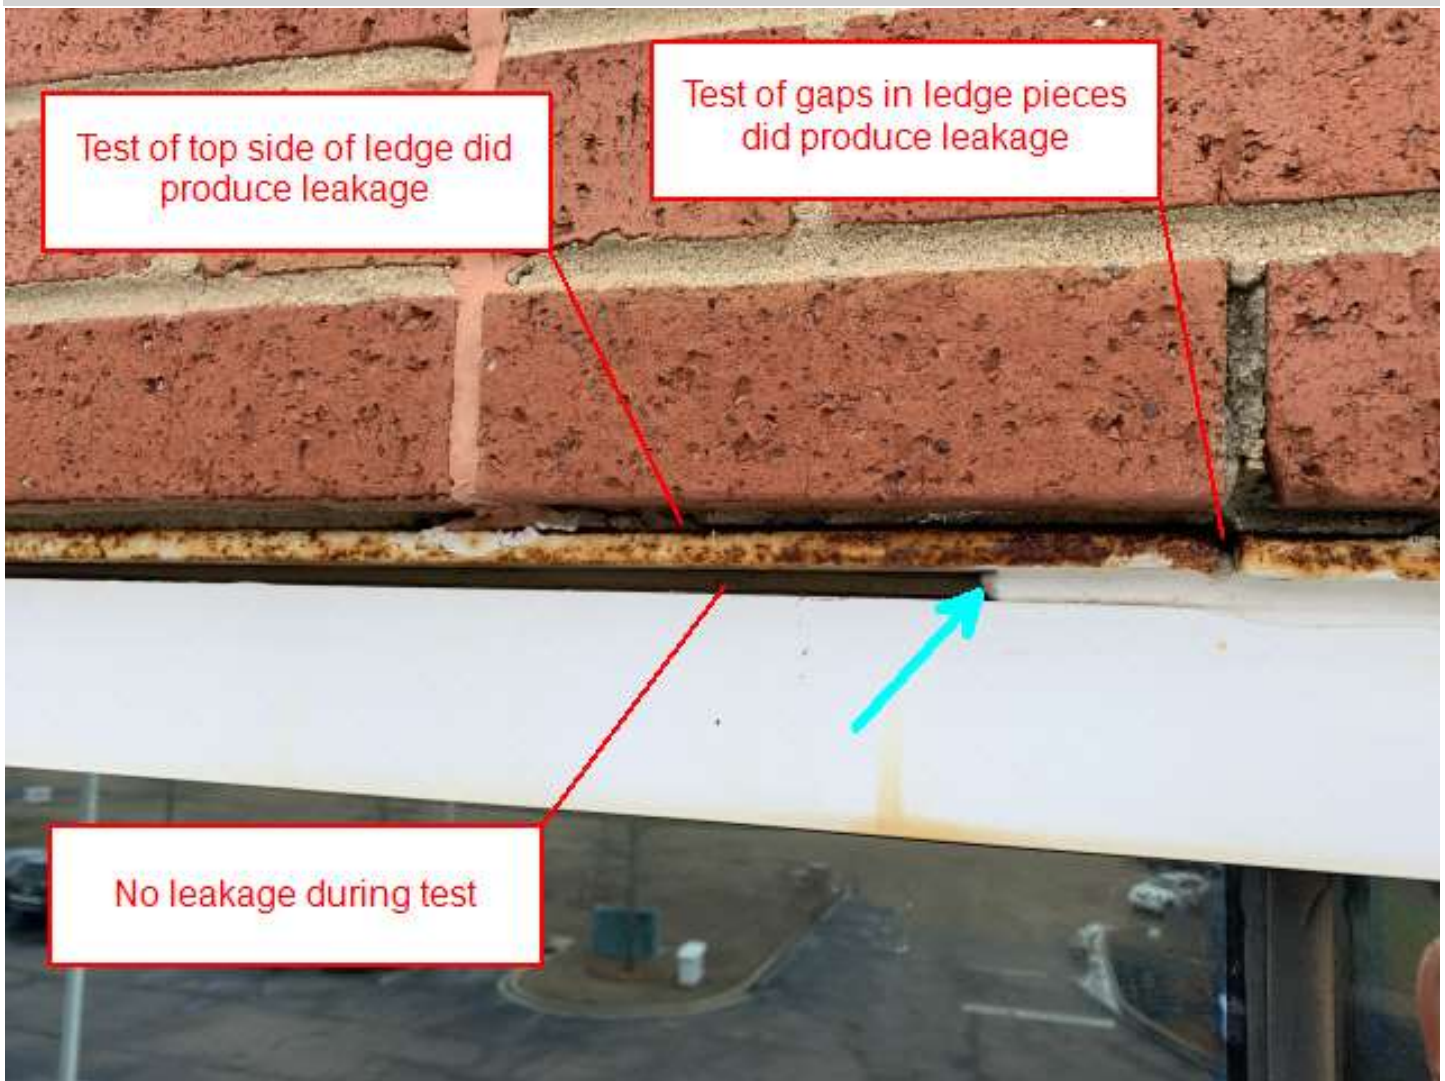
Example where sealant stops (blue) although no interior leakage was produced testing this area. Areas above ledge angle and gaps in ledge angle did produce leakage.

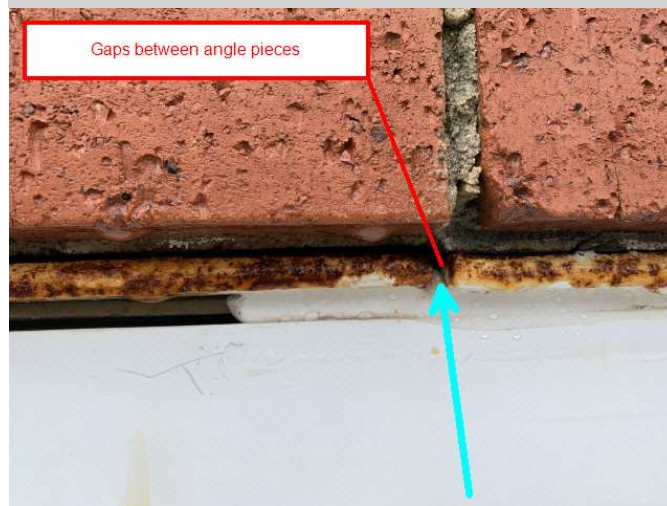
Test of gap in brick angle ledge pieces produced leakage.

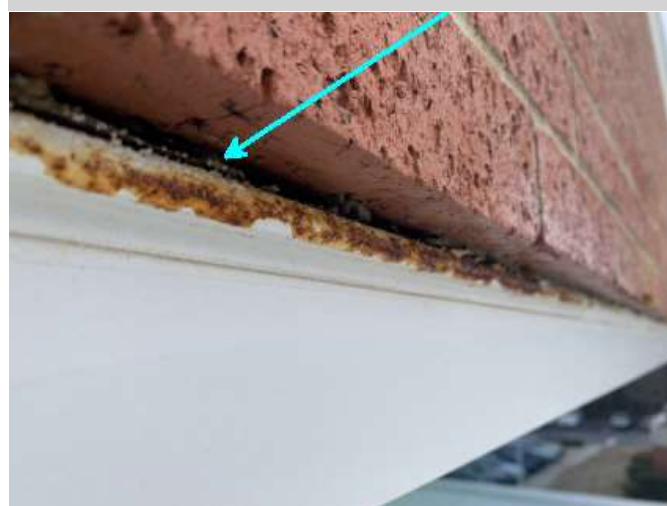
Close up of brick angle ledge above windows - test of upper side of angle produced leakage

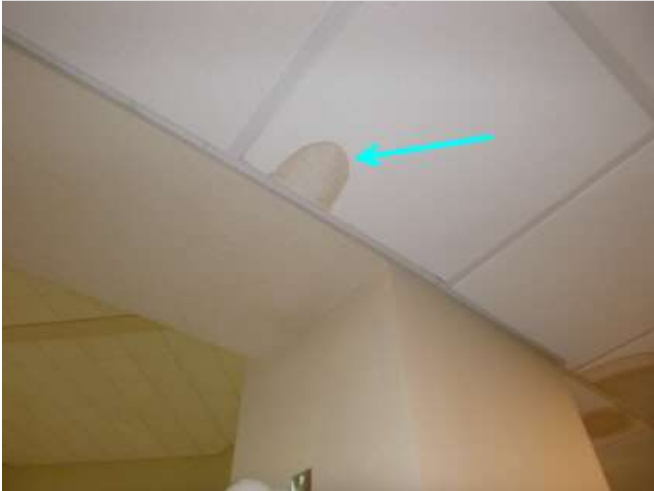
Water stain at north side of column

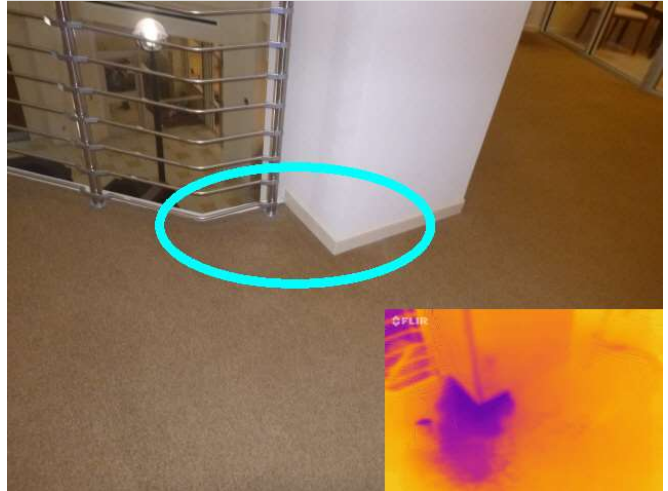
Wet carpet at base of column. Infra red (bottom right) shows wet.

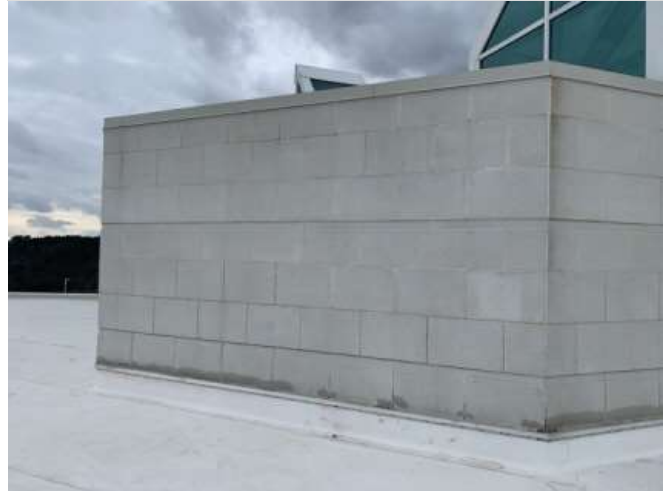
Exterior wall water test areas above leak area

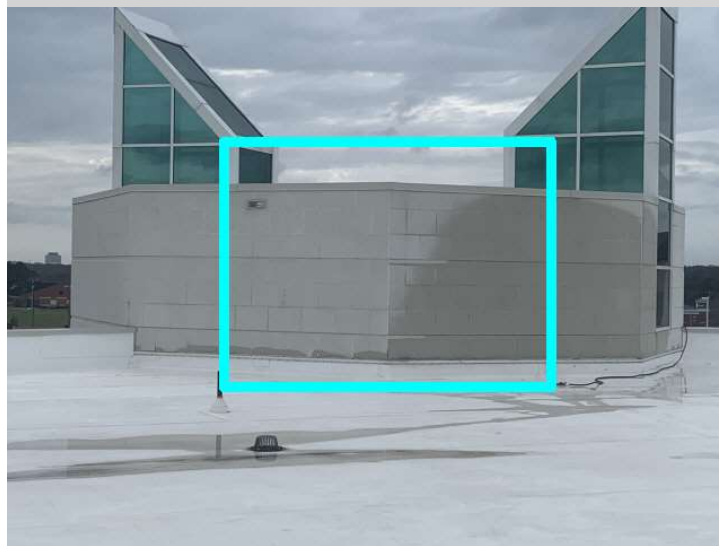
Darkening color of block when wet indicates the stone is not sealed.

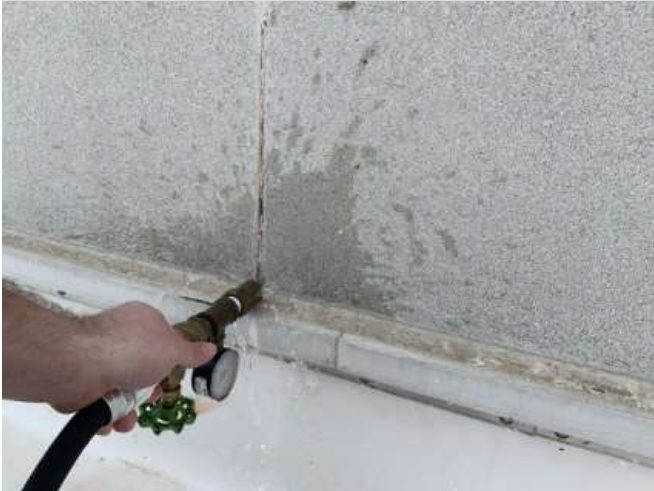
Water test in progress

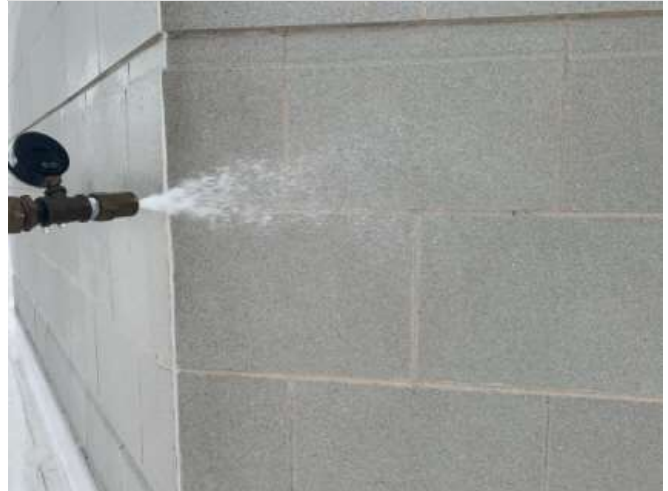
Water tests of block wall produced leakage.

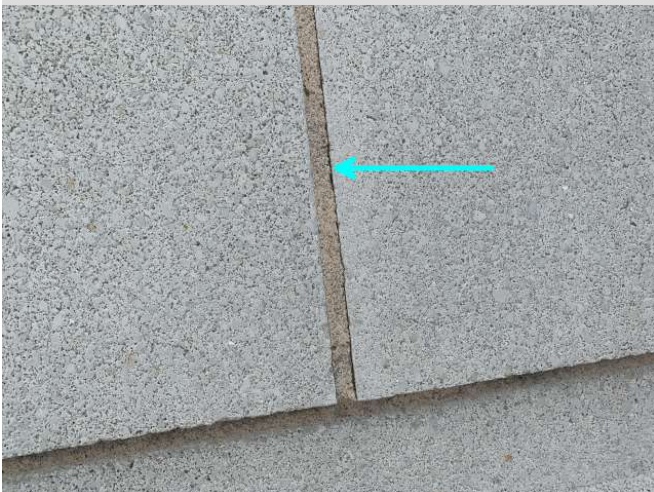
Example of typical crack in block mortar in test area (many like this)

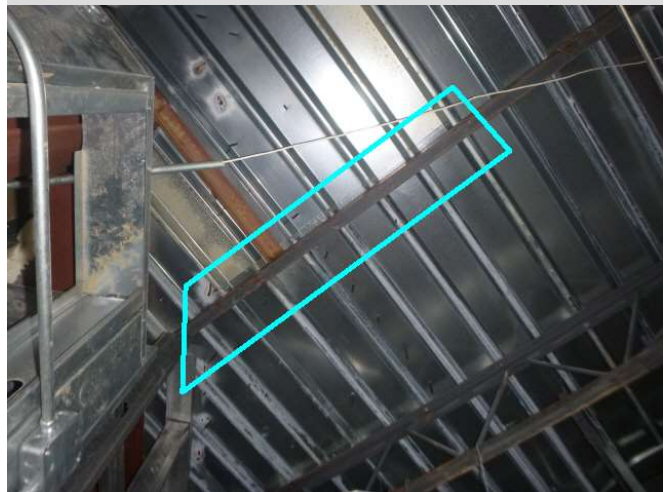
Leaks produced between seams of roof decks in area directly below wall during tests.

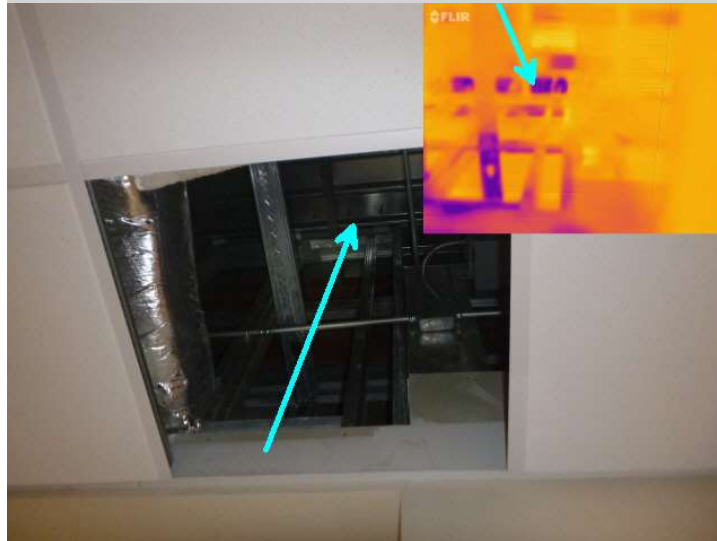
Leakage produced during testing directly above column, water ran down column and wet carpet at base of column .

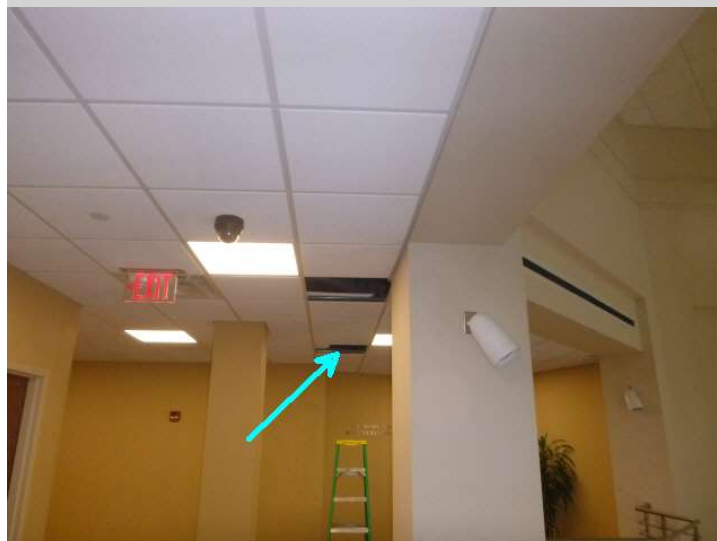
Leakage noted along roof deck rib further along walkway

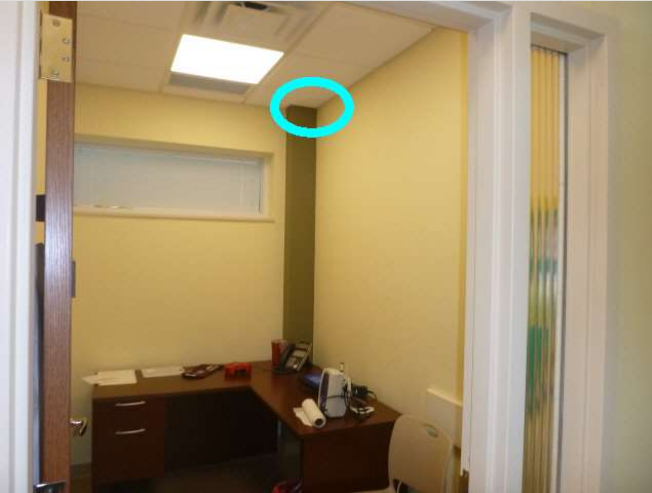
Interview room small stain

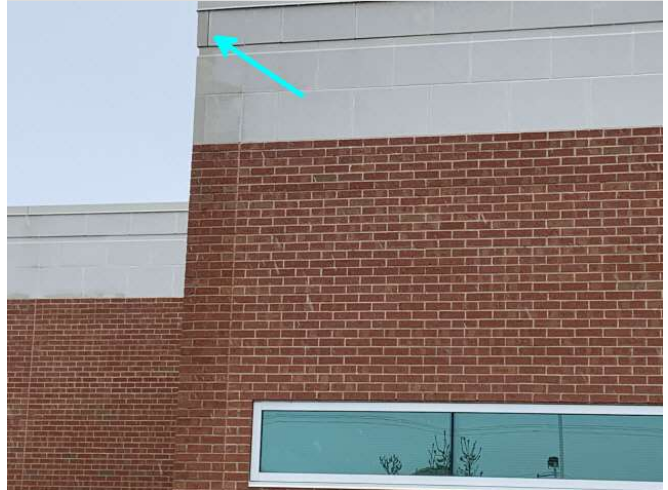
Large gap in stone mortar joint noted at corner

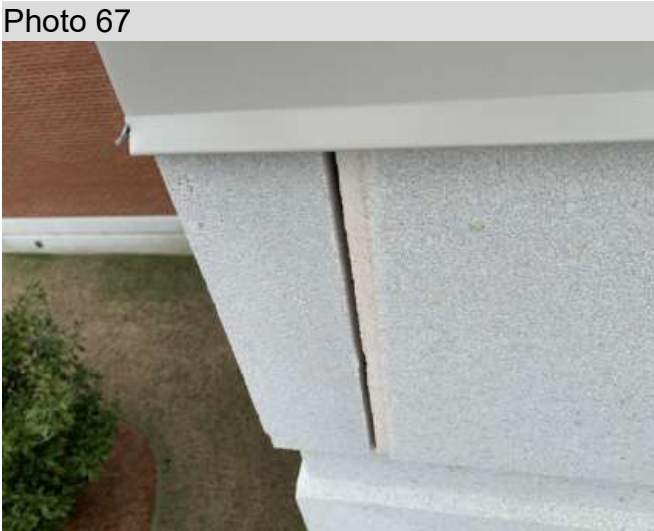
Closeup of large gap above the leak area in the corner interview room

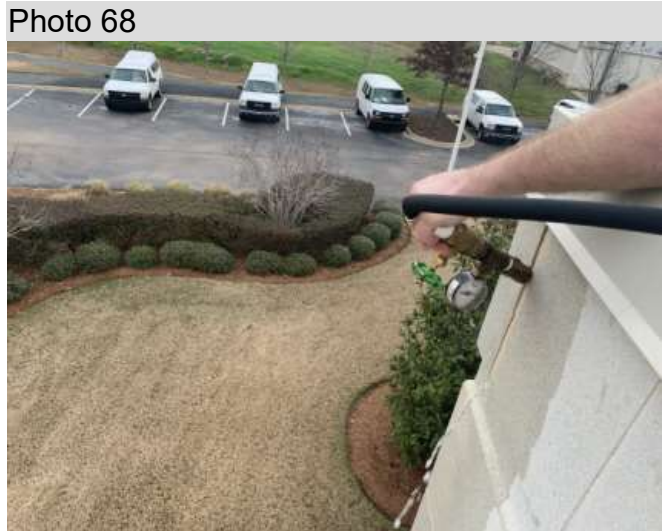
Water test of the gap did not produce the reported leakage.

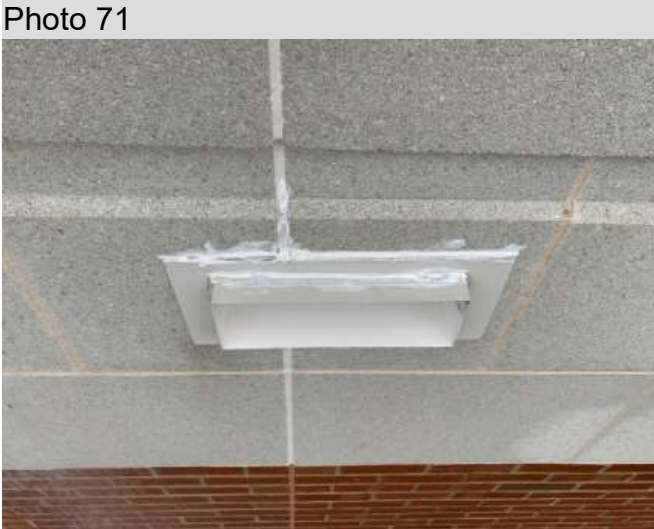
Close up of scupper shows unprofessional sealant application

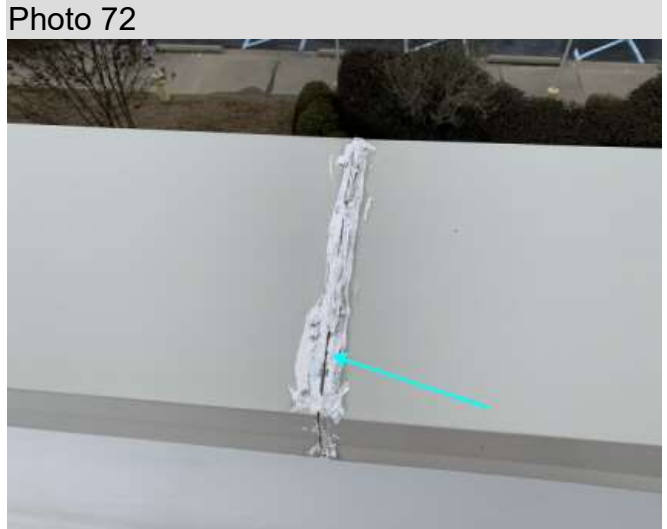
All coping seams and corners should be professionally resealed (improper as sealed)

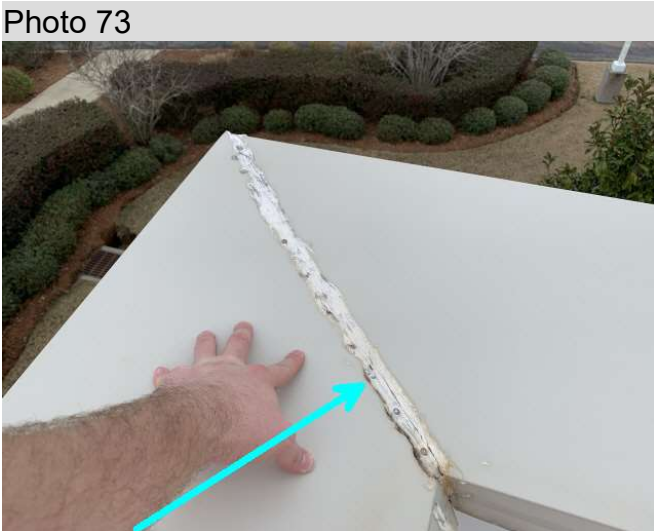
Water test of corner coping seams did produce the reported leakage.

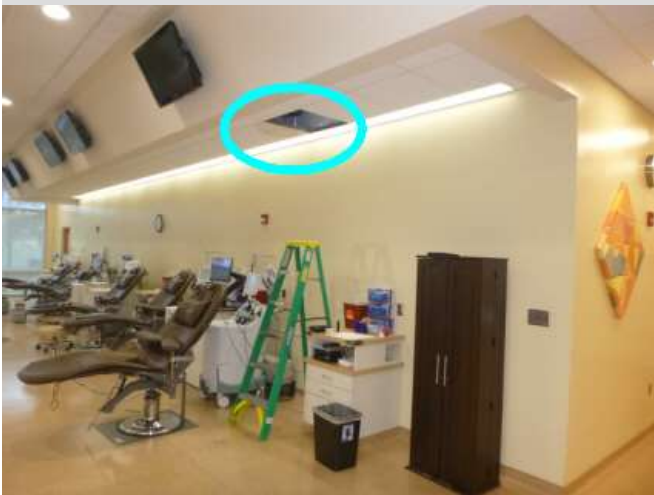
Water stain from previous leakage

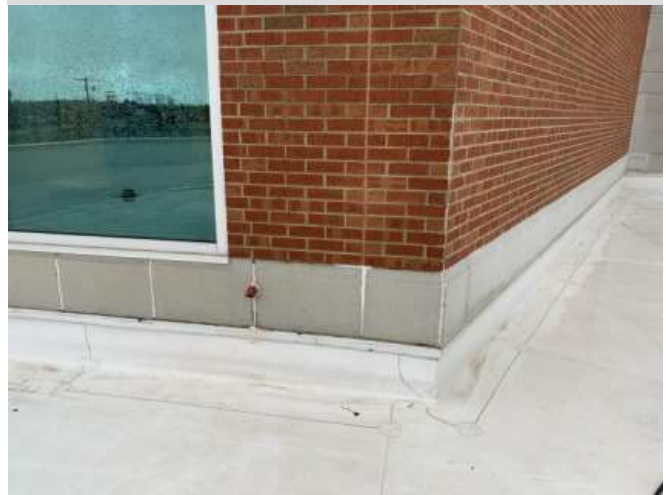
Exterior directly above leak area

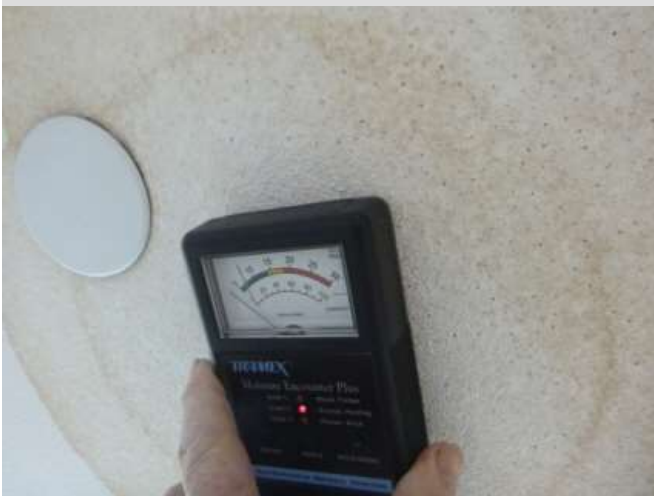
Moisture scan of water stain shows area is currently dry.

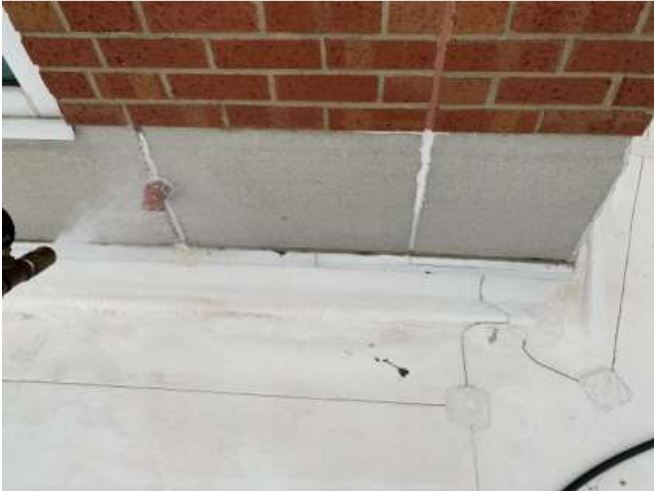
Water tests of various areas above leak area did not produce visible leakage during tests.

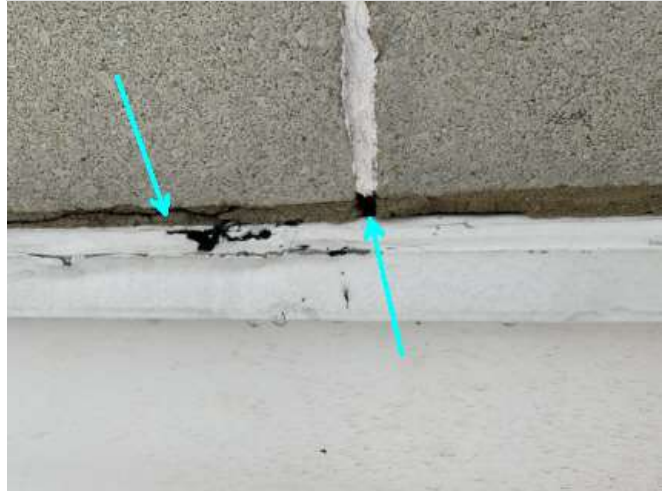
Gaps and cracks note in mortar
