**Water Intrusion Assessment
Property Address
City, ST 12345**

ATTN: I. B. Client

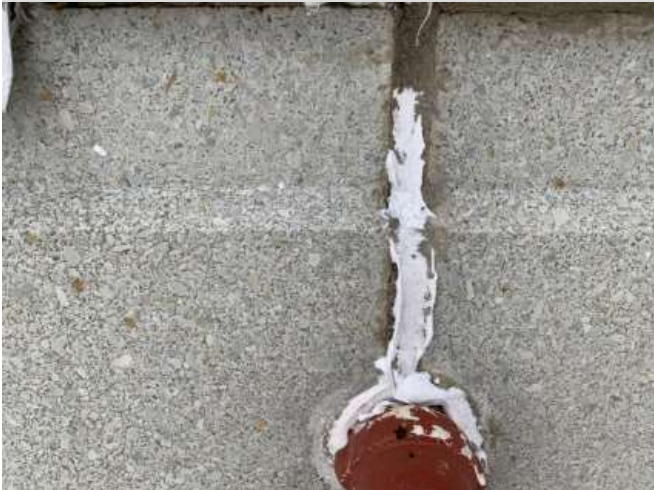
Previous repair attempts with sealants (not professional application)

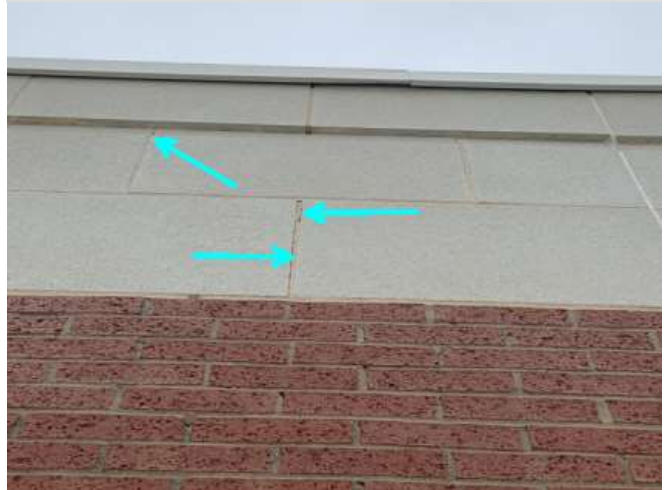
Example of cracks in stone mortar

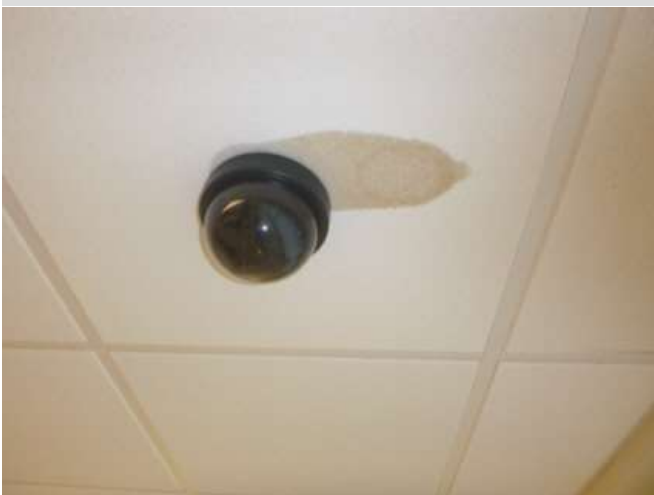
Small leak area at camera

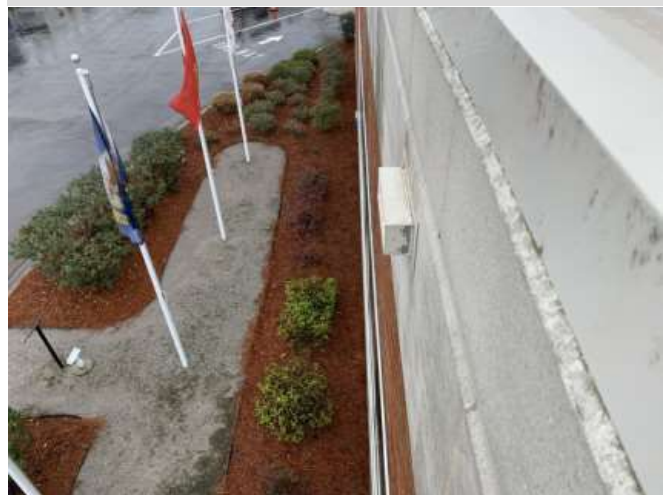
Exterior of Leak area #7

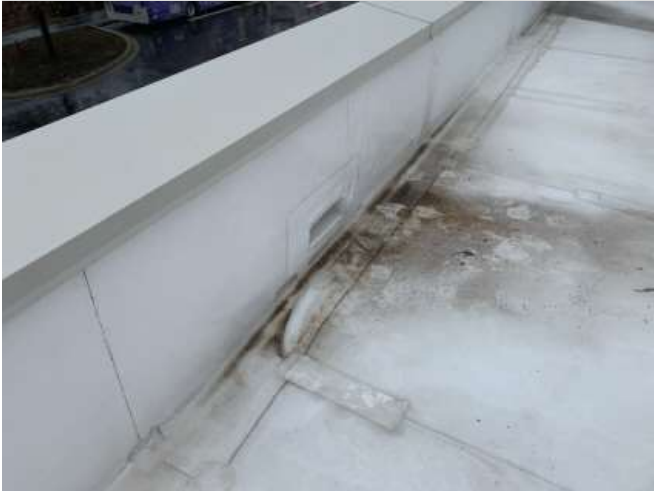
Test of roof area and coping above leak area did not produce any visible leakage

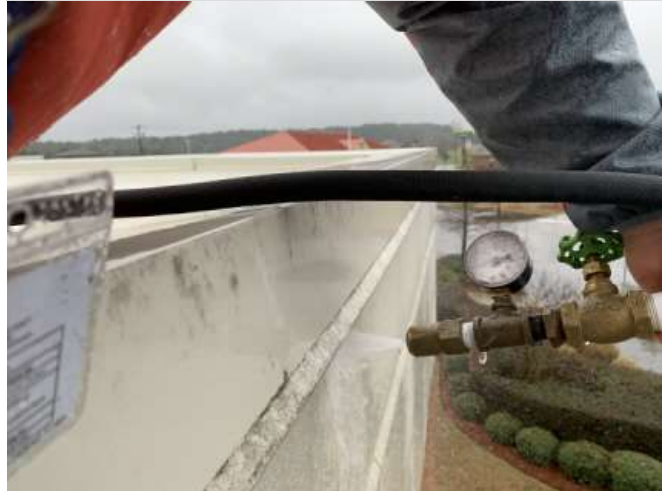
Water test of gaps in the exterior block wall below coping produced leakage in exact location of interior.

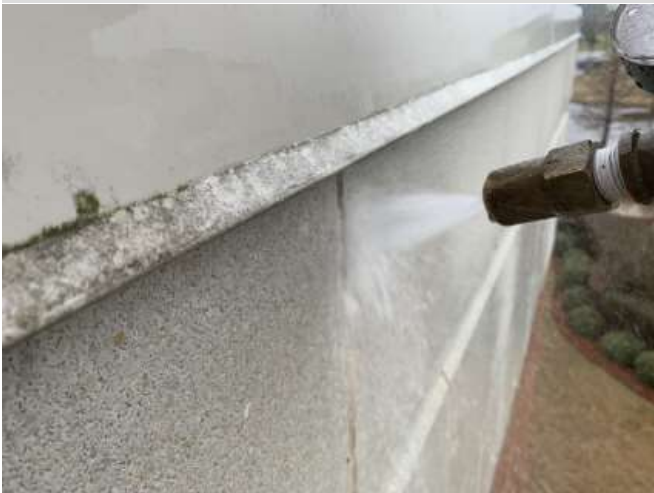
Water test of mortar gaps / cracks produced reported leak.

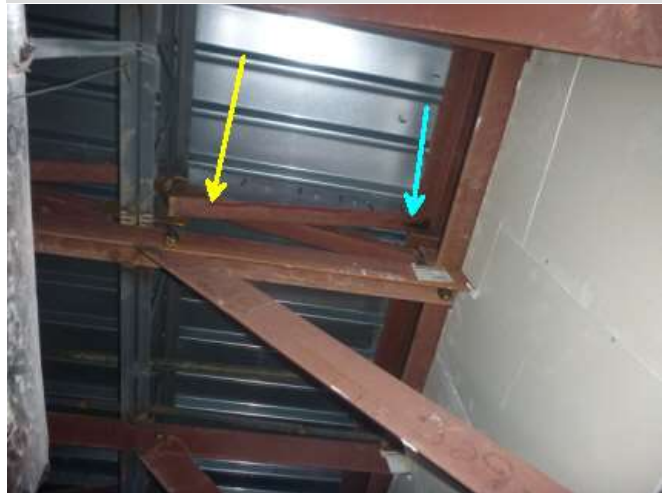
Small leak came in at exterior wall roof deck juncture (blue) and ran down the angle iron cross brace and drip to exact area of stain (yellow). Note active water trail visible.

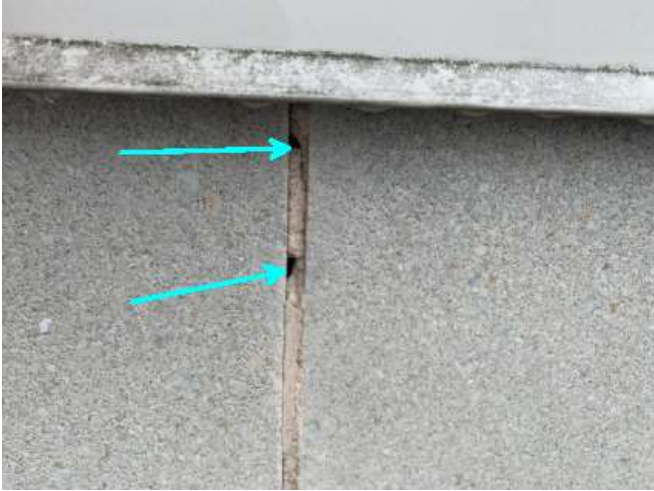
Typical crack / gap noted in stone mortar joints (area tested)

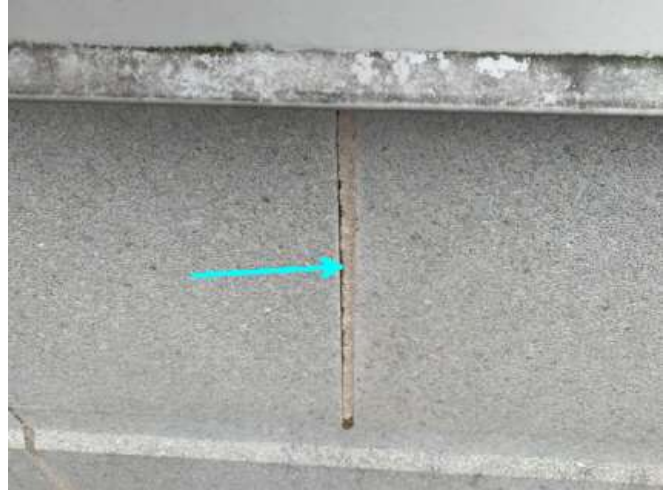
Typical crack block mortar

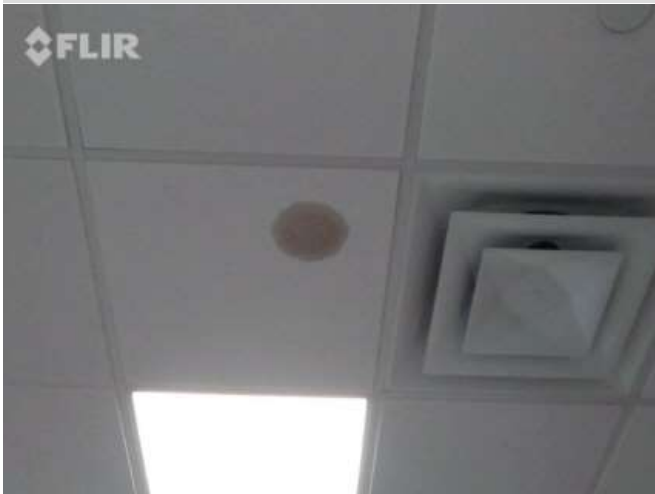
New water stain noted below drain in front entryway

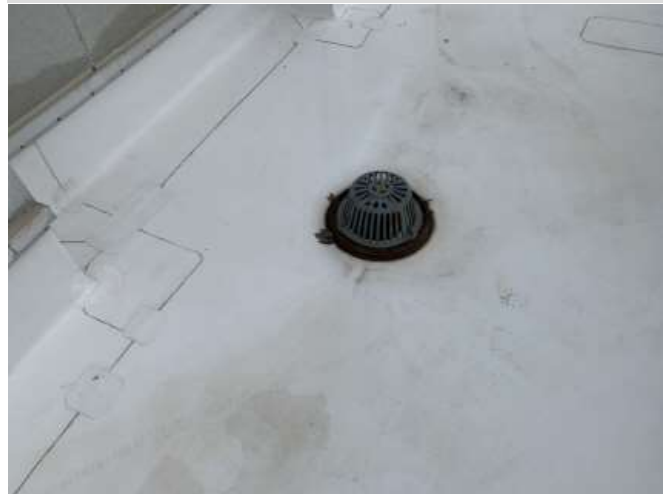
Roof drain directly above stain in front entryway

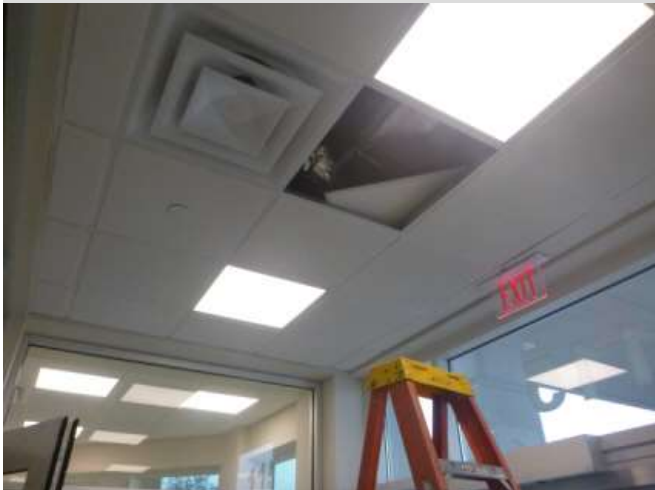
Removal of tile to inspect leak area.

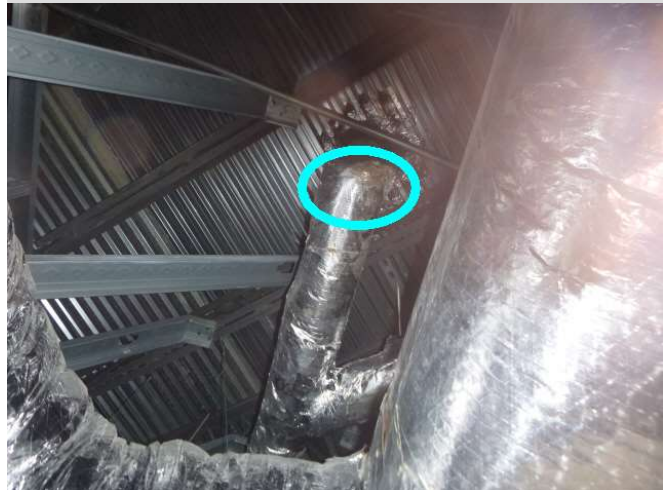
Elbow in roof drain directly above stain in entryway

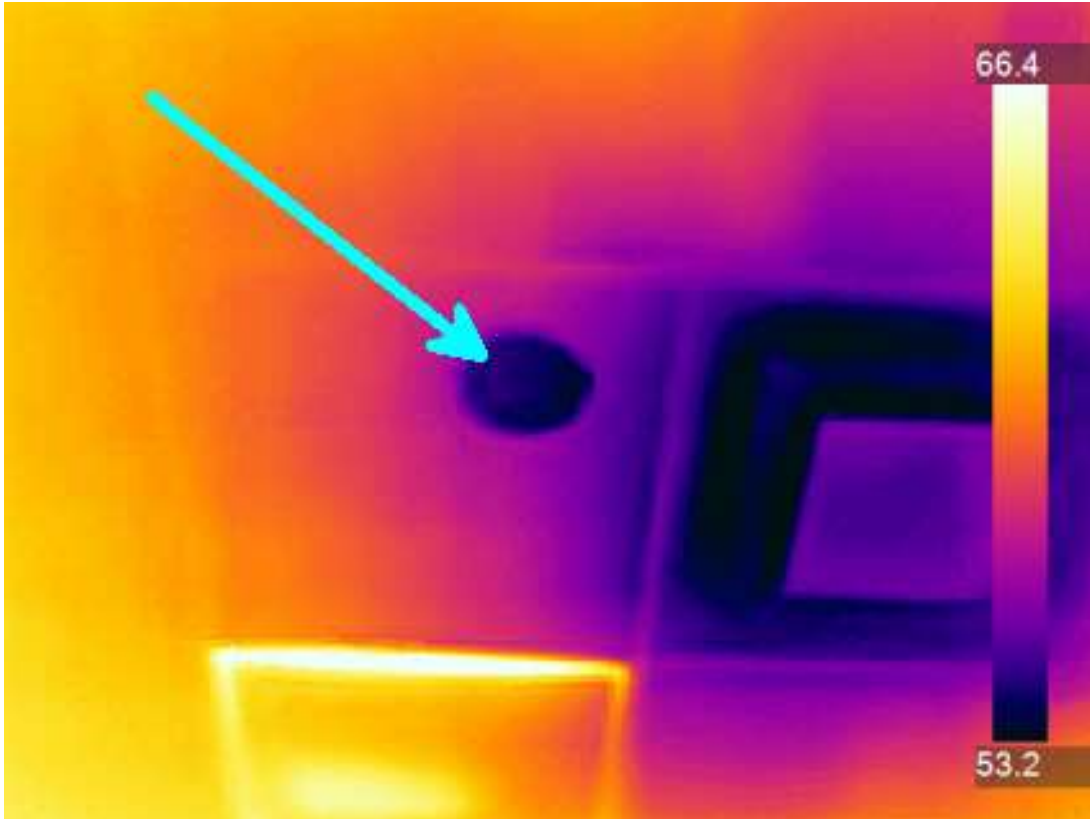
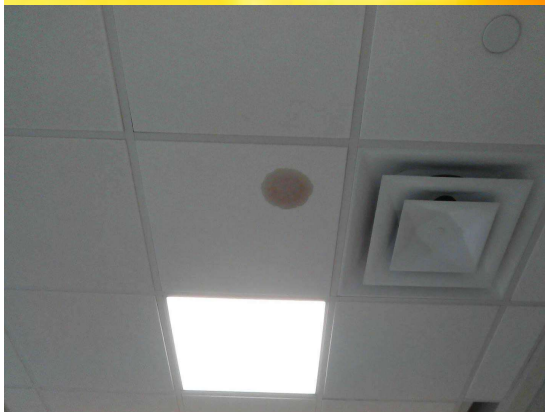
Camera Model: FLIR ONE Pro
Max: 71.2
Min: 52.5
Atmospheric Temp: 68.00
Relative Humidity: 0.50
Distance: 3.00
Emissivity: 0.90

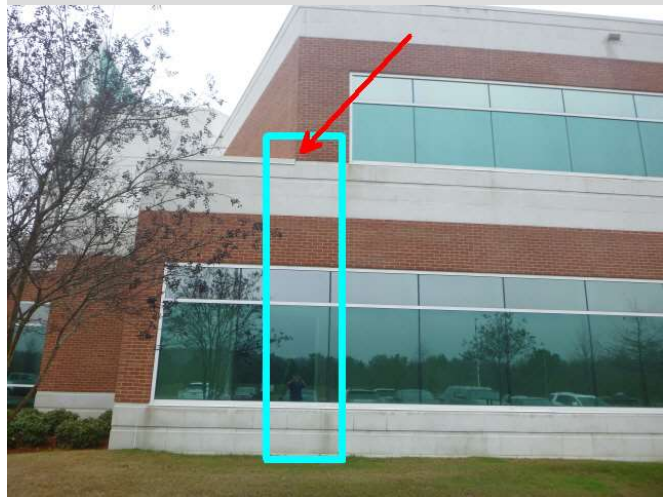
Exterior of leak area. Leak directly below lower roof termination into 2nd floor exterior wall (red)

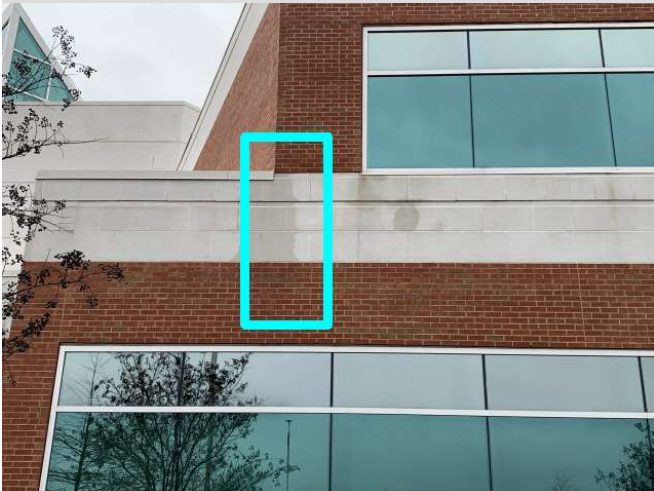
Roof to wall transition

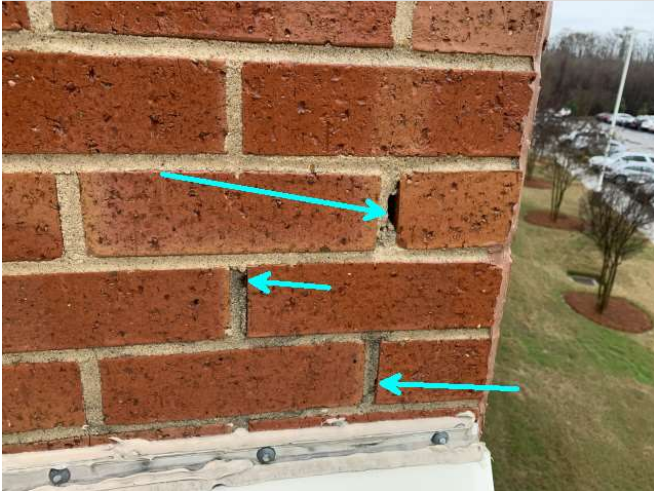
Gaps in brick above critical termination.

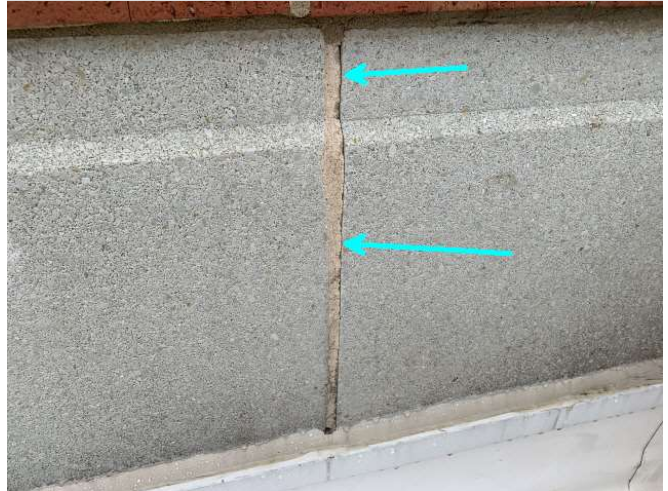
Cracks in nearby stone mortar joints

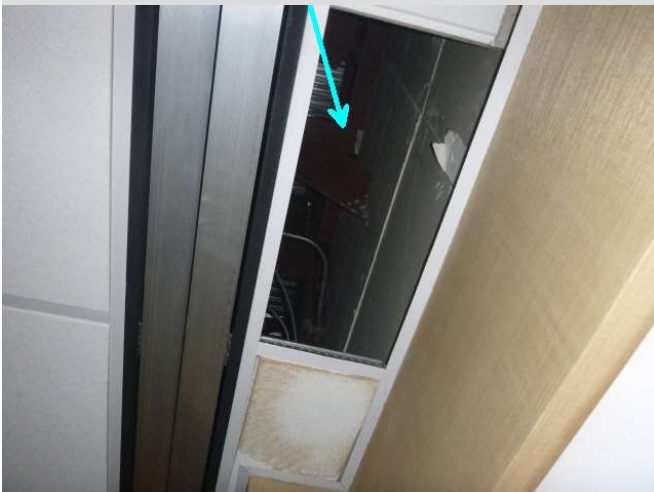
Leakage during test at transition

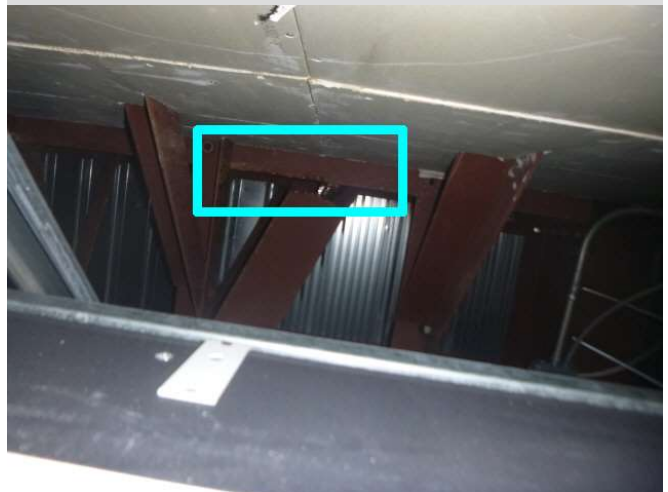
Water leaking in this area during testing

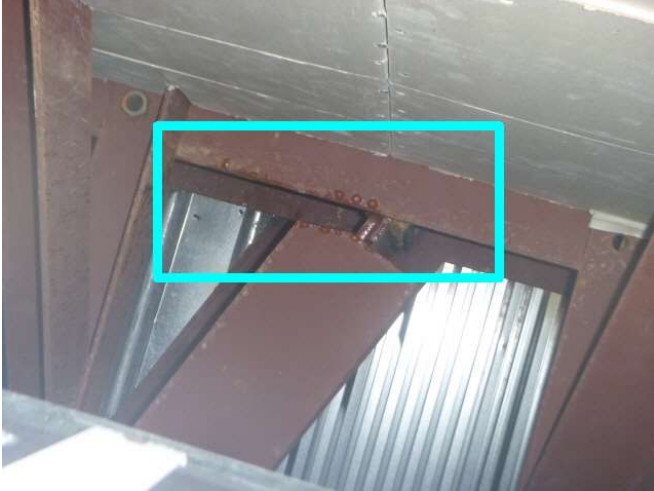
Visible water dripping during test
