the BUILDING CONSULTANT

Field Report **Attorney work Product** **Project Information**

15 Feb 2025

Field observation report for:**Overview:**

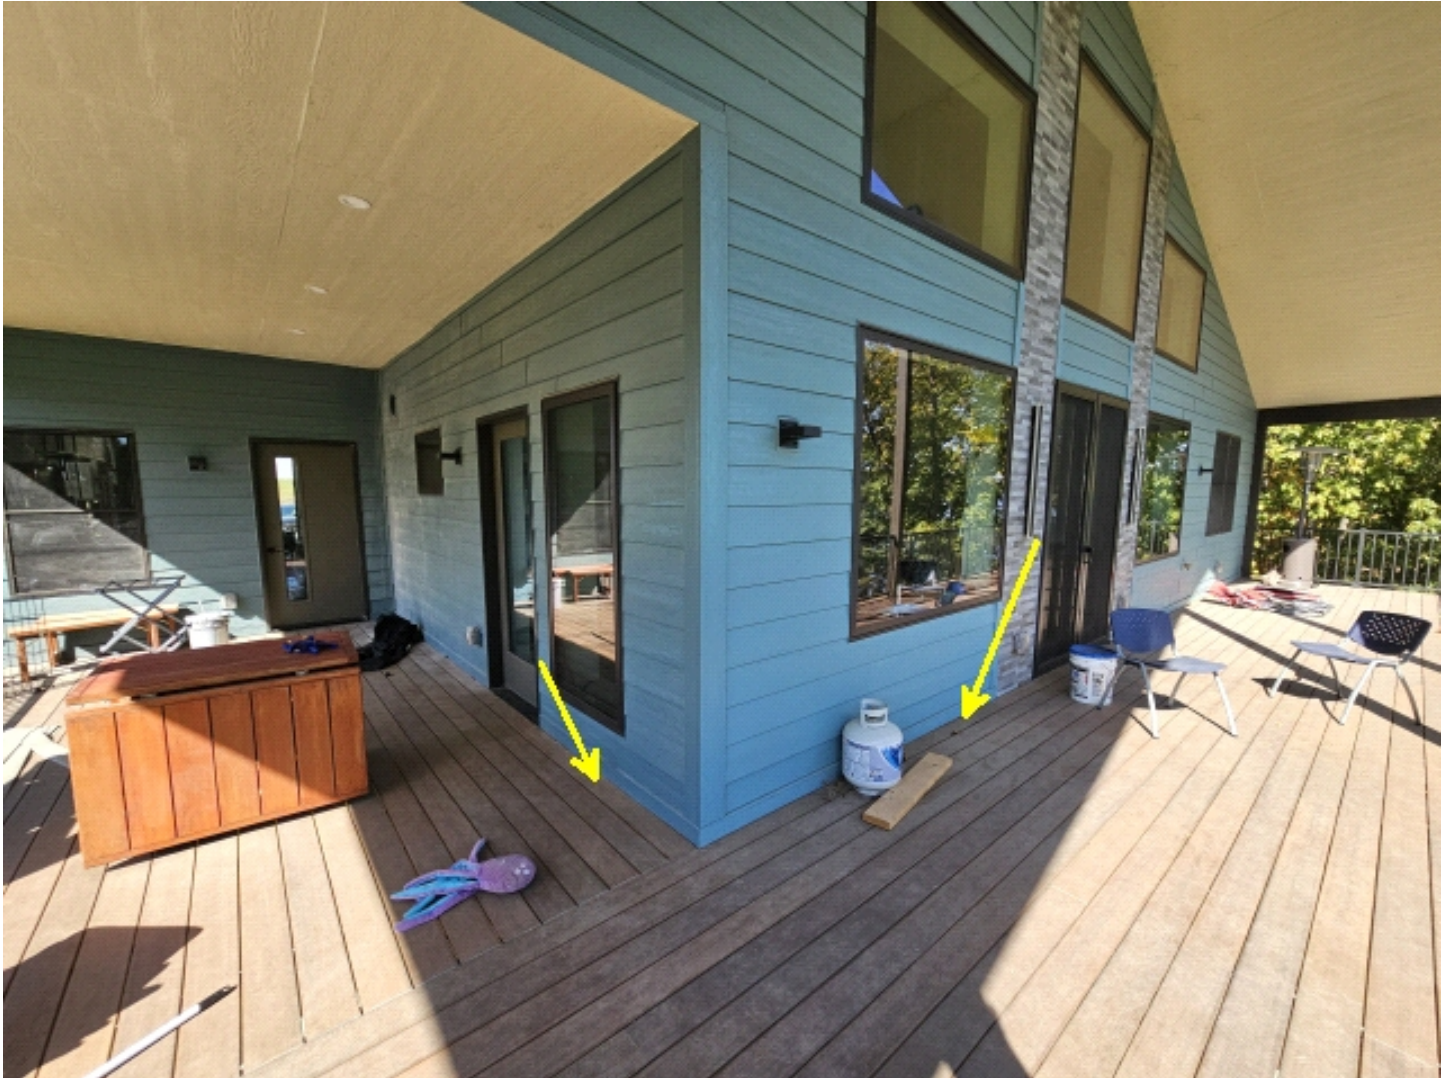
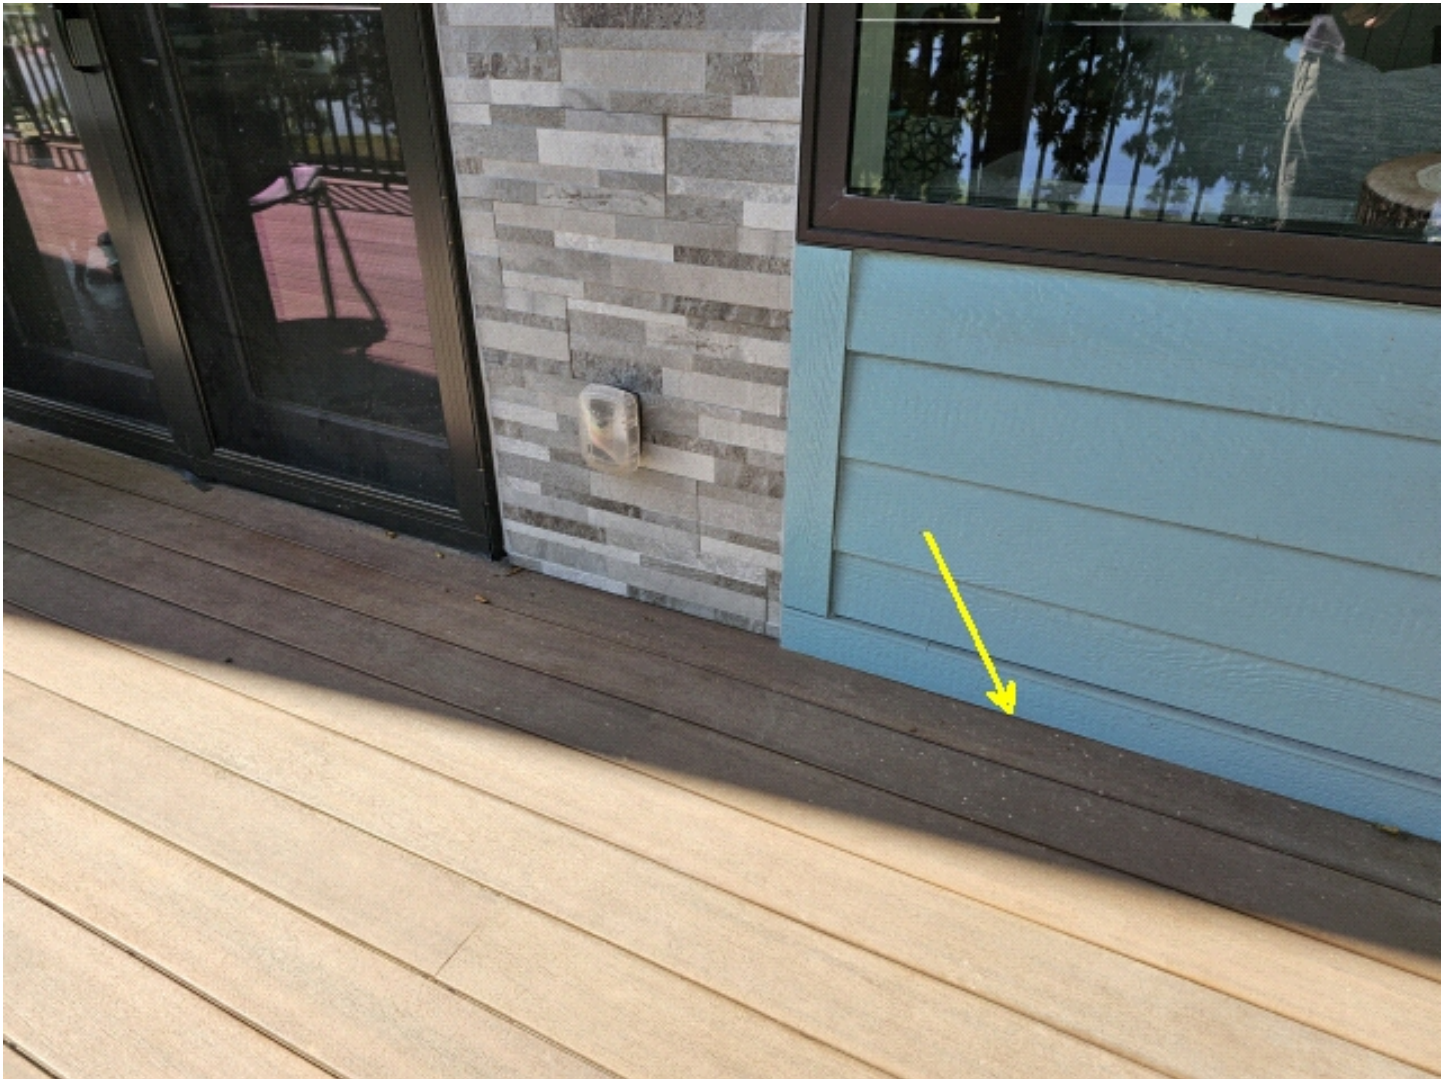
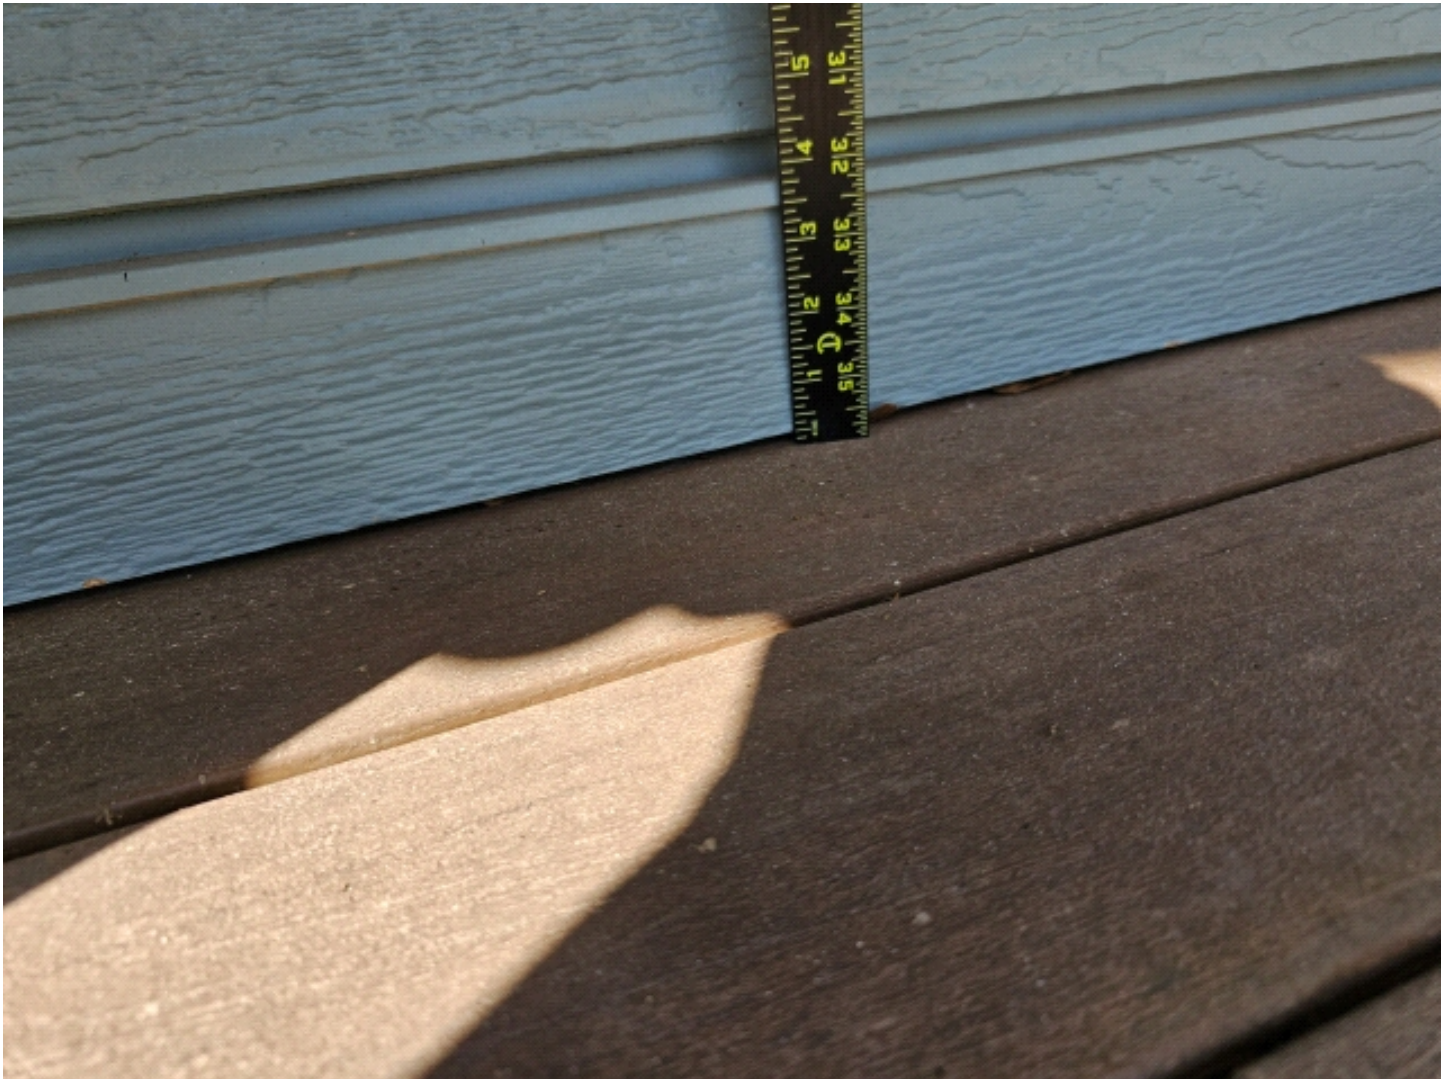
Clearance at deck surfaces

- **Clearance at deck surfaces.** LP is specific in the requirement of one (1) inch clearance of the siding and trim in an exposed area and 3/8" minimum clearance in a roof protected area for their products above any surface that collects or pools moisture such as porches, patios, walks, etc. Further, the bottom of the trims or siding cut edges or any place where water might hang is to be sealed and painted to prevent moisture from wicking into the material. The builder ignored these and did not see to it these details were performed correctly.

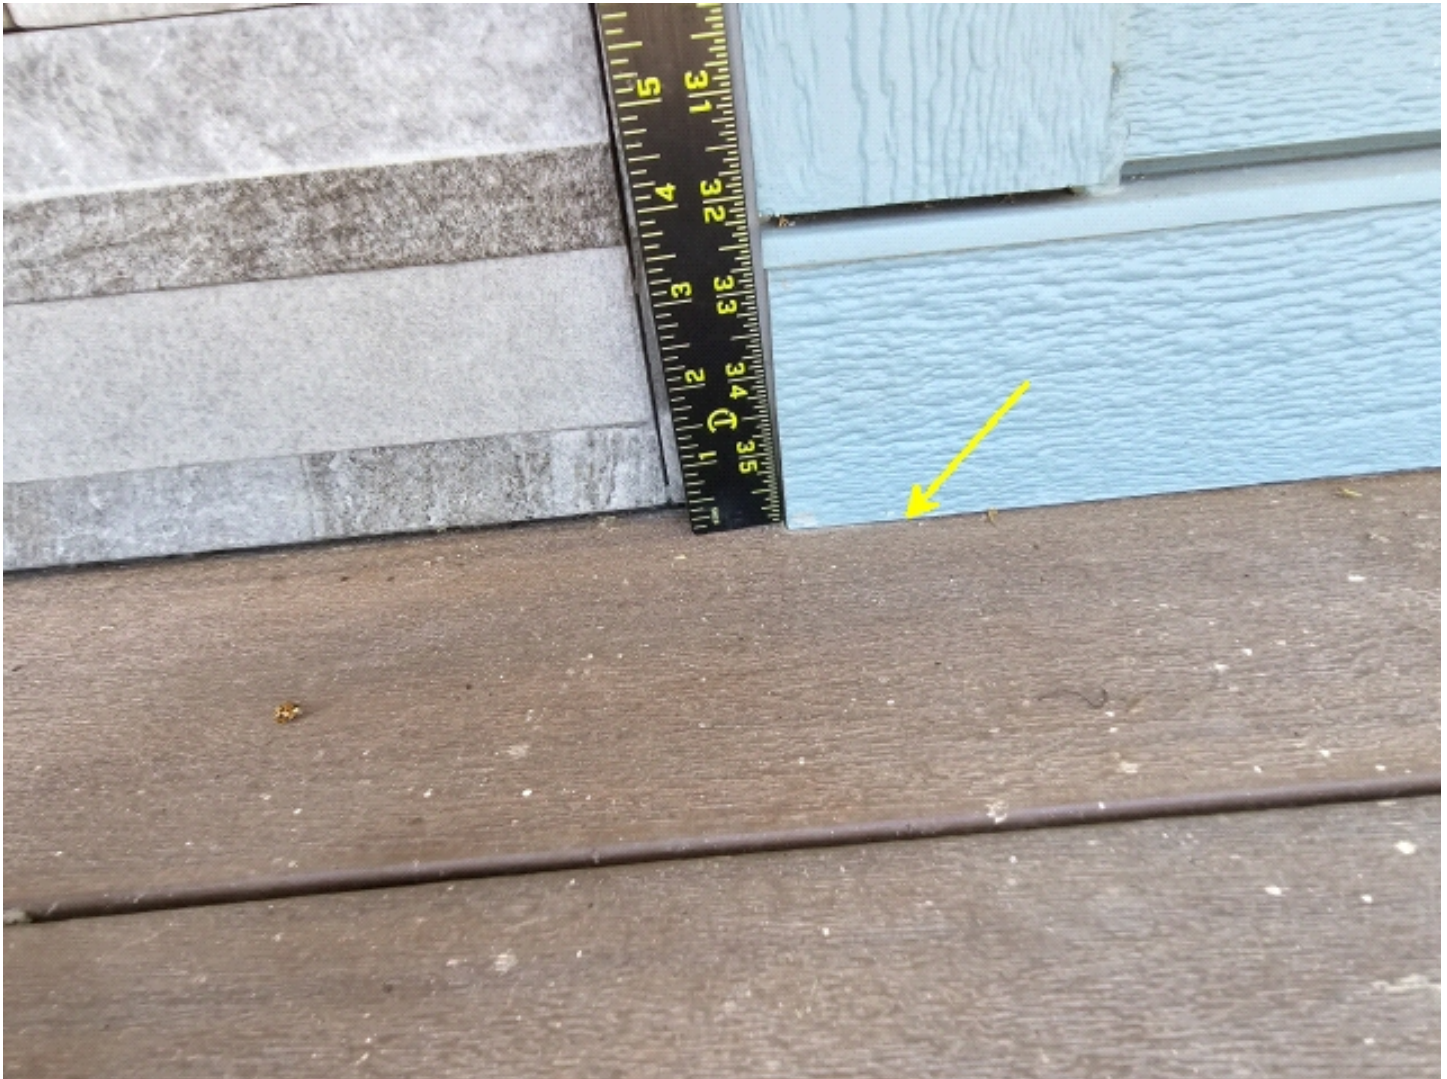
Siding trim is in contact with the deck surface.

LP requires a 1" clearance for their materials in a weather exposed area. The clearance can be reduced to 3/8" under a covered protected area. this area is covered although the roof is high and open at the gable end.

at any rate this trim is not correct and lack the proper clearance of either 3/8" or 1". The bottom edge is not painted as LP requires.

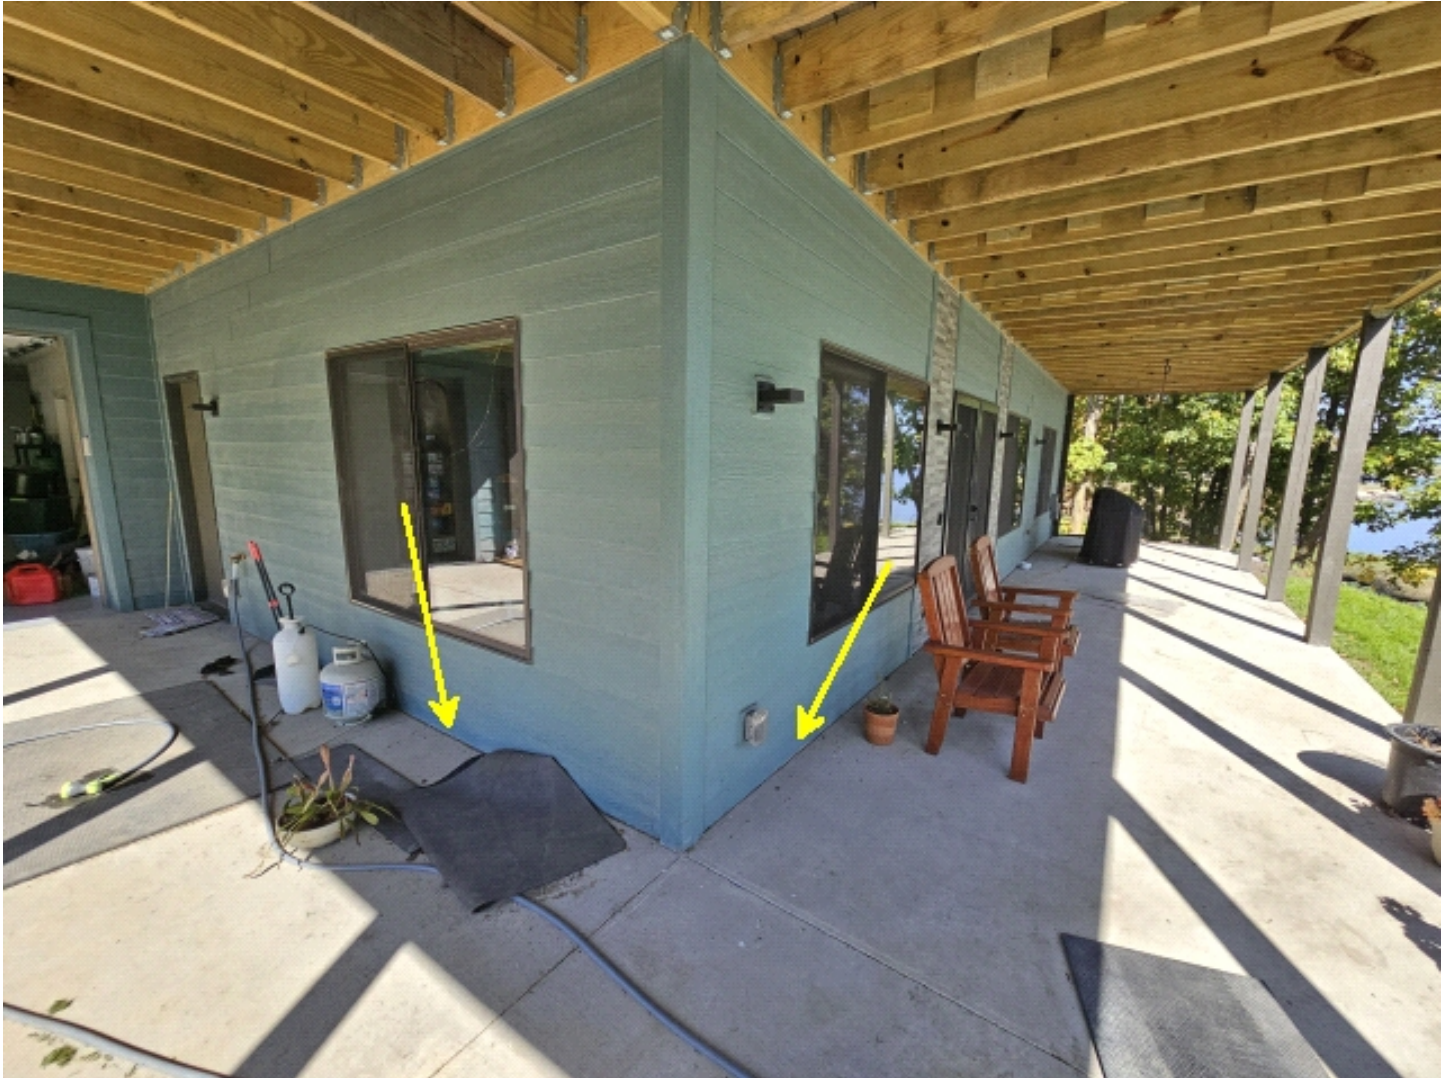
1" Clearance from concrete is specified by LP SmartSide.

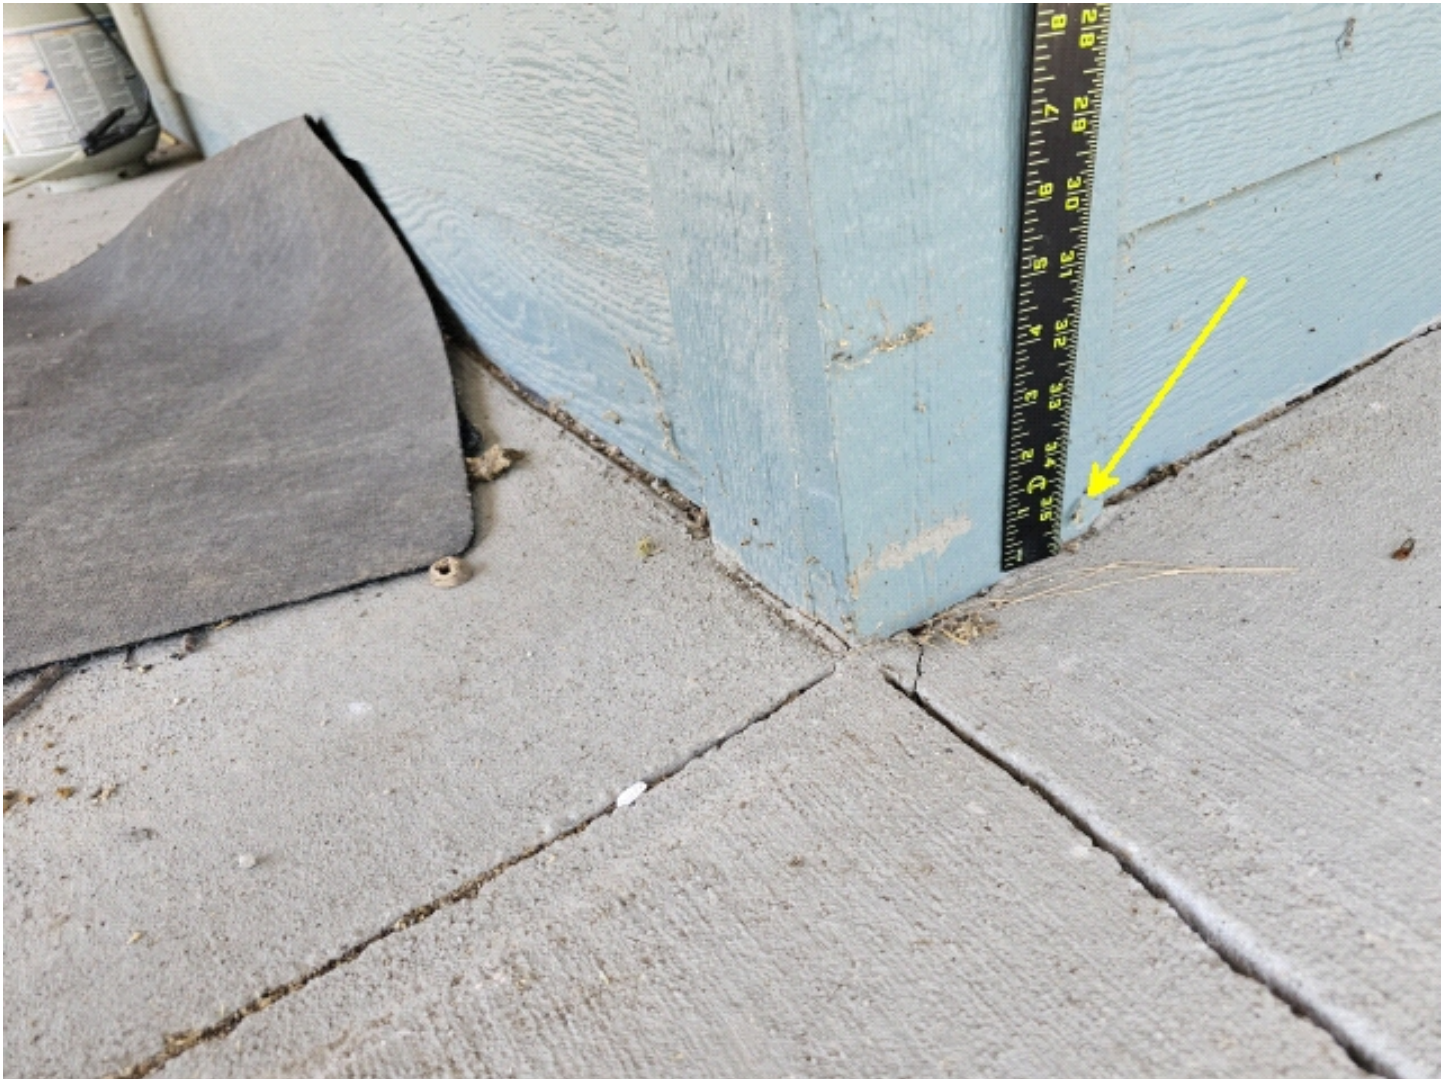
1" Clearance from concrete is specified by LP SmartSide.

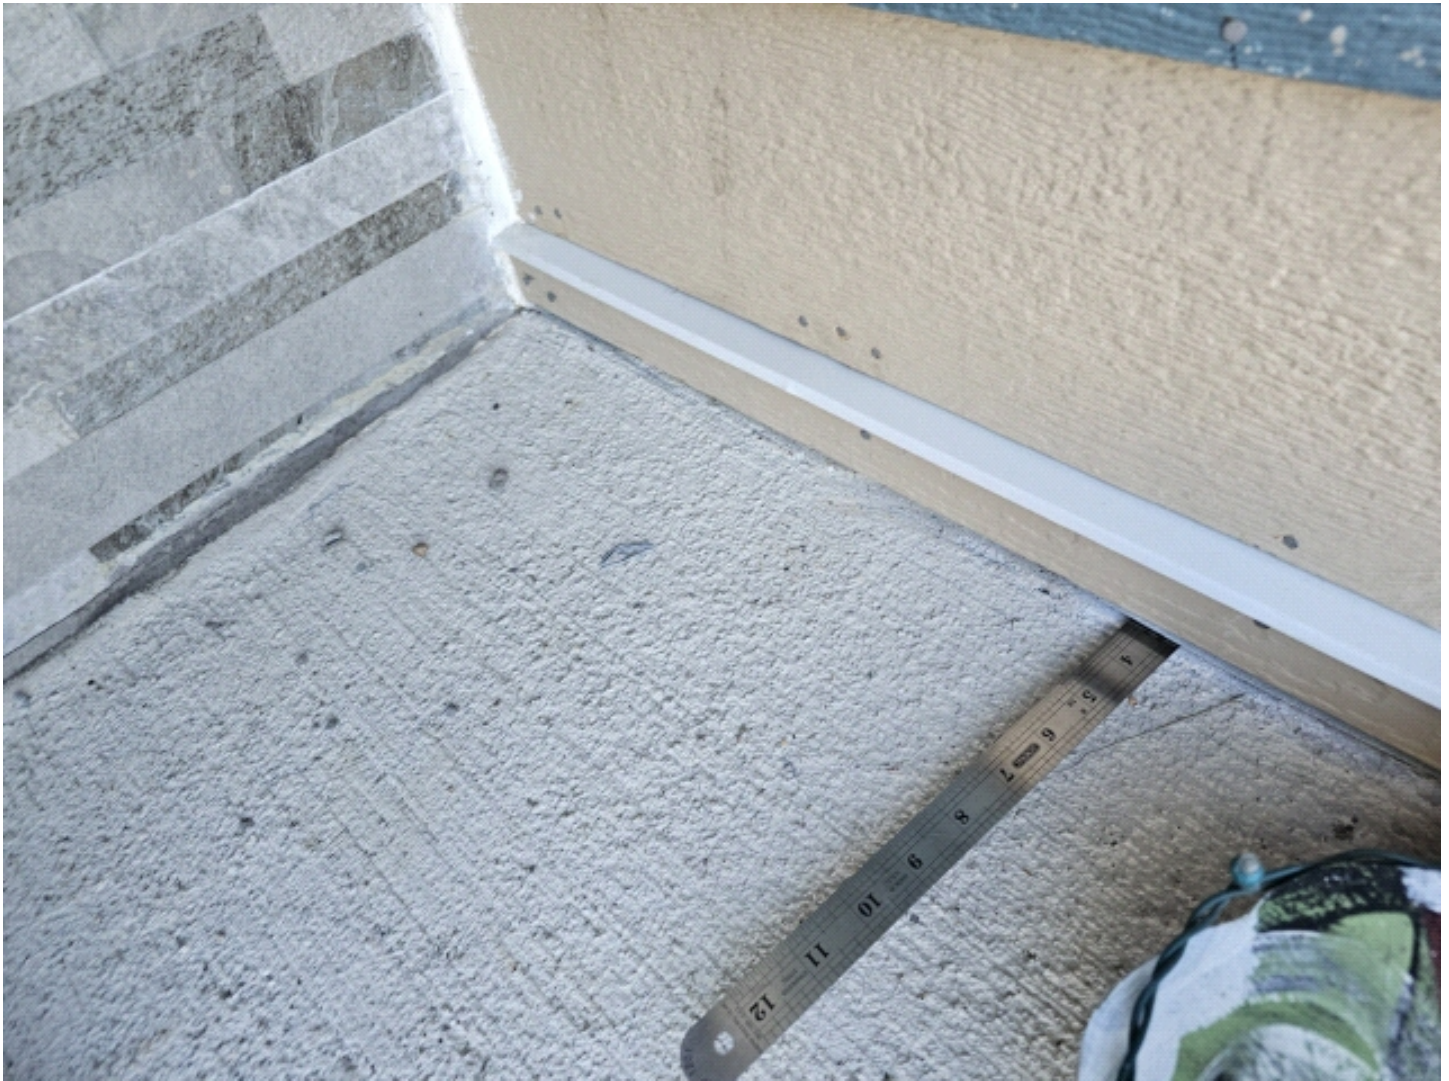
1" Clearance from concrete is specified by LP SmartSide.

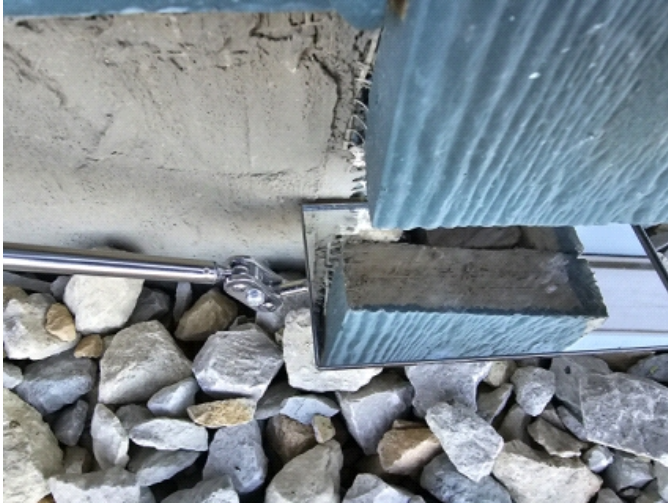
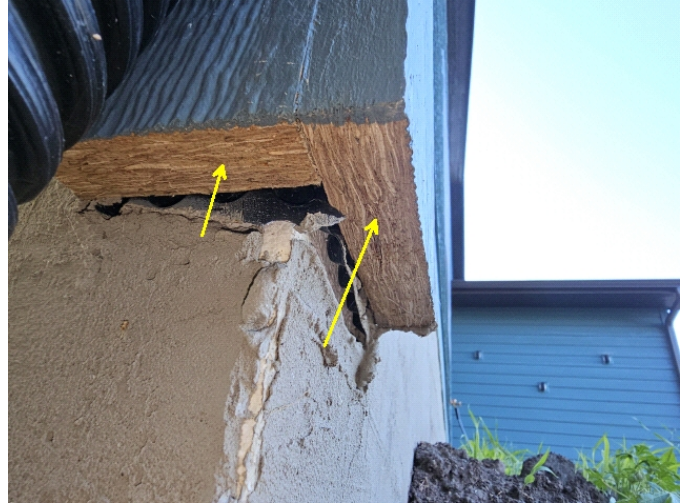
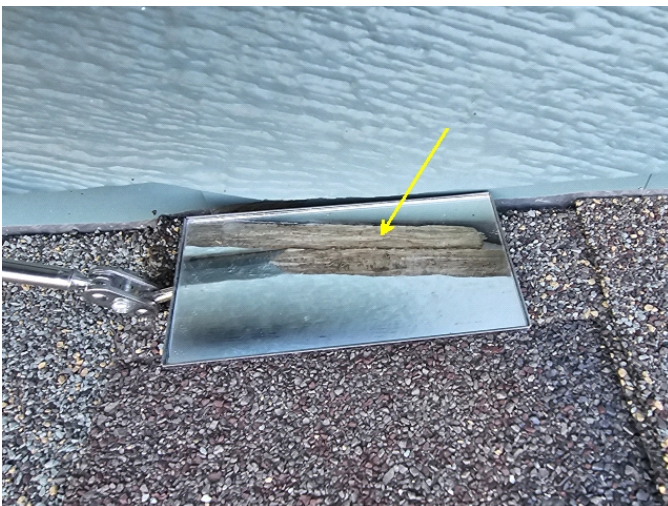
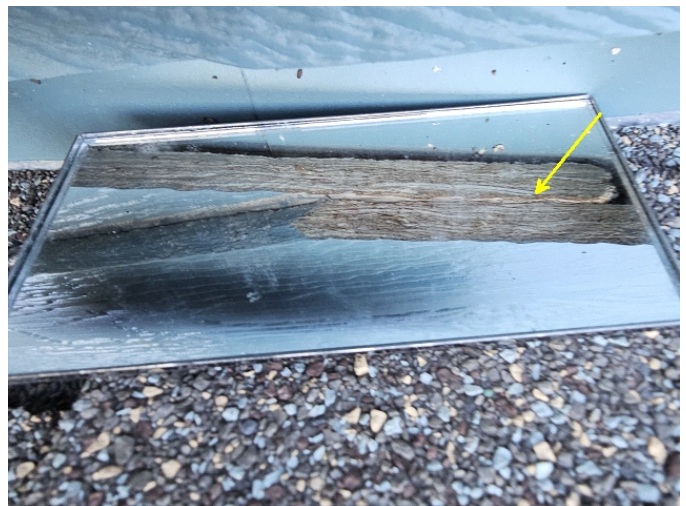
LP Paint and Finish

- **Sealing and Painting Cut Edges of Siding and Trims.** LP is specific in the requirement to paint all cut edges and all exposed edges of the siding and trims. The builder ignored these direction and requirements and left many cut edges unsealed and exposed to the weather. These unprotected edges of the trims and siding will wick moisture and start the degradation of the material.

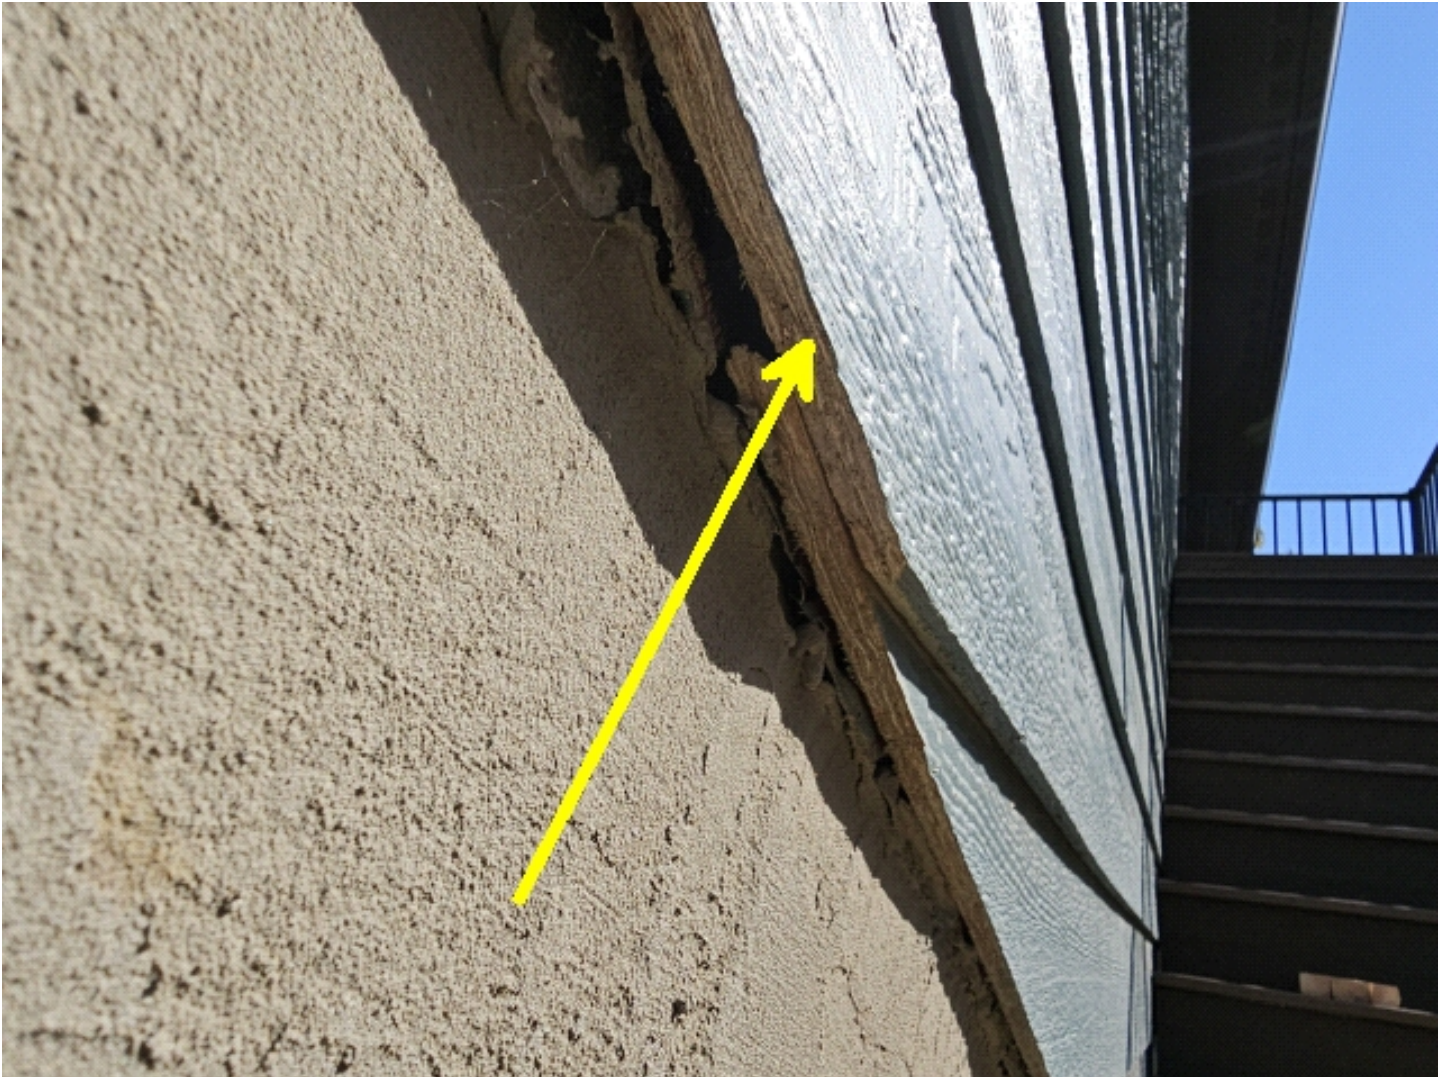
Siding not sealed and painted at the bottom curt edge as required by LP SmartSide

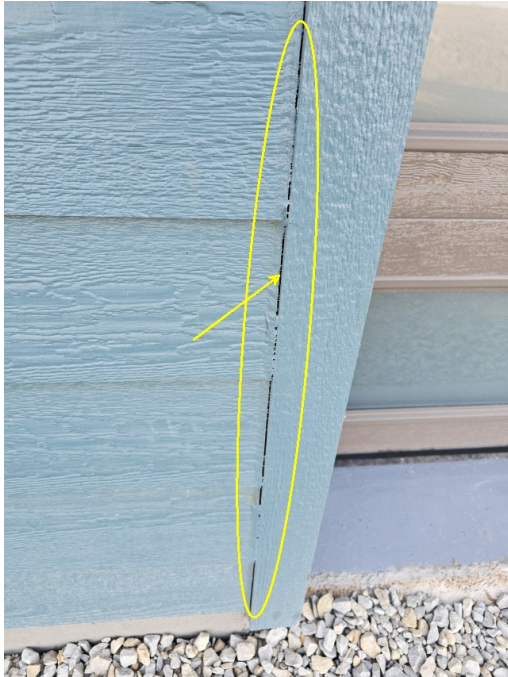
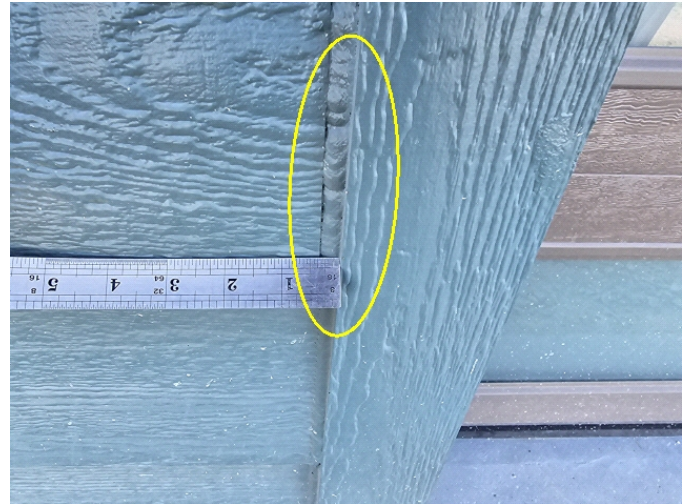
There are many sealant joint failures on this home. Most of the sealant failures are due to not leaving and appropriate gap at the transitions. The siding board shrinks as it acclimates and the sealant detail cannot handle the cyclic joint movement and it fails in adhesion due to the poor joint design and profile.

LP specifies a 3/16" gap be left at and vertical transitions such as windows, doors, and trims. The gap is to have sealant applied to close it off to the elements.

Here is an example of a siding board being cut to short.

Instead of replacing it with a proper length the builder just attempted to fill the gap with sealant.

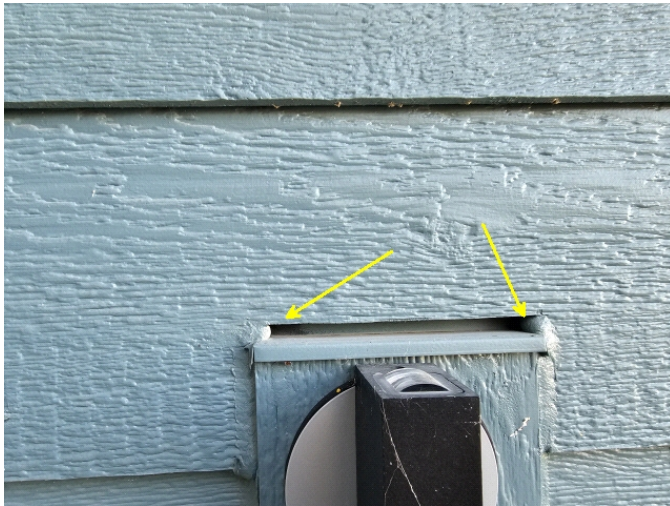
End dam sealant not complete at the edges of the metal flashing. This is a moisture pathway behind the siding Which could lead to moisture intrusion into the ICF wall.

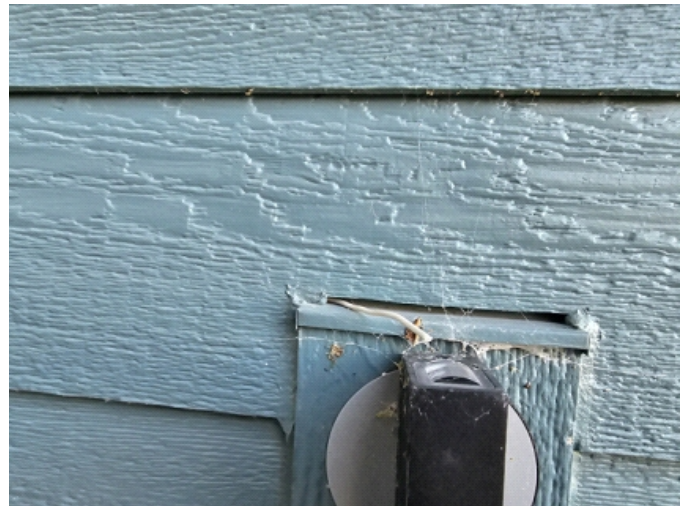
Wire inserted into the non-sealed joint.

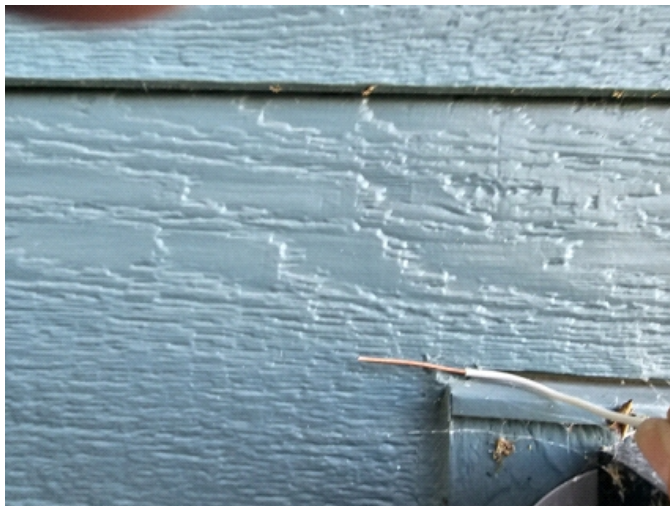
Wire easily inserted behind the siding, this is an open path for moisture to intrude behind the face of the siding.

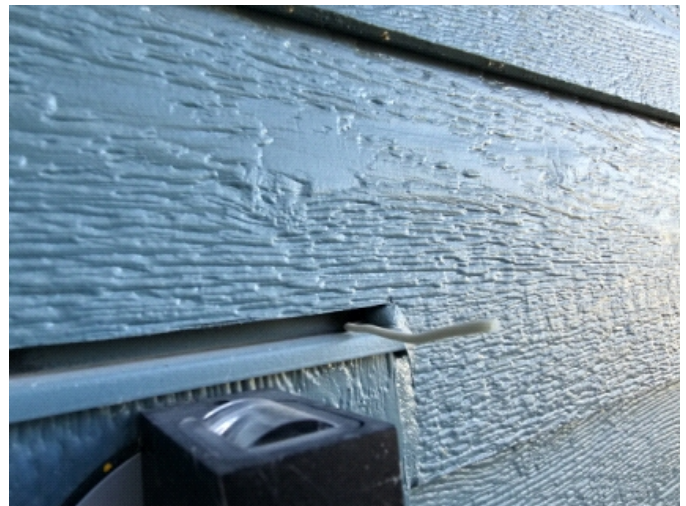
Wire inserted into the non-sealed joint.

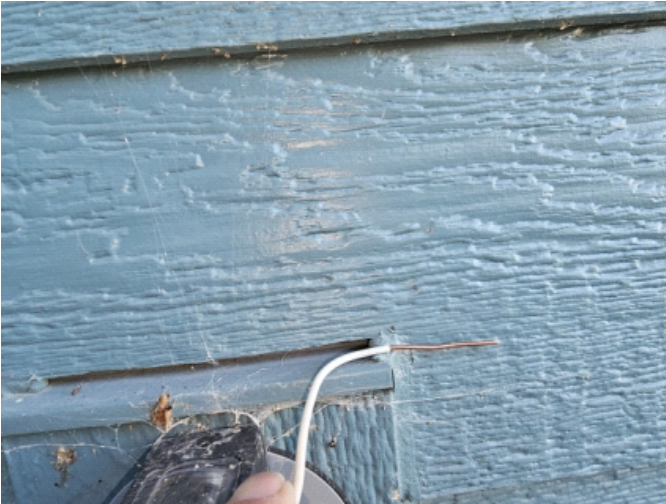
Wire easily inserted behind the siding, this is an open path for moisture to intrude behind the face of the siding.

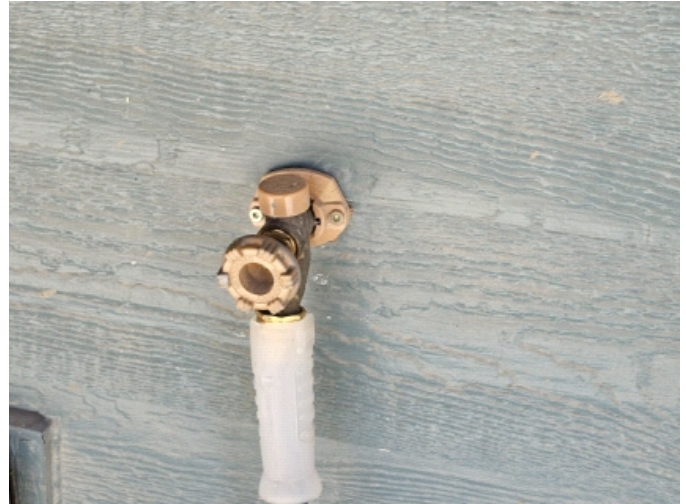
Missing penetration mounting block.

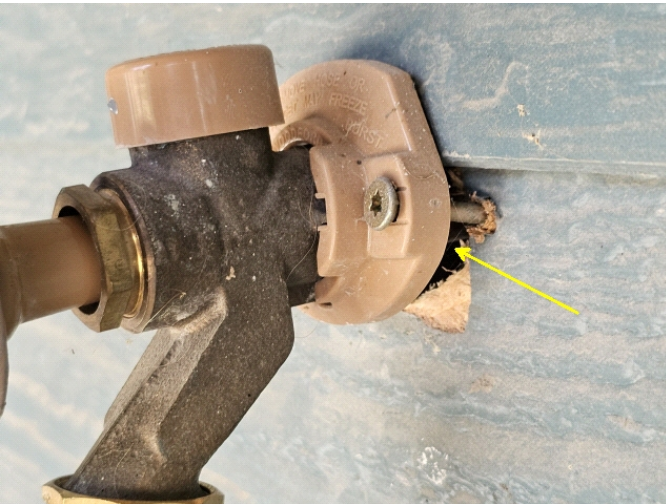
Missing penetration mounting block.
There is hole left open at the hose bib

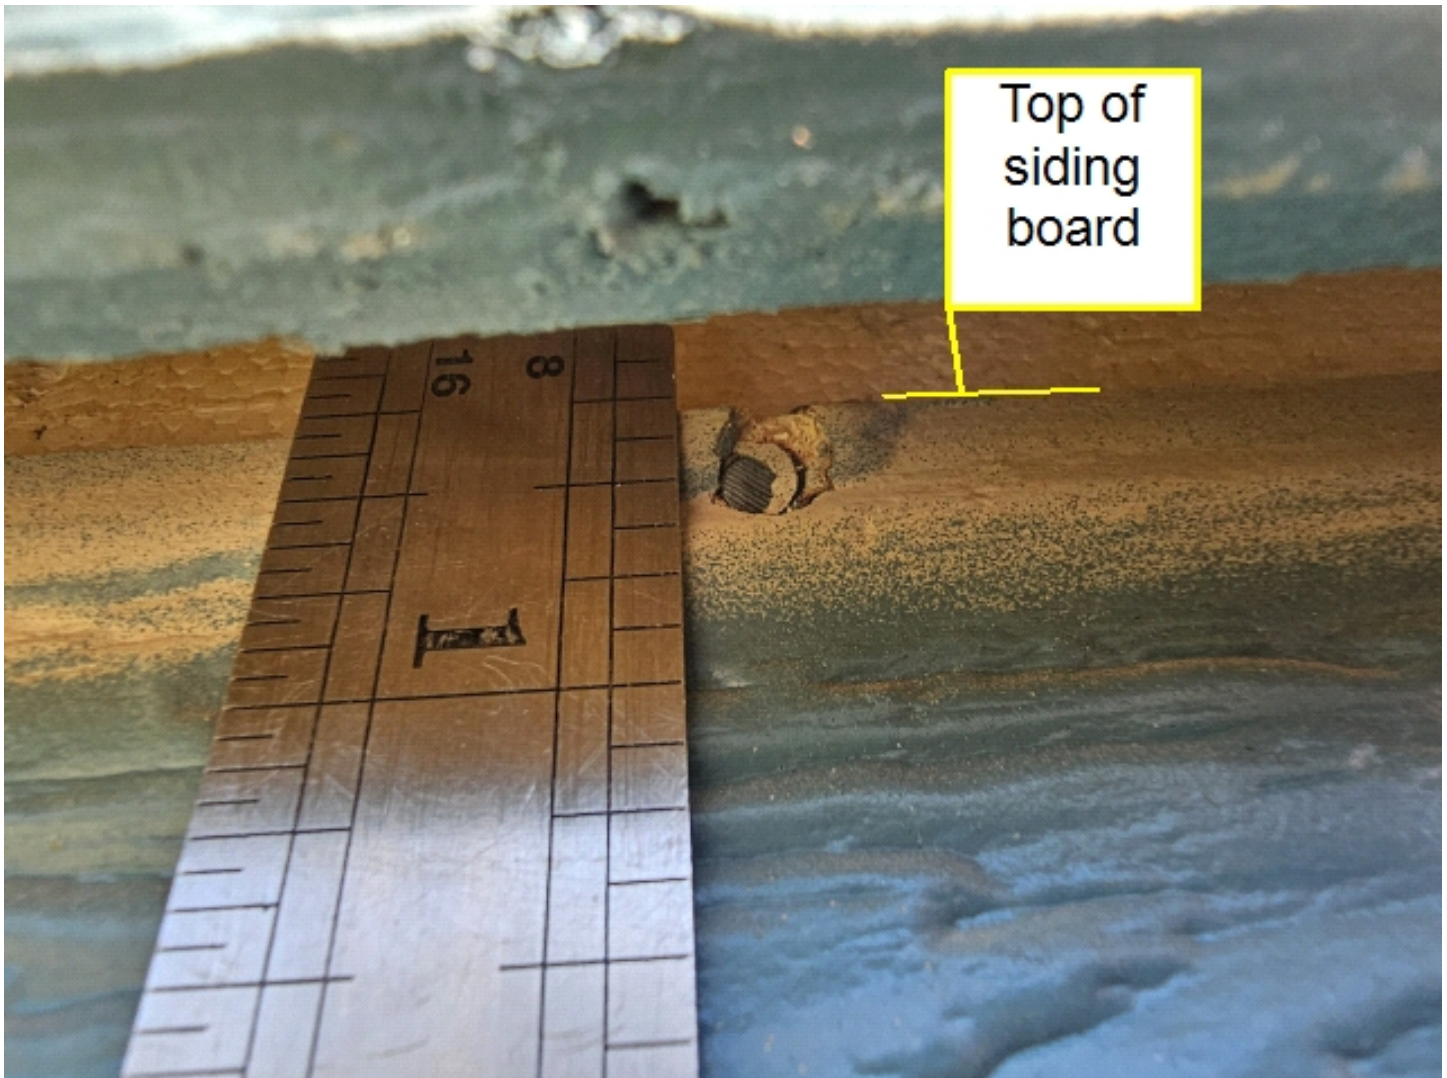
Fasteners are to be placed 3/4" down from the top of the board.
The placement is wrong and the type of fastener is wrong

The builder did not follow the manufacturer's instructions to attach the siding with #8 stainless steel screws or their equivalent. Instead the builder chose to use nails to attach the siding. Additionally, even if nails were allowed the placement of the nail in the siding does not meet manufacturers requirements, much of the siding is high nailed which compounds this defective installation. The siding will have to be removed and replaced and fastened correctly to properly remediate this builder defect.

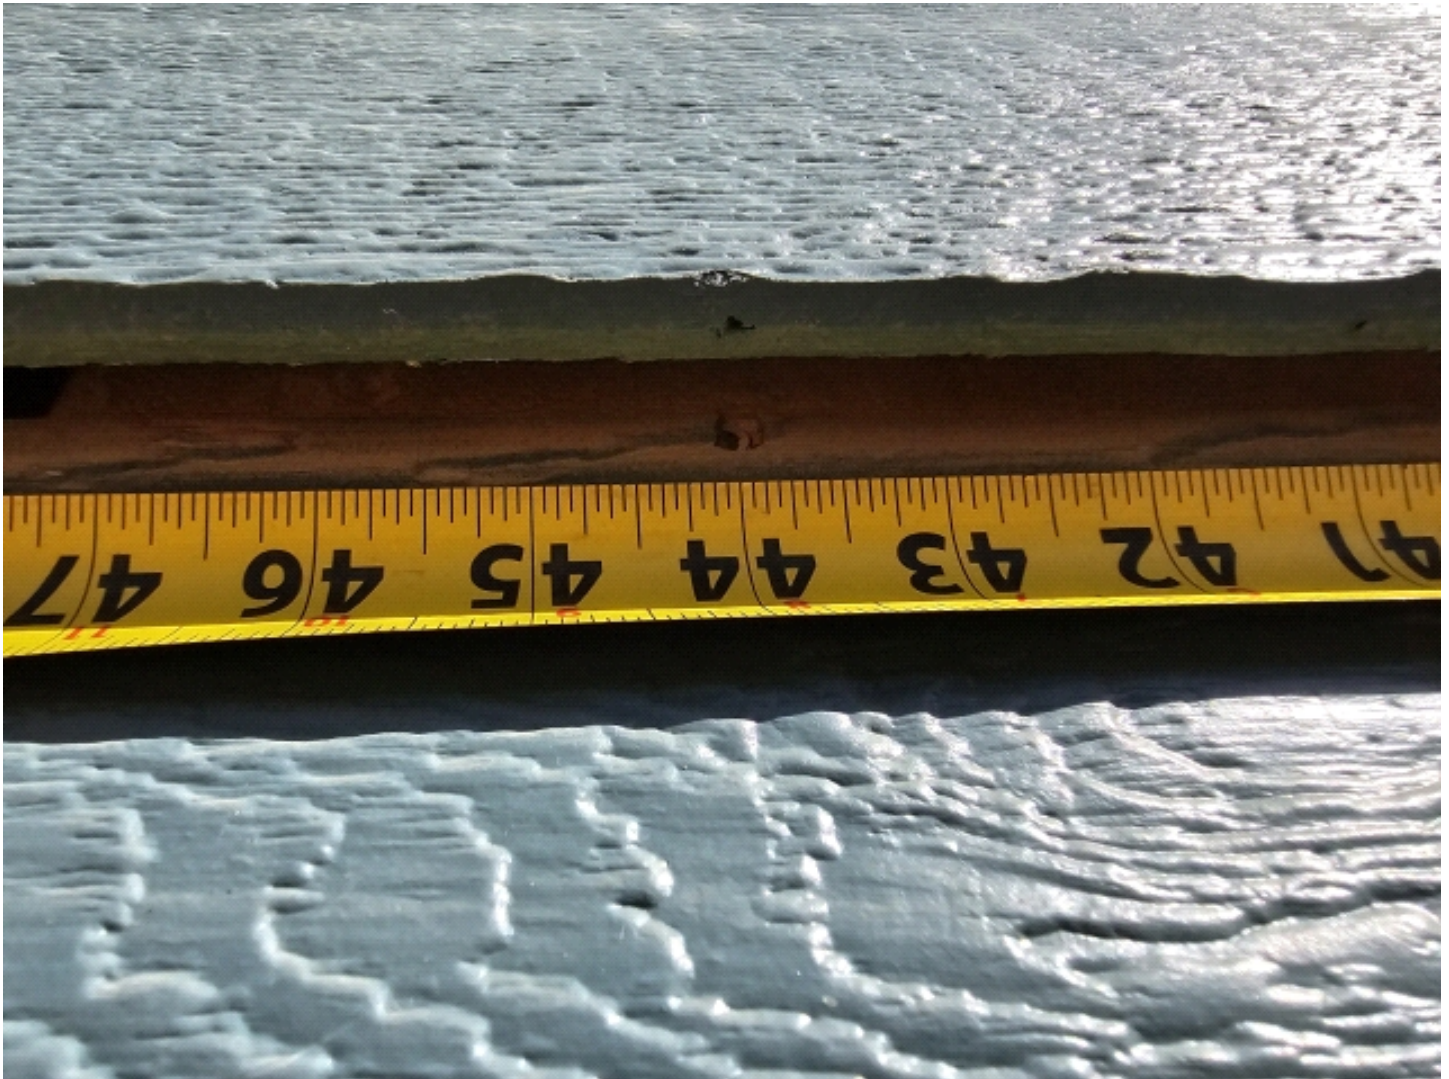
Fasteners are to be a minimum of 24" o.c.

The next fastener to the right is 44" away.

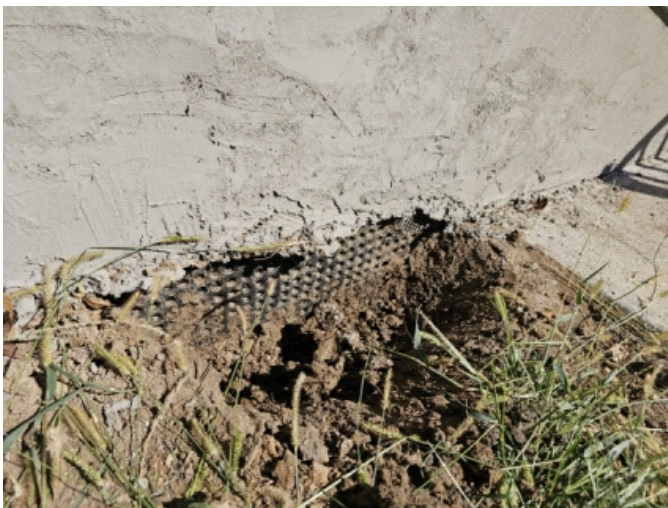
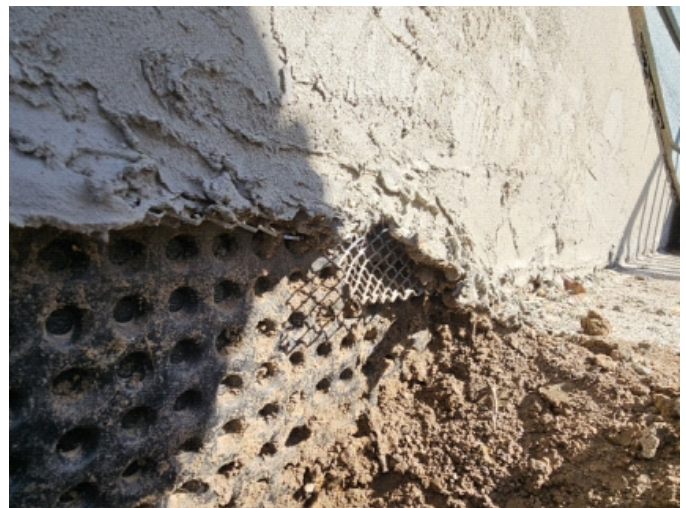
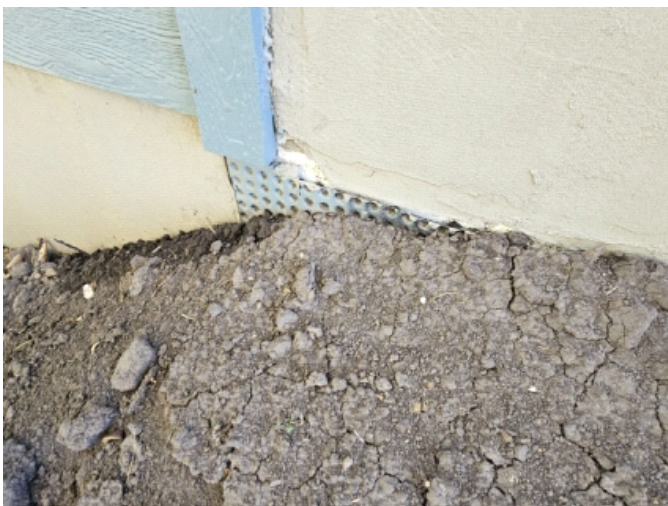
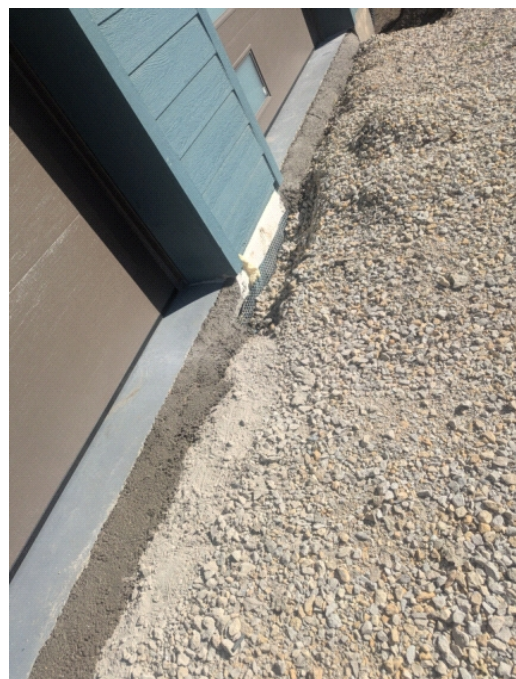
The builder used a dimpled mat in an attempt to waterproof the foundation. A dimpled mat is not a waterproofing membrane. Rather, it is a material that allow water a path to drain and thereby controls hydrostatic ground water pressure against the foundation walls.

The dimpled mat is not properly terminated in many areas at its top edge. Water is getting in behind the mat between the mat and the ICF's. This moisture is then migrating through the joints in the ICF's and wetting the interior drywall. This is specifically occurring in the lower level garage wall that is under the upper garage entry wall. The dimpled mat is ineffective at waterproofing these foundation walls.

Below Grade Waterproofing. The builder used only a dimpled mat applied over the ICF's for waterproofing. This dimpled mat allows an air gap between the ICF and the dimpled mat material. This does relieve the hydrostatic ground water pressure against the foundation but is by no means a waterproof membrane, it does not seal the ICF surface against water intruding into the ICF assembly moisture intrusion. It only relieves the horizontal pressure and thereby has a minimizing effect on moisture intrusion. The dimple mat is not properly secured at its top edge with a termination bar and sealant. Rather, it is left open in many places allowing moisture into the air space and giving it the potential to work through the joints in the ICF's and into the finished space as it is in the under garage. There is an area in the lower garage where this moisture is working through the ICF's and is allowing microbial action on the back side of the drywall. Had this wall been properly waterproofed with a peel and stick membrane designed to waterproof ICF foundations this leak and accompanying microbial action would not be occurring. The builder did not properly waterproof this foundation.. The brand of ICF's used on this project are Stronghold Insulated Concrete Forms. Strongholds cut sheet drawings show a waterproof membrane applied to the ICF's. A dimpled mat is not a waterproofing membrane. Rather, it is a drainage sheet meant to provide a path for drainage and help eliminate hydrostatic water pressure against whatever it is applied to. In speaking with the tech department at Stronghold they recommend a peel and stick waterproof membrane. The only way to correct this defect is to dig out the foundation, clean it off, properly prime the ICF's and apply a peel and stick waterproof material that is designed to waterproof ICF's
