the BUILDING CONSULTANT

Field Report **Attorney work Product** **Project Information**

15 Feb 2025

Field observation report for:**Overview:**

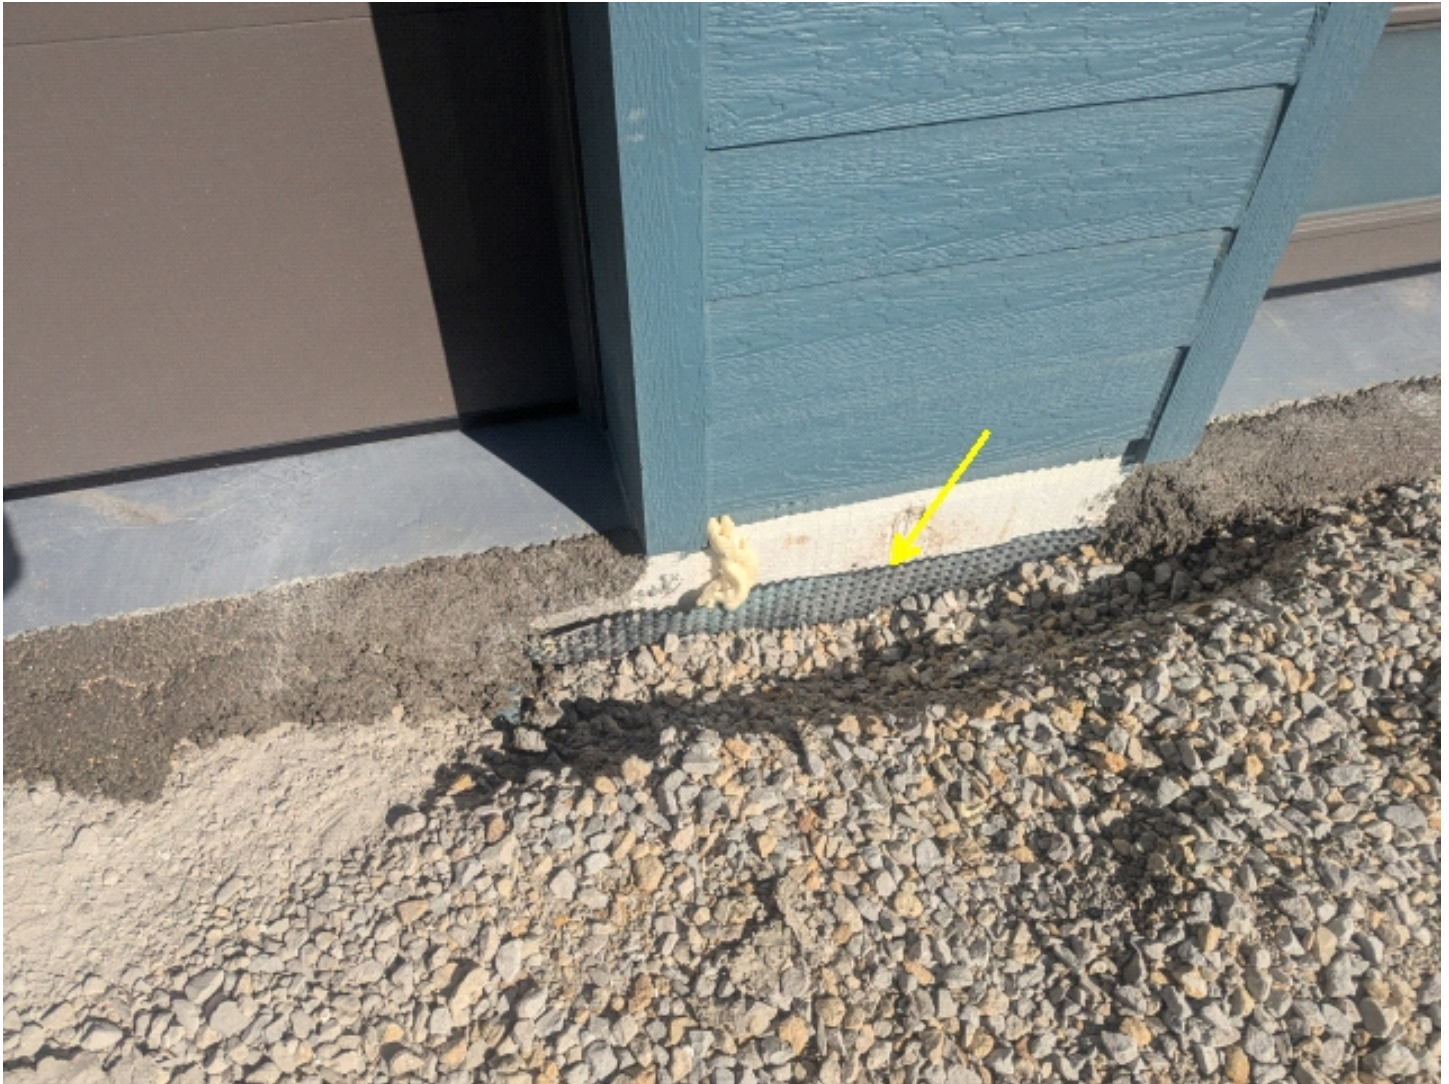
Dimpled mat not terminated and sealed at its top edge.
This is directly above the leak to the interior in the lower level garage.

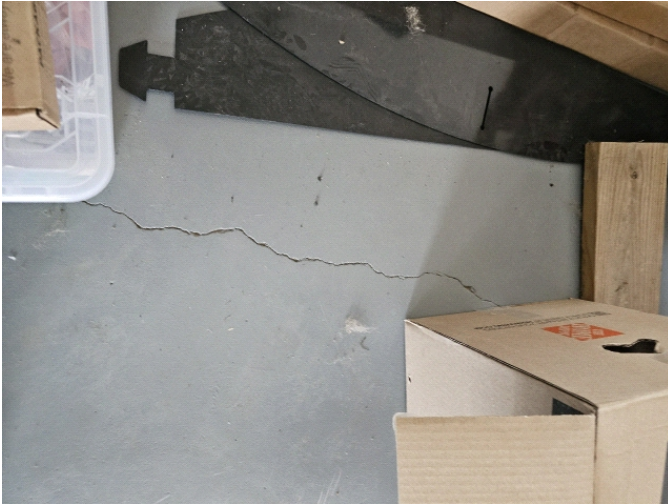
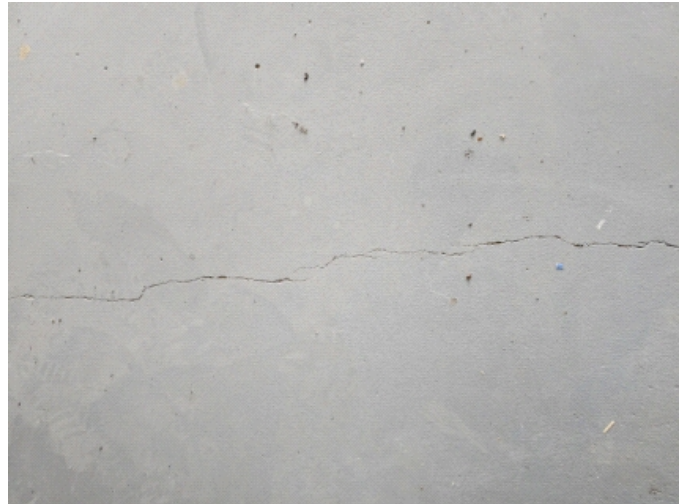
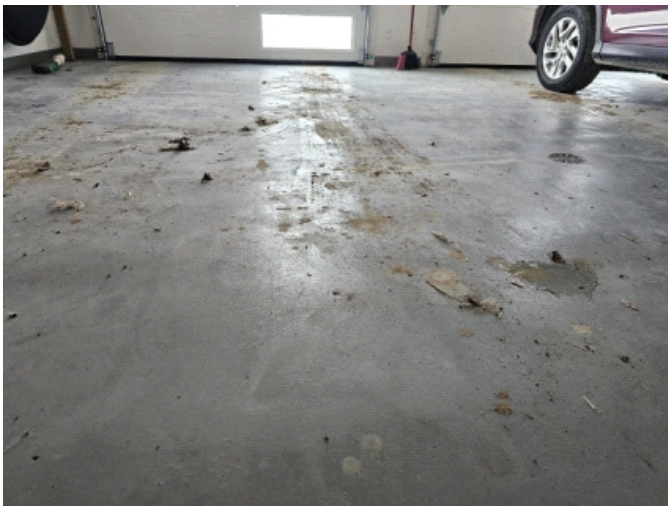
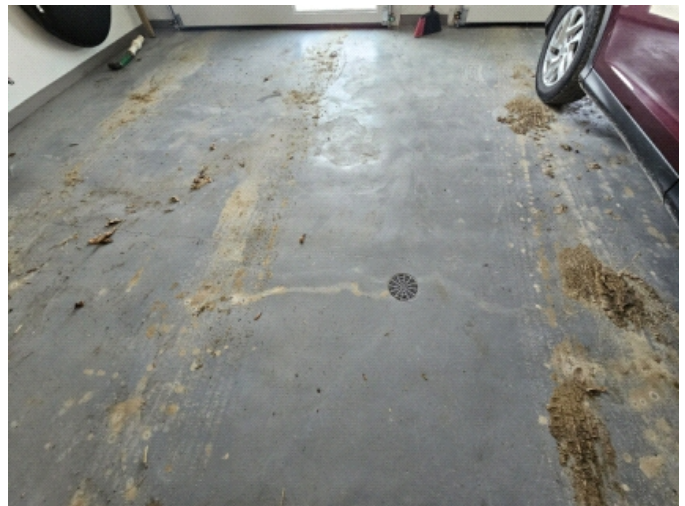
The garage has a centralized floor drain. The concrete floor is to slope towards the drain so any water on the floor does not puddle and collect. The garage floor was placed and finished in a defective manner with depressions that allow puddles of water to form. There were no relief cuts to control and isolate cracks installed in the concrete floor. This has led to numerous unsightly cracks in the concrete floor.

Water does not run to the drain. Evenly.

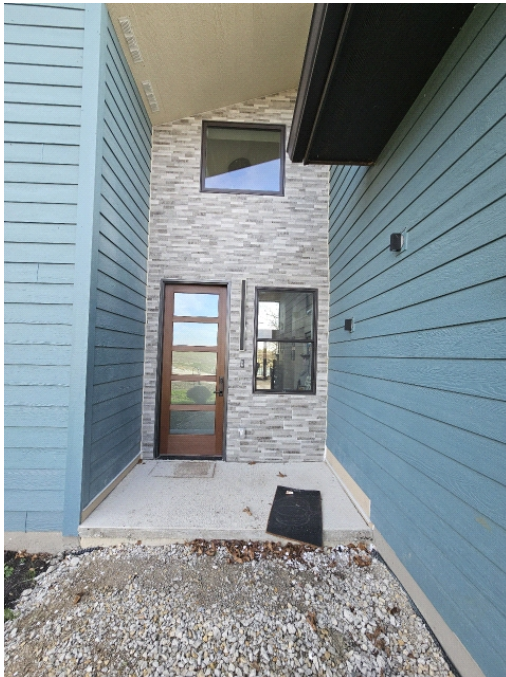
Entry stoop, concrete leaks into under stoop room. Builder has made multiple attempts to stop water leaks. His last attempt was to try to caulk all the seams in the exterior tile.

The stoop cap is not waterproofed and flashed correctly. It needs to be removed and redone to correct details so as not to leak to the interior.

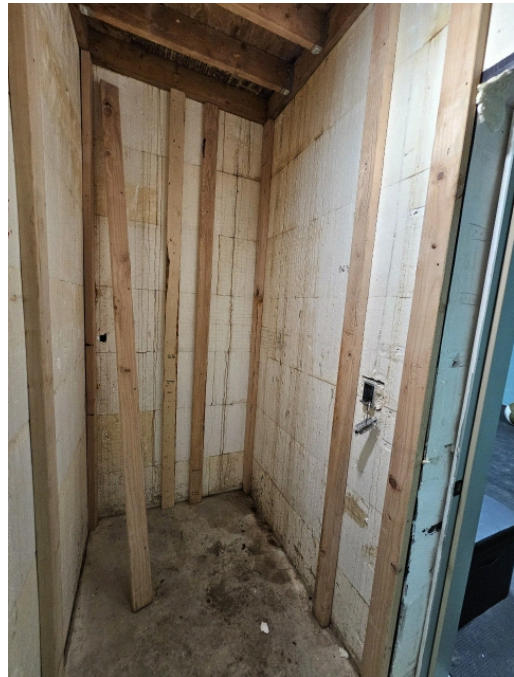
Obvious water intrusion staining running down the interior face of the ICF's.

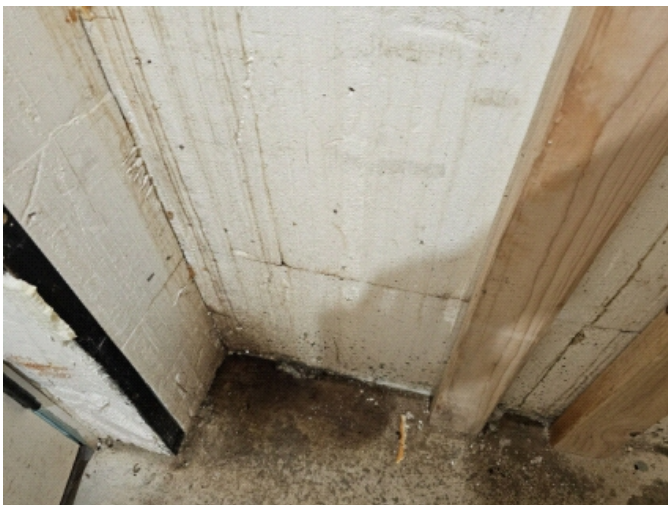
Water puddling on the floor from the leak at the stoop above.

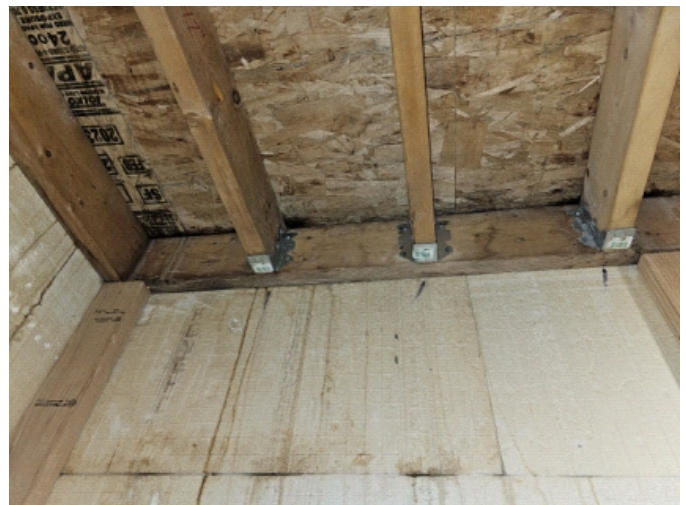
Framing and sheathing appears wet.

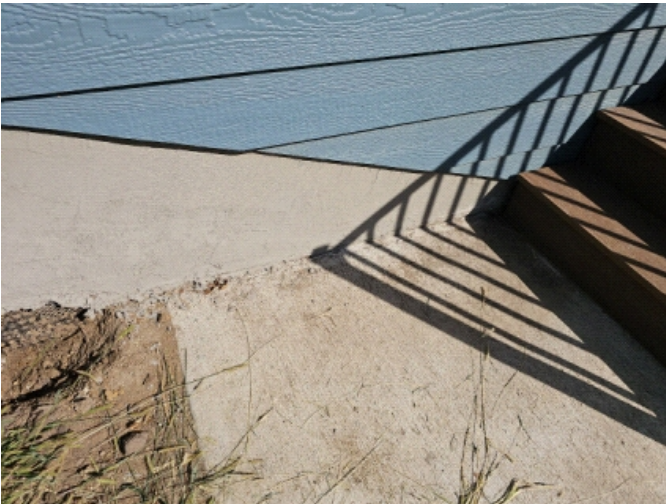
Expansion joint should be used between slab and backplate. Back plaster is terminated on top of slab. Any frost heave will cause damage to backplaster.

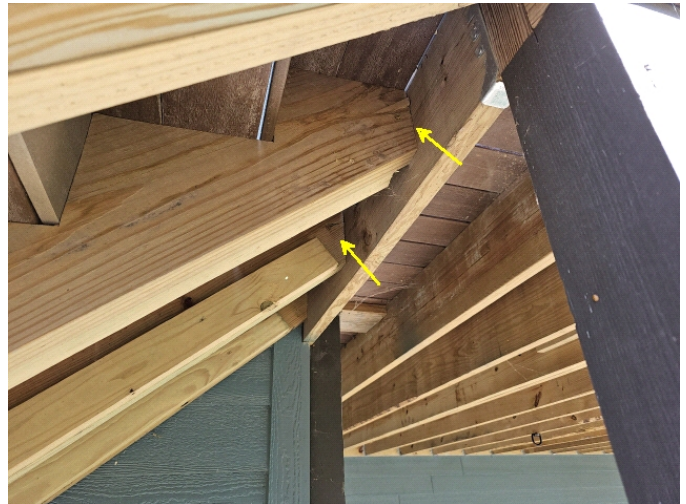
Stairs missing attachment brackets.

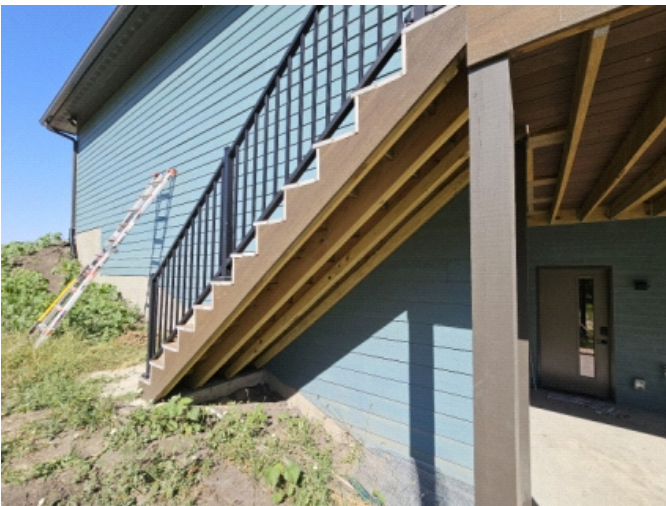
Stair stringer span is 11'-4". A center span support is required for spans exceeding 6'-2".

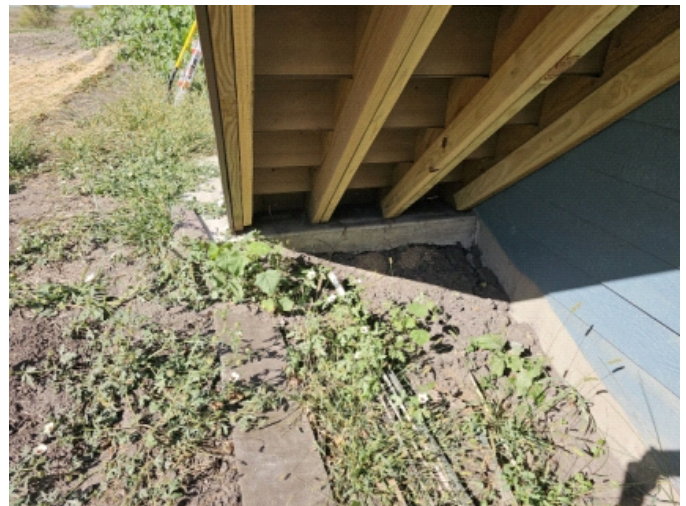
Stairs set on slab on grade. Stairs are to sit on frost footing.

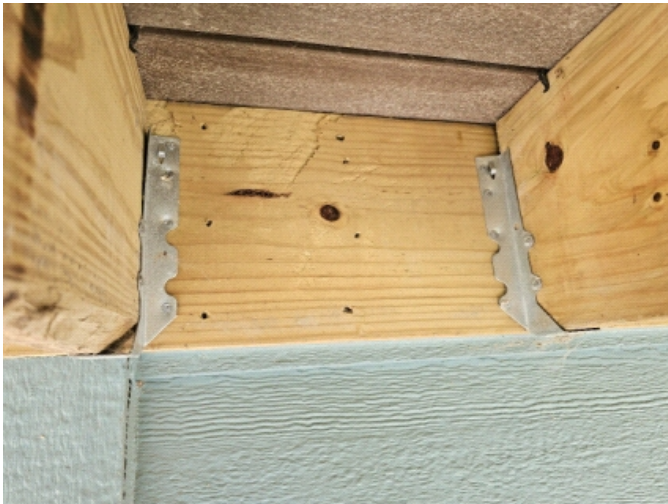
Deck rim joist is attached with 3 nails at 16"o.c.
This deck connection to the ICF's is deficient

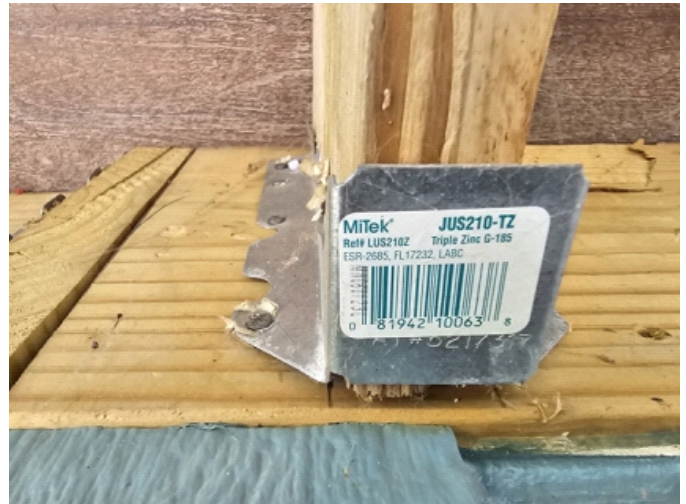
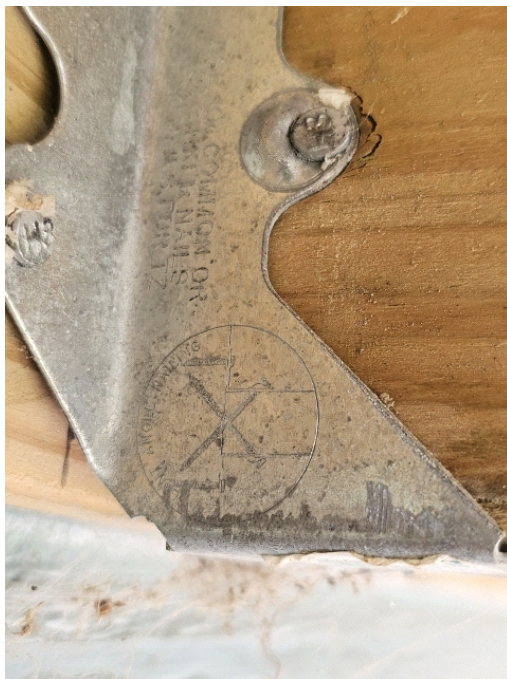
Joist hanger shows longer nails to
be used at the angle holes. The
builder ignored this instruction.

Deck. The angle nails used in the joist hangers are too short. All angle nails need to be removed and replaced with the appropriate length of fasteners specified by the joist hanger manufacturer. There is stamped instructions on the joist hanger showing what fastener is to be used. The builder ignored these instructions and used the wrong length fastener. The stair span is greater than 6'-2". Therefore, code requires intermediate support be installed. The stairs are not mounted correctly at their attachment to the deck at the top specific straps/hangers er required for attaching stairs to the deck.

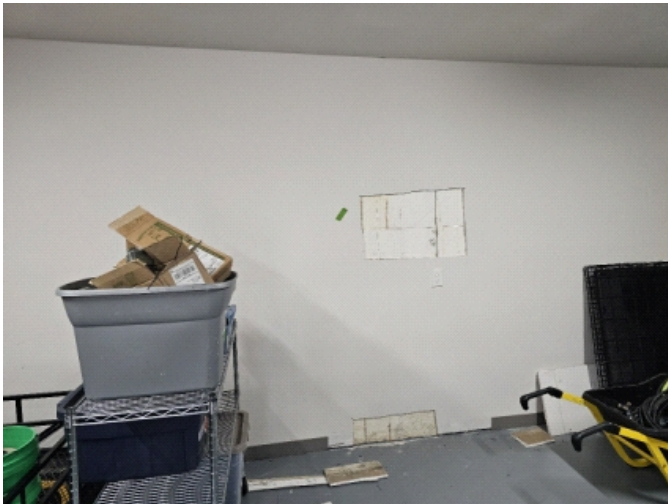
Lower level garage. Foundation is not properly waterproofed and water is intruding creating an issue that wets the drywall resulting in a microbial action taking place on the back side of the drywall.

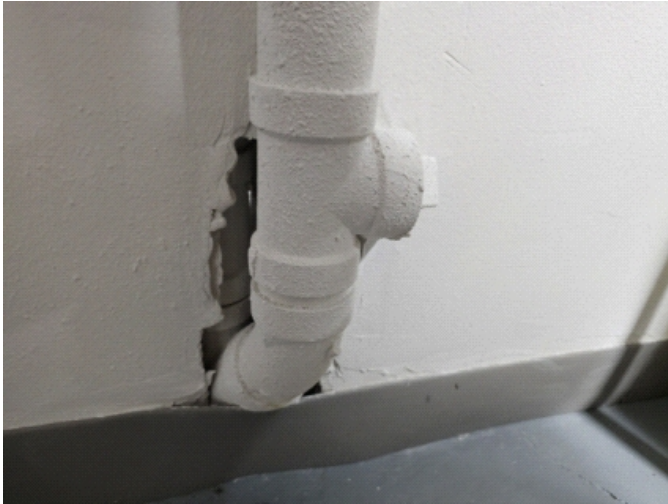
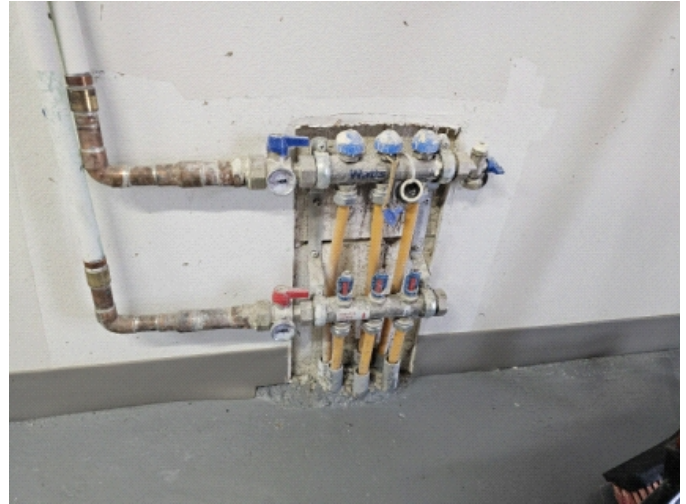
Tubes for in slab heat. tubes are misplaced too close to the ICF and do not allow drywall to cover the foam. The foam is to be completely covered on the interior living space to prevent smoke hazard if exposed to fire.

Tubing assembly was not covered and protected during drywall taping, finishing, and painting.

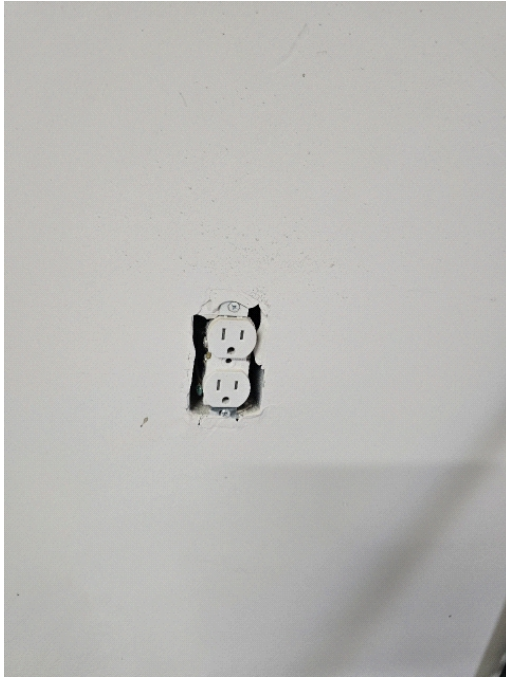
Cover plate missing. Builder did not inspect job and ensure subcontractors work was properly completed

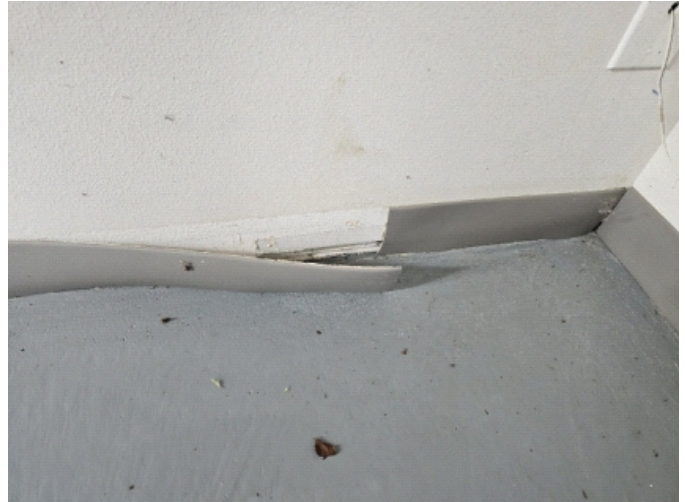
Vinyl baseboard already coming loose. Sloppy and incomplete application.

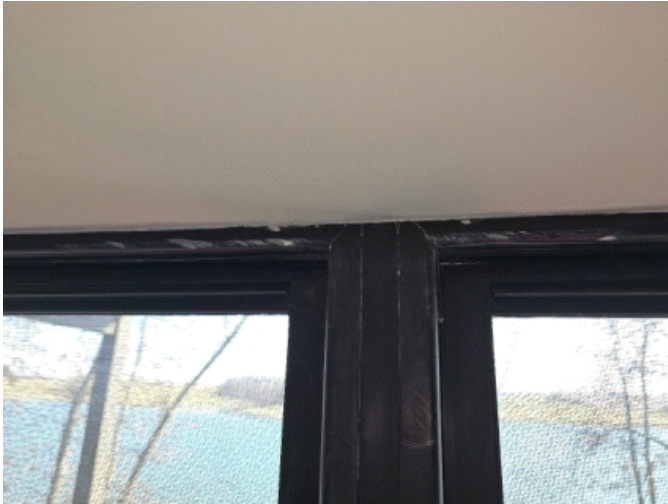
Master bedroom window damage.

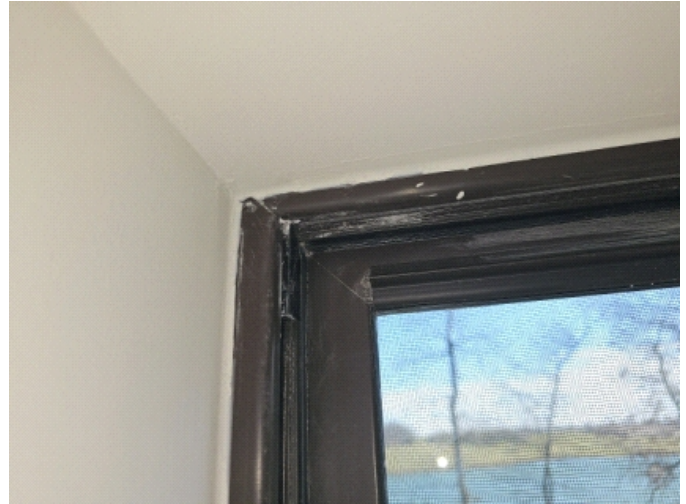
Example of what builder thinks is final clean.

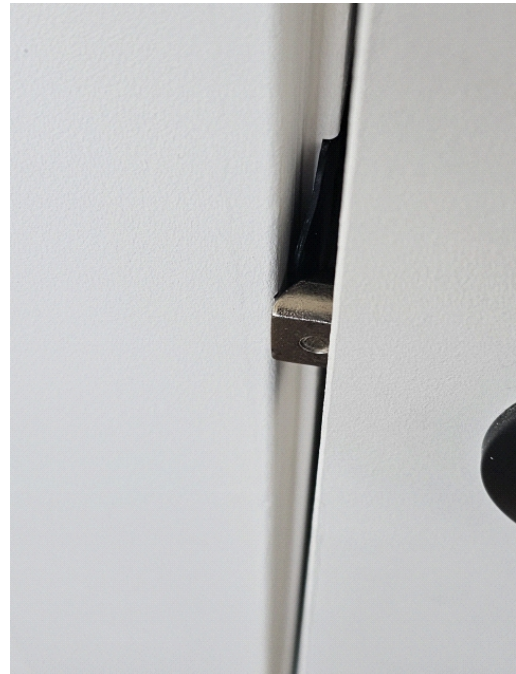
Doors should have extended strike plates. Latch drags on finished wall and scores and damages the surface.

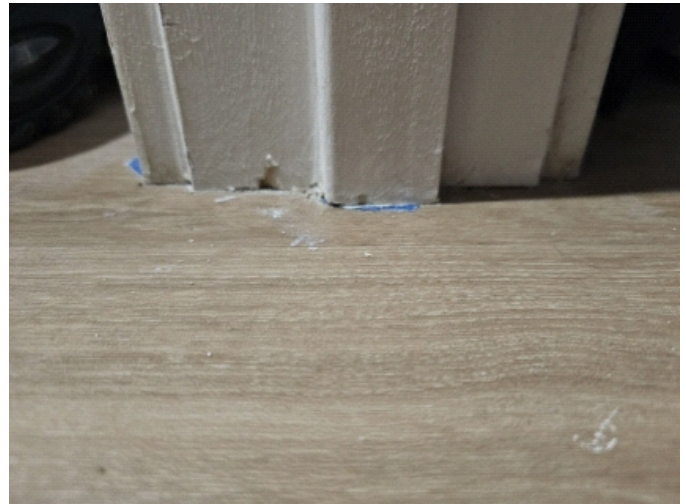
Undercut saw damaged trim.

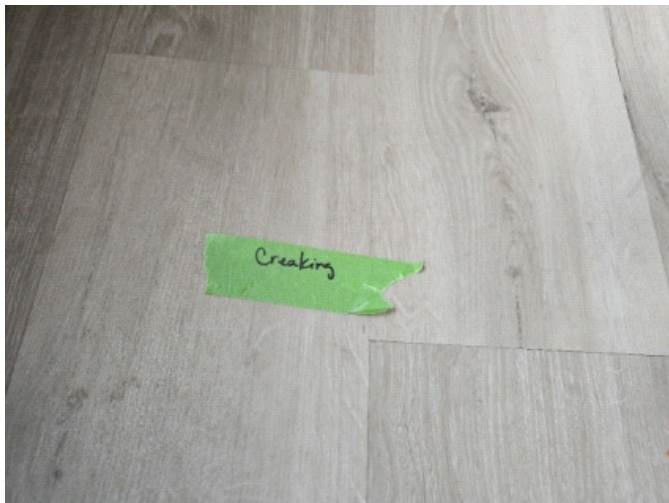
Multiple areas where subfloor creaks. Subfloor should have been screwed down.

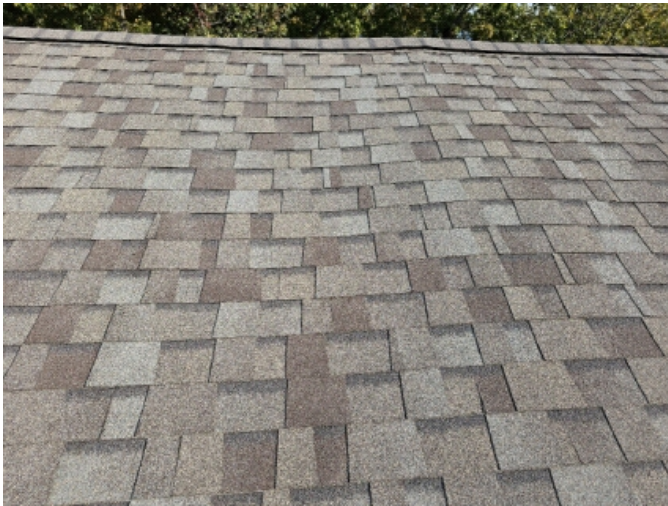
The roof is a gable roof configuration with the ridge running from front to back There is a dip along the ridge of 2.5" to 3". The attic area at this point is inaccessible due to the roof being a vault and the spray foam insulation being applied to the underside of the roof deck. The spray foam encapsulates the trusses. The only way to assess the dip in the roof is to deconstruct it from the top side.

Extreme dip in roof framing noted.

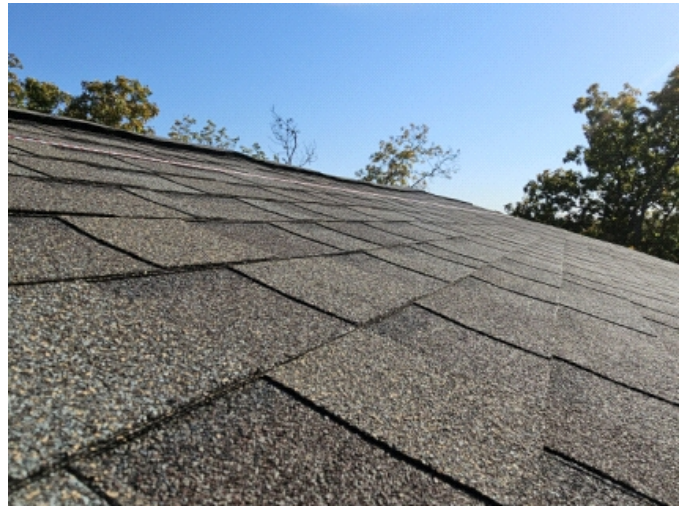
Measuring dip in roof.

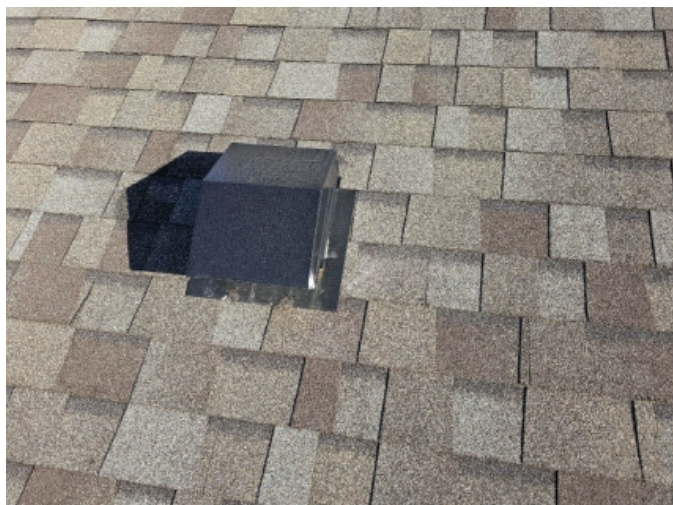
Vent hood not installed into shingles correctly.

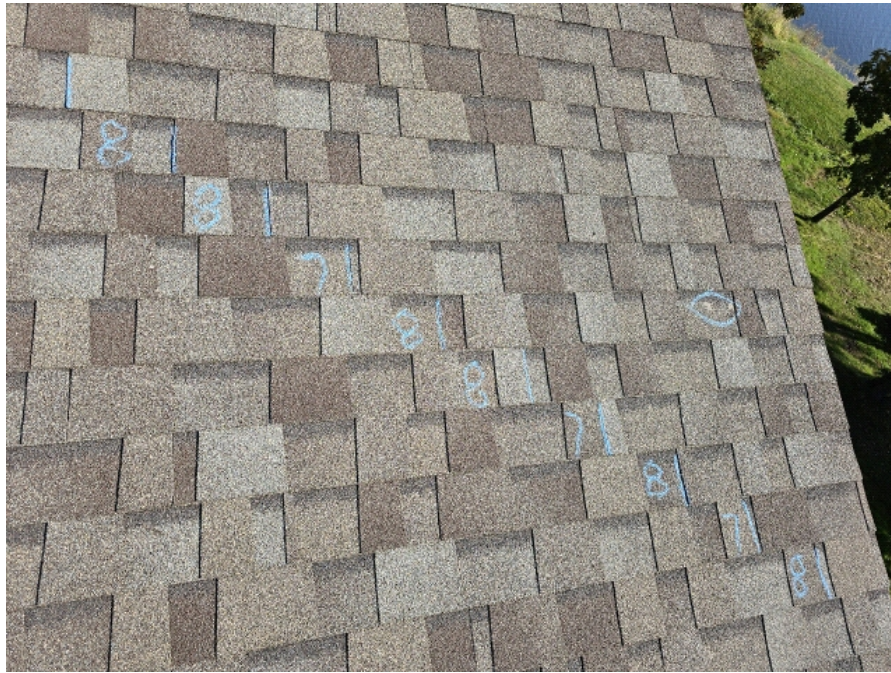
Shingle row offset is not according to manufacturers specification. The shingle manufactures have specific details for the offset and nail placement. If not followed the nails could land under a butt joint and allow moisture to leak under the shingle. This defective installation could void certain sections of the manufacturers warranty as well as be an insurance claim deniability in the event of a leak water loss.

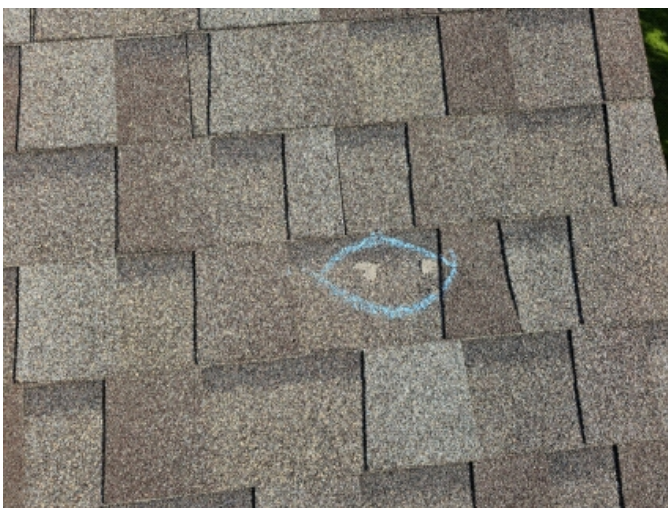
Example of packed holes in shingles where siding scaffold brackets were attached. Case can be made thus roof is not in new condition at turnover as it should be. Shingles with patched holes should have been replaced with new shingles.
