the BUILDING CONSULTANT

Field Report **Attorney work Product** **Project Information**

15 Feb 2025

Field observation report for:**Overview:**

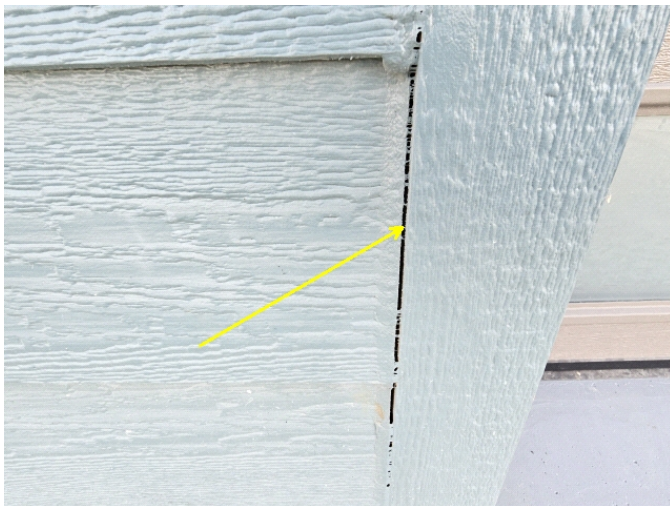
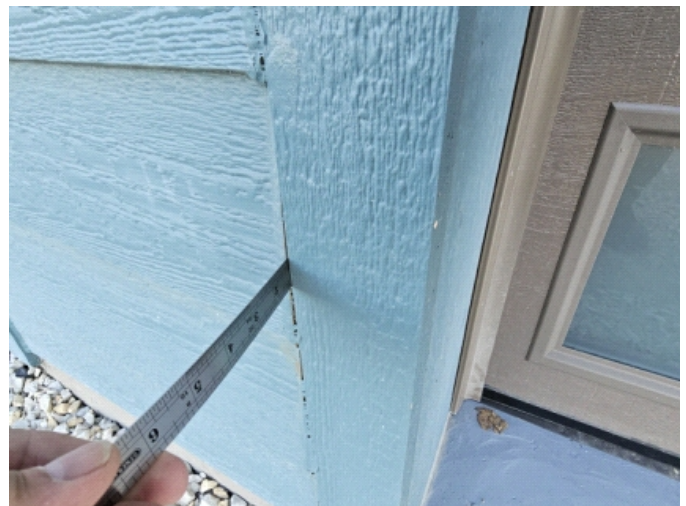
Here is an example of a siding board being cut to short.

Instead of replacing it with a proper length the builder just attempted to fill the gap with sealant.

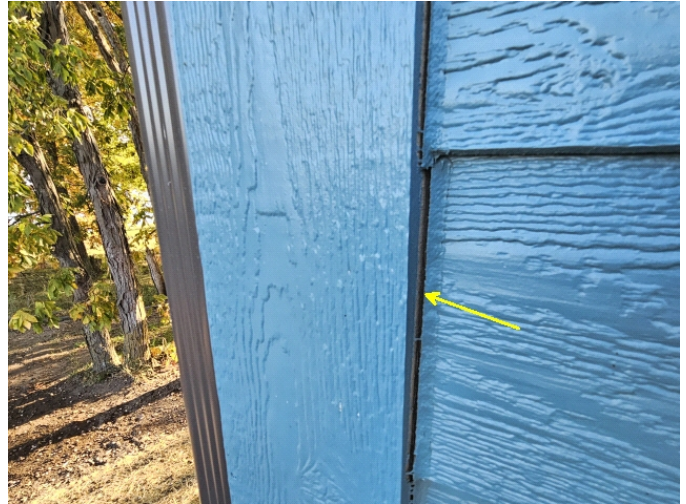
Required 3/16" gap was not left at the window

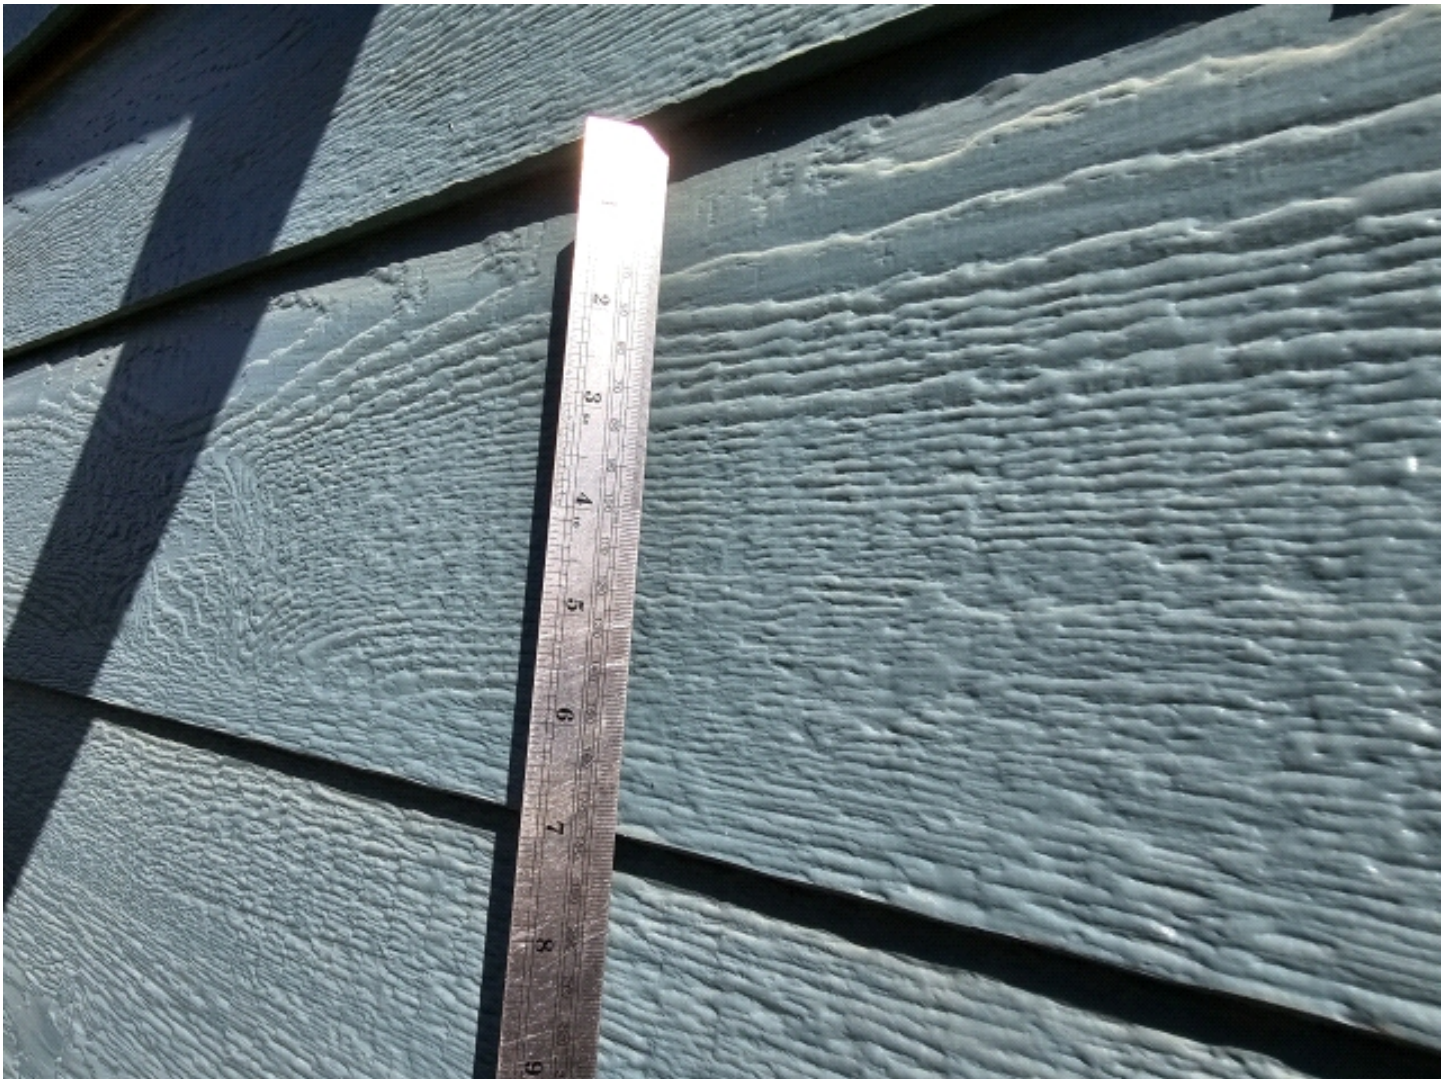
The builder did not follow the manufacturer's instructions to attach the siding with #8 stainless steel screws or their equivalent. Instead the builder chose to use nails to attach the siding. Additionally, even if nails were allowed the placement of the nail in the siding does not meet manufacturers requirements, much of the siding is high nailed which compounds this defective installation. The siding will have to be removed and replaced and fastened correctly to properly remediate this builder defect.

Siding is LP SmartSide 8" horizontal lap siding.

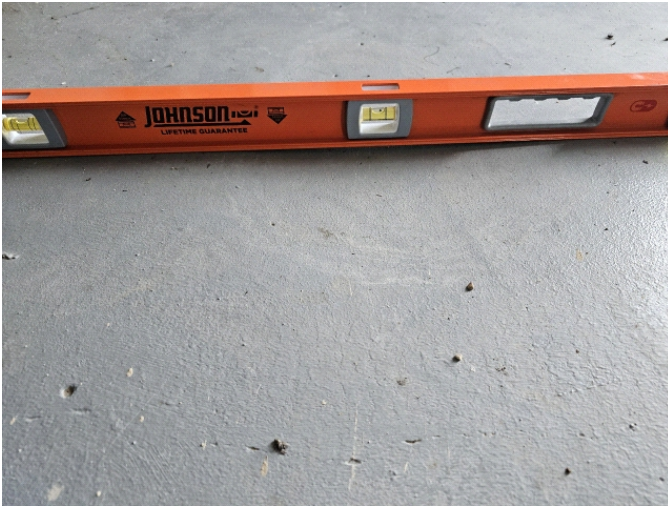
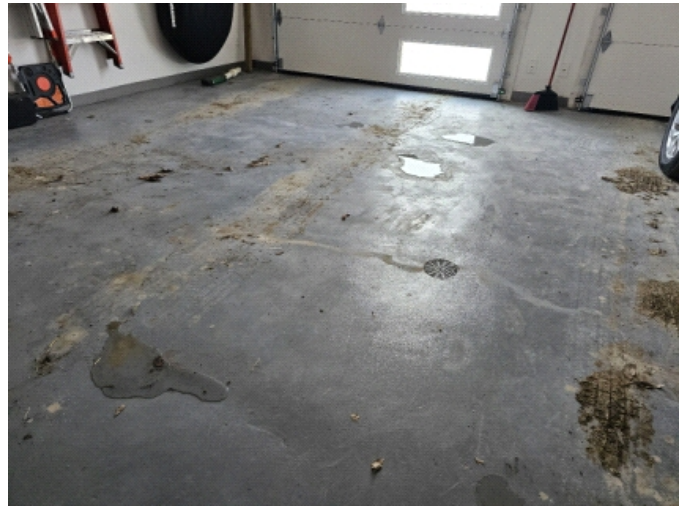
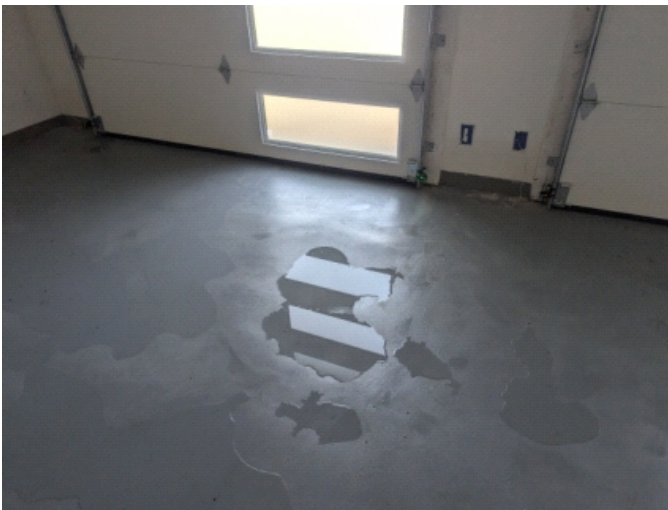
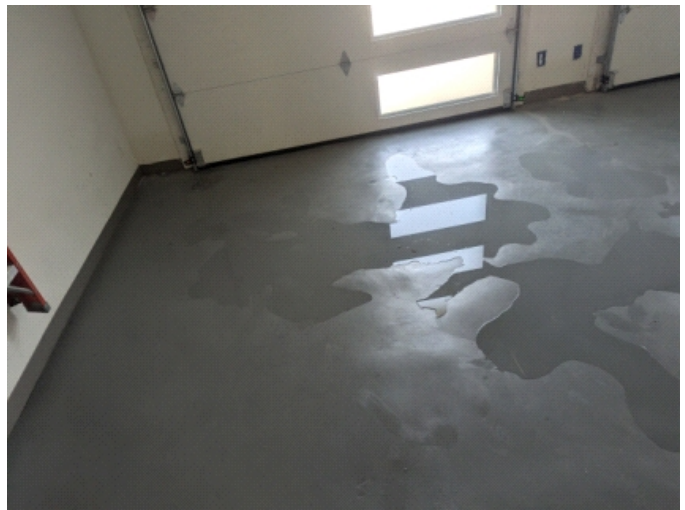
Garage Floor. The garage has a centralized floor drain. The concrete floor is to slope towards the drain so any water on the floor does not puddle and collect. The garage floor was placed and finished in a defective manner with depressions that allow puddles of water to form. There were no relief cuts installed in the concrete floor to control and isolate cracks. floor. This has led to numerous unsightly cracks in the concrete floor. This could lead to a moisture pathway that will leak into the ceiling of the space below.

Water collects and puddles.
Floor is not properly sloped towards drain

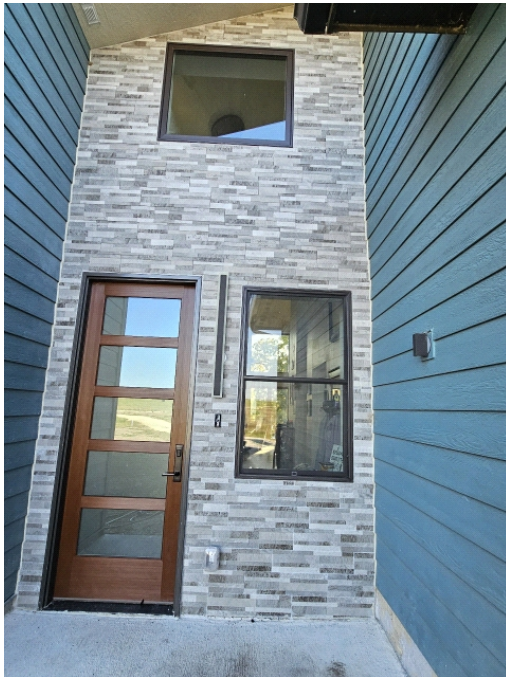
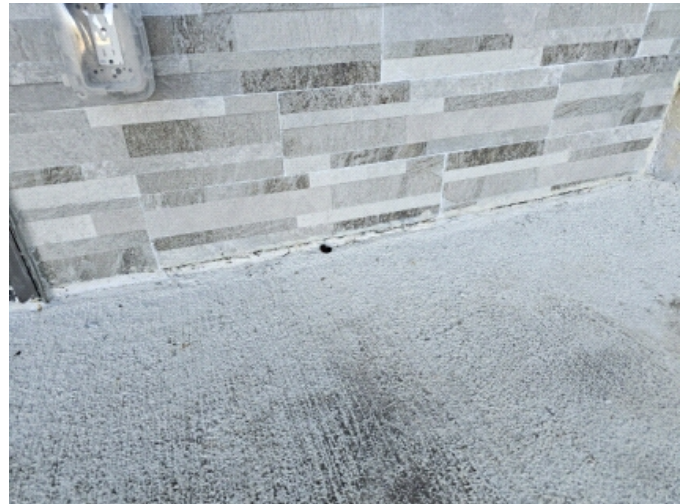
Adhered Tile Stone Veneer Panels The adhered tile stone veneer panels are missing a drainable weep screed at the

base of the assembly and at the tops of the doors and windows. To try to mitigate the leak at the stoop the builder has taken to trying to caulk closed the joints in the tile panels. This is not at all the strategy to correct this leak. At the time of redoing the stoop and mitigating the water leak into the room below it will require removing some siding and some of the tile panels to turn the water proofing membrane up the side of the ICF's above the stoop concrete. At this time, it would be good to redo the tile panels to the correct details around the windows and door. It is questionable as to the installation of the wire lath and its attachment to the ICF's. The wire lath needs to be installed with screws not wide crown staples as is done in most cases. As this is opened we can see how the lath was fastened to the walls. If found to be stapled I recommend removing all the panels and wire lath and reinstalling the panels over MVIS by Laticrete. This is a system that works much better over ICF's than does the conventional wire lath and scratch coat assembly.

No weep screed at bottom of assembly. Brand of panels, not identified, need brand name to review required installation details.

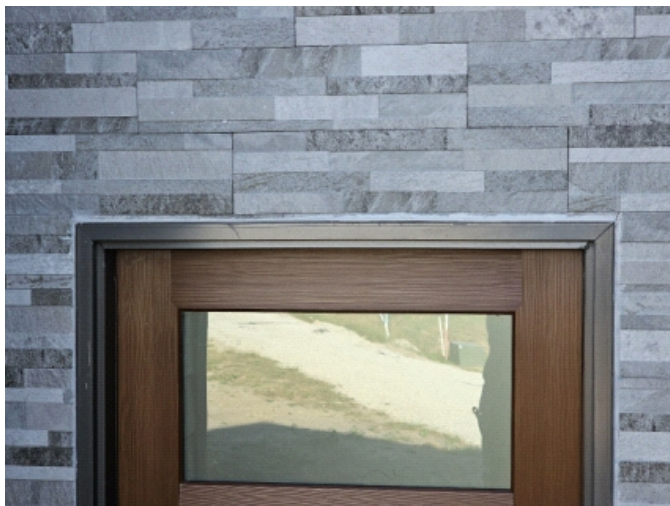
Sealant at door transition blocks any required drain path. Need instructions.

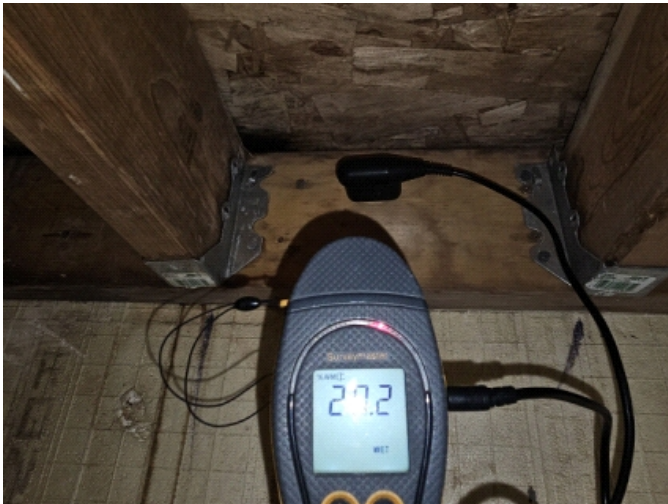
Room under Entry Stoop. The room under the entry stoop leaks water whenever rain is landing on the exterior concrete stoop. The builder has made many attempts to correct this defect but to no avail. The stoop cap is installed without the correctly detailed waterproofing and flashing membrane. The stoop cap needs to be removed and reinstalled over a correctly detailed and installed waterproofing membrane

Framing is wet.

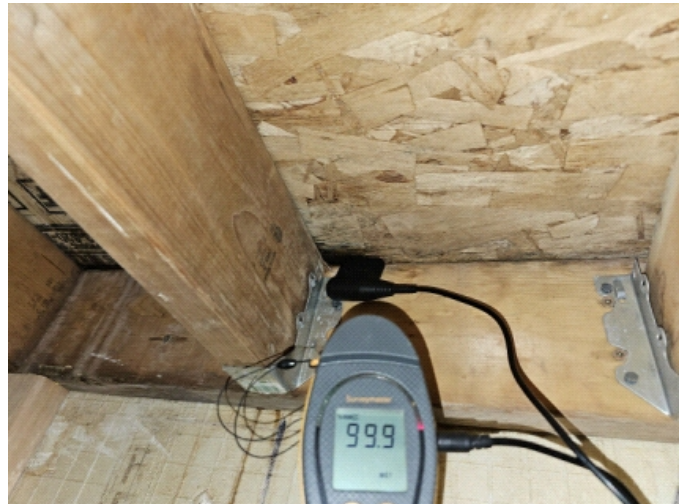
Sheathing is wet.

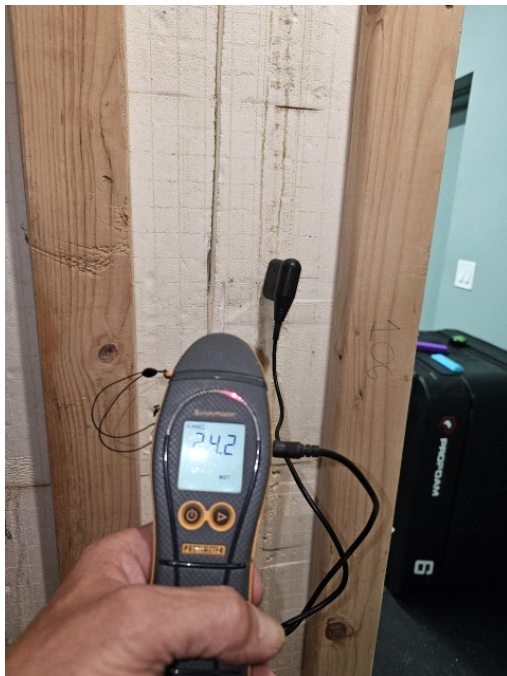
Foam is wet in places.

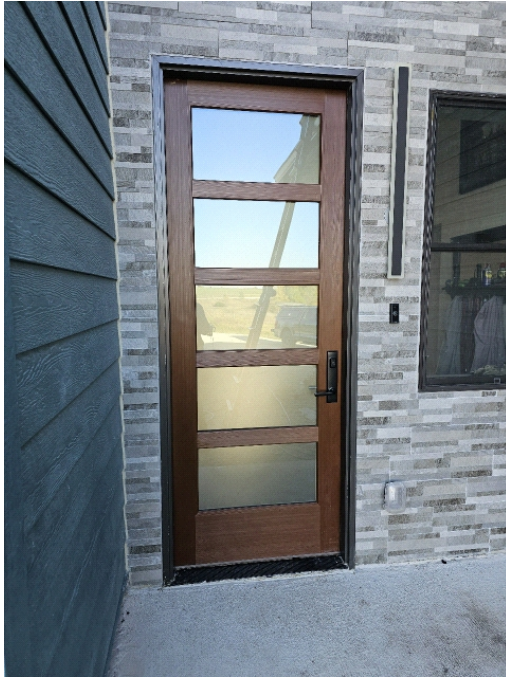
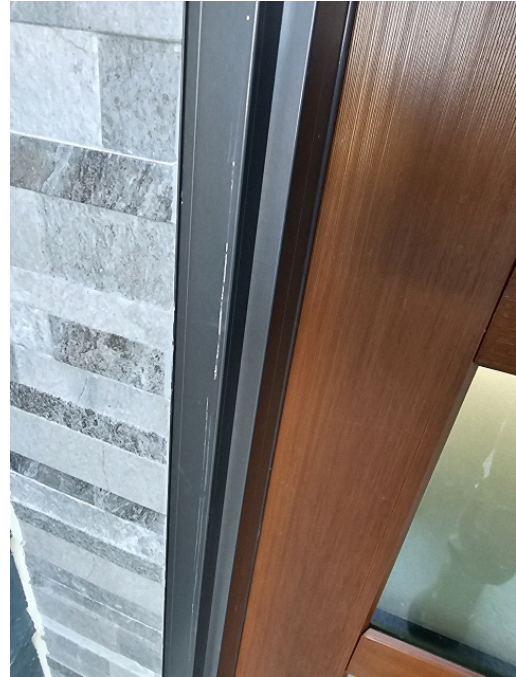
Finish scratched on metal frame.

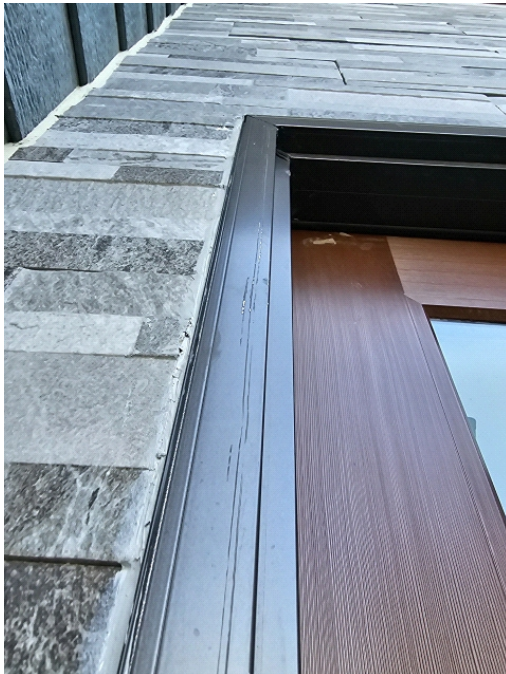
Looks like the door was drug across the ground damaging the finish and leaving grooves in the metal.

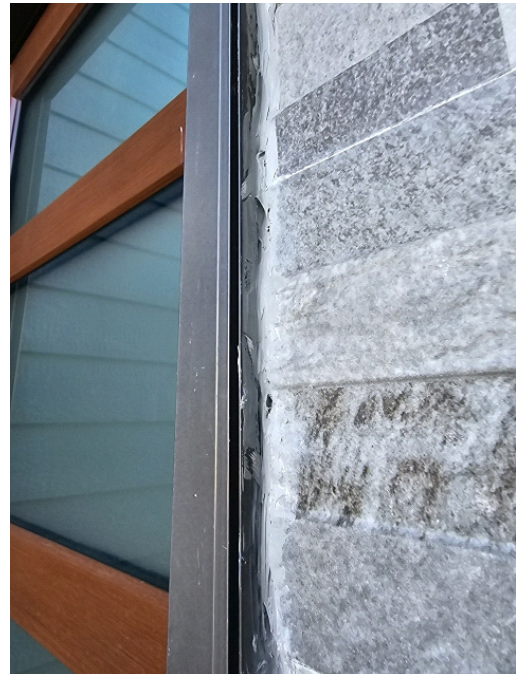
Sealant smeared on door frame.

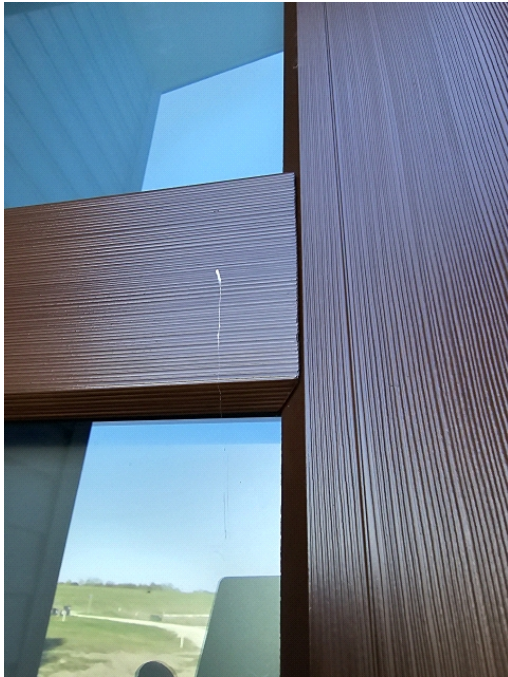
Sealant dribble on door.

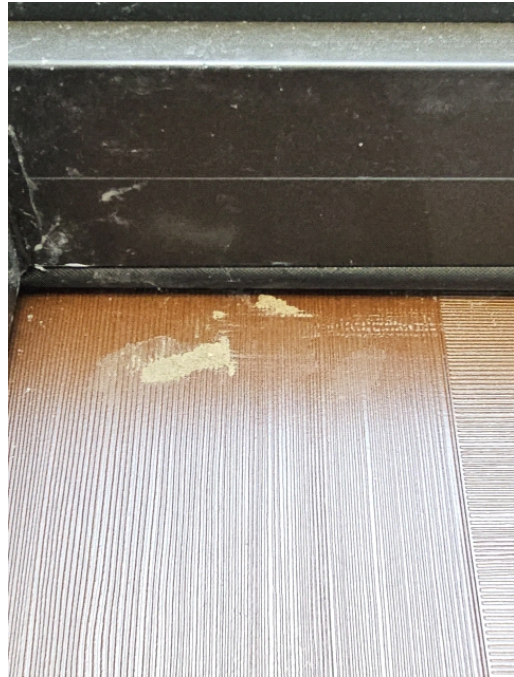
Sealant smeared on door.

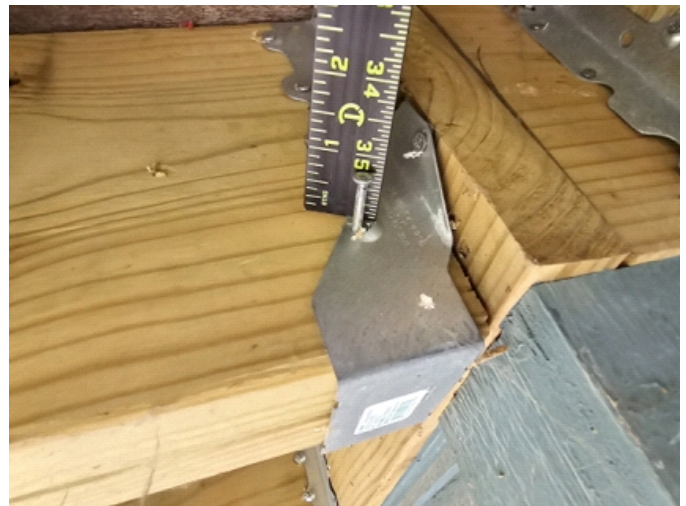
Joist hanger shows longer nails to
be used at the angle holes. The
builder ignored this instruction.

1.5" nails used at angle holes

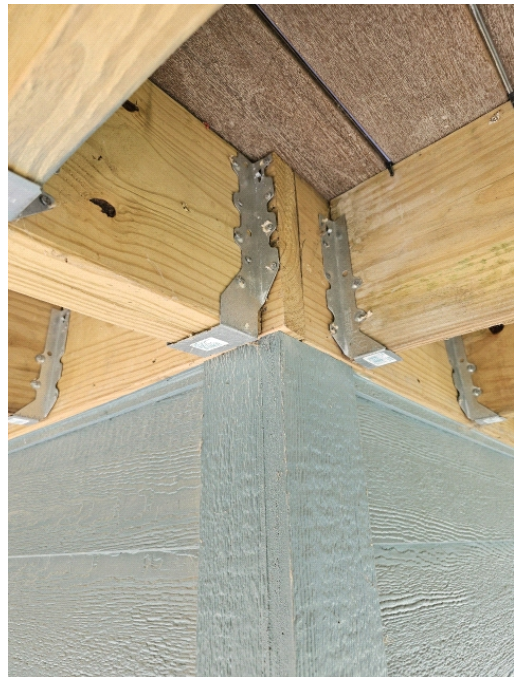
Beam bearing hanger installed too close to end of supporting member. Nails are splitting wood , attachment is in question.

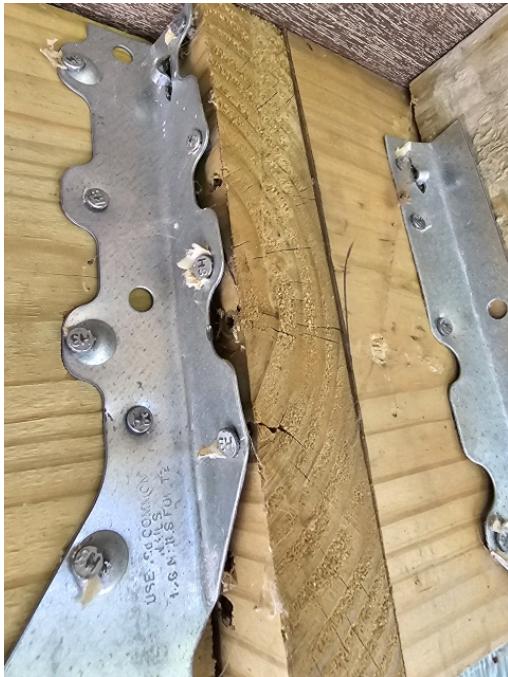
Wood is splitting at nail. Nails used are too short.

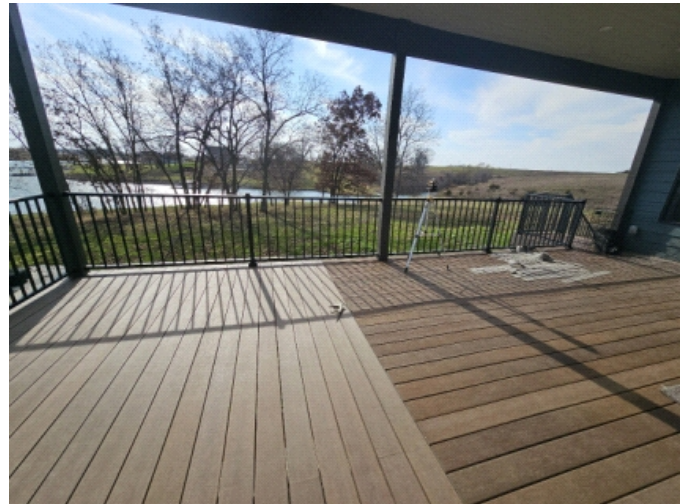
Measuring deck surface level plane.

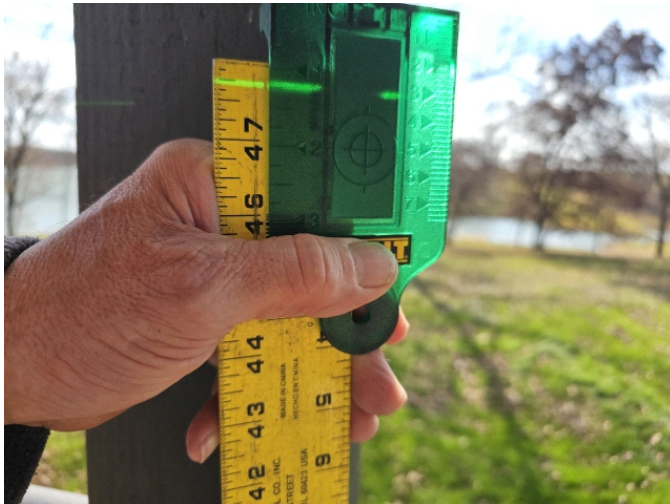
47 3/4" center reference.

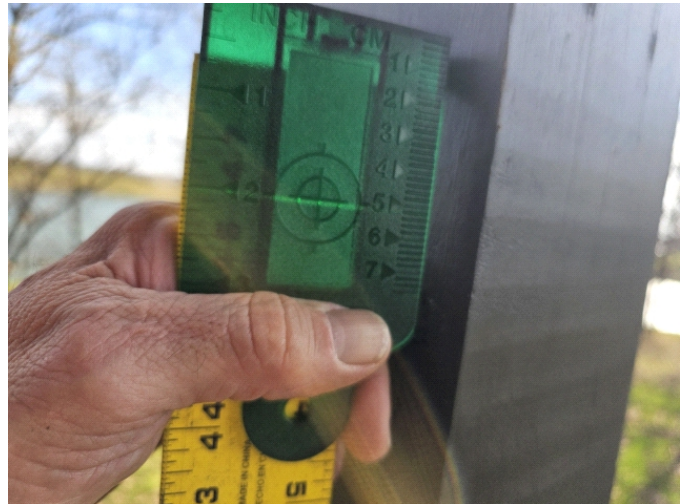
46 5/8 lake side. This point is 1 1/8" lower than center reference. This should be monitored to make sure footings are not moving.

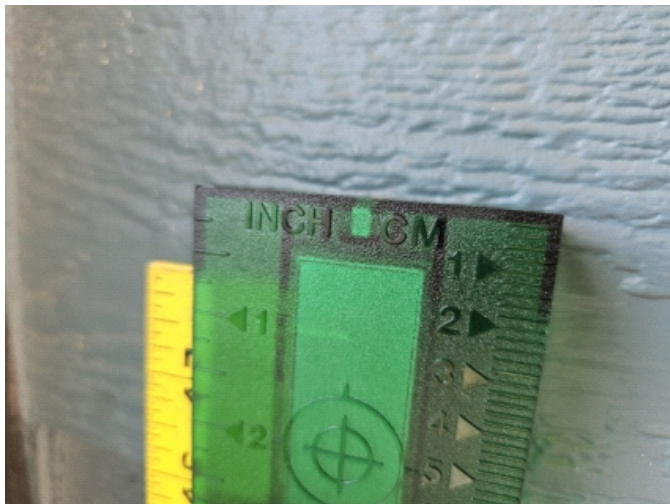
47 1/2 house.

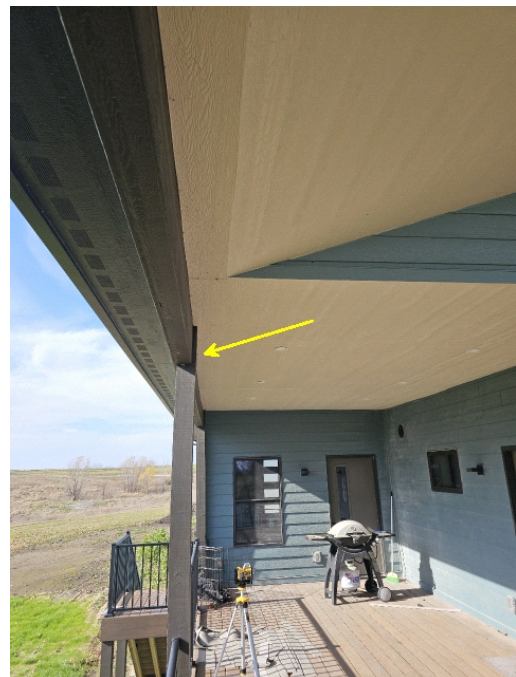
Beam bows out approx 2" in the center of the span.

This appears to be poor framing. Monitor for any movement over time.

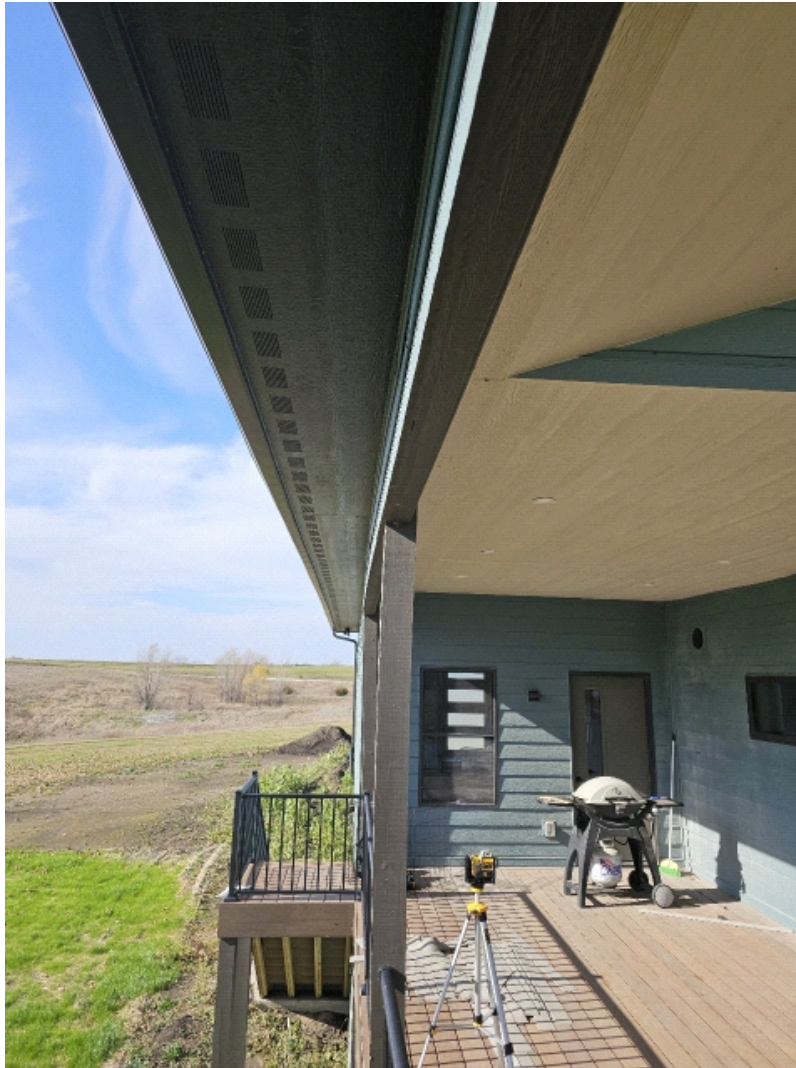
Beam has notable bow outward at center of span.

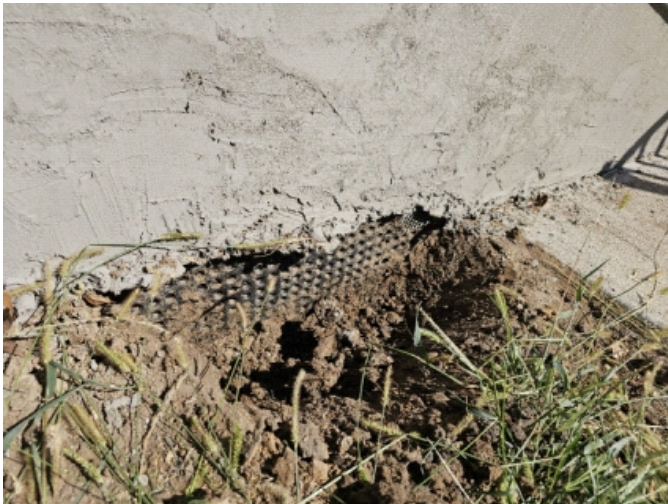
Wire lath exposed, not terminated correctly at base.

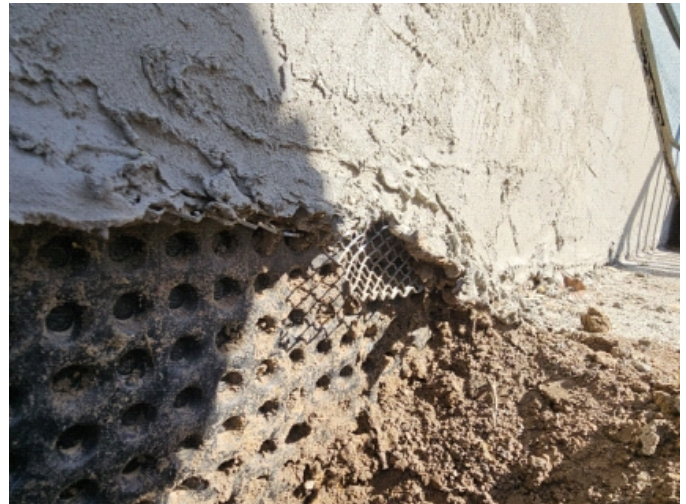
All metal lath is to be fully encapsulated in scratch coat to protect against exposure to the weather.

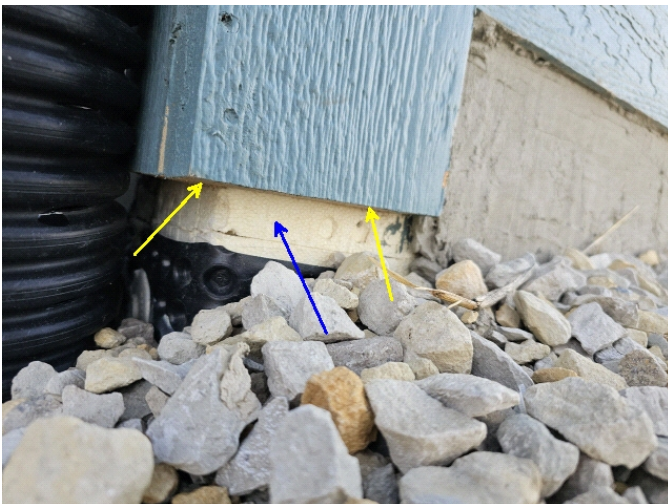
Exposed ICF, blue arrow.
LP SmartSide trim edge left exposed, not properly sealed and painted at the cut edge, which is a requirement of LP SmartSide, yellow arrow.

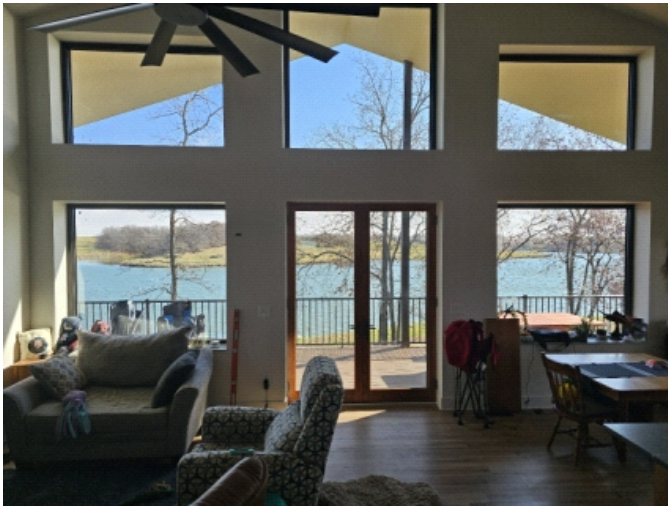
Door and windows do not line up.

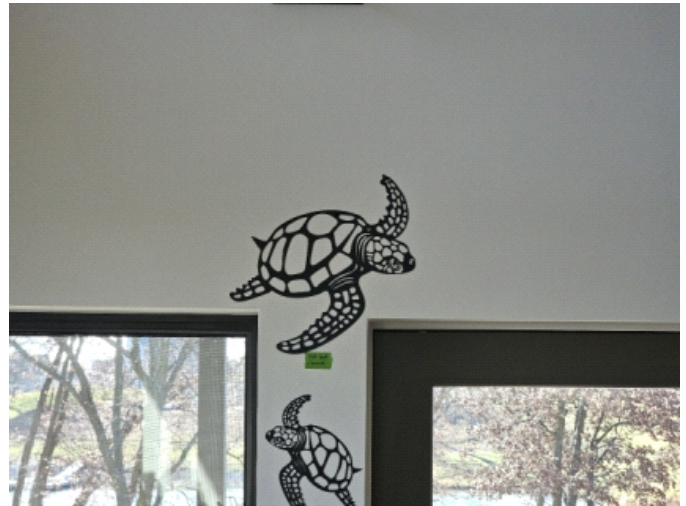
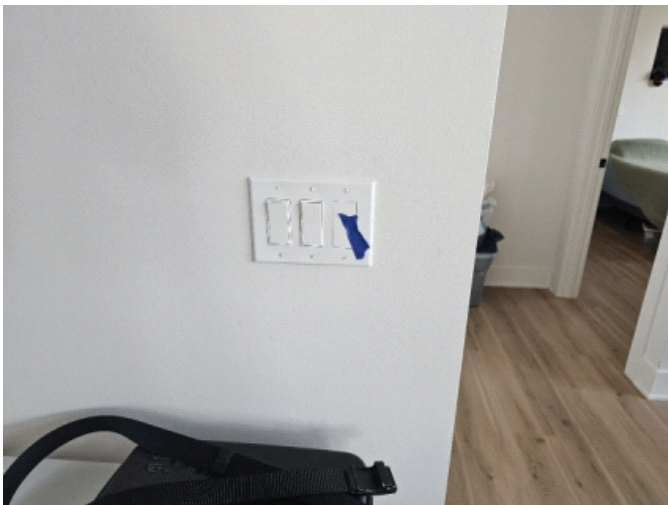
Switch plate to nowhere.

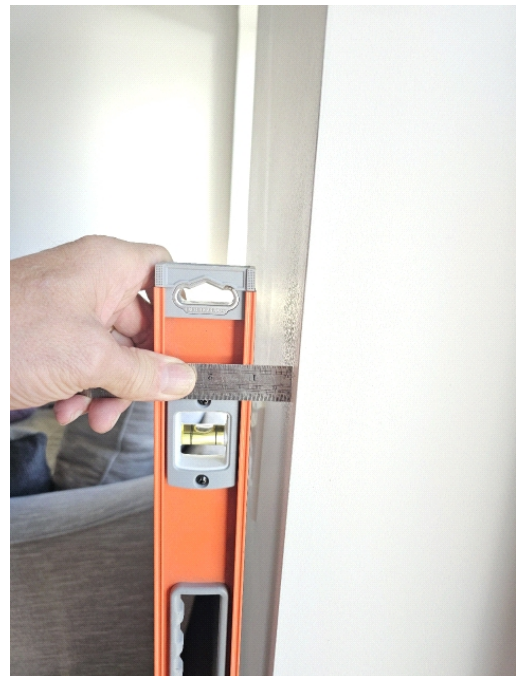
Back wall out of plumb 7/8" in 4'.

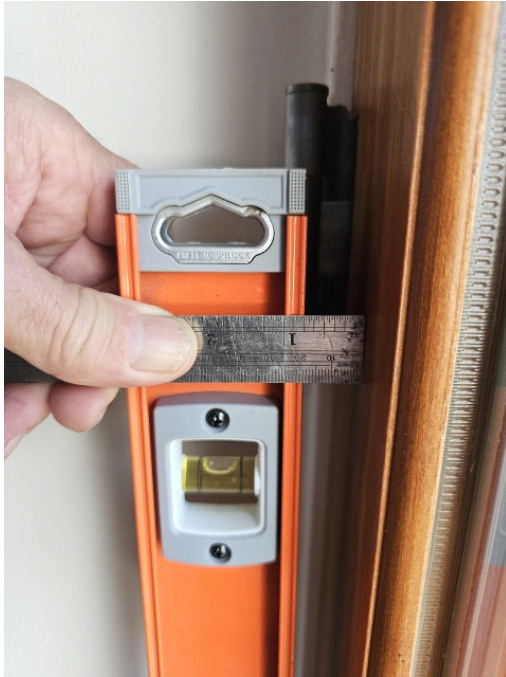
Deck door out of plumb.

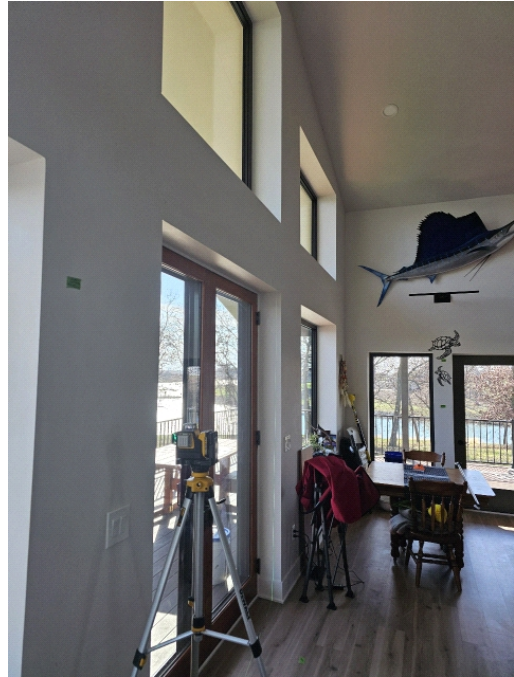
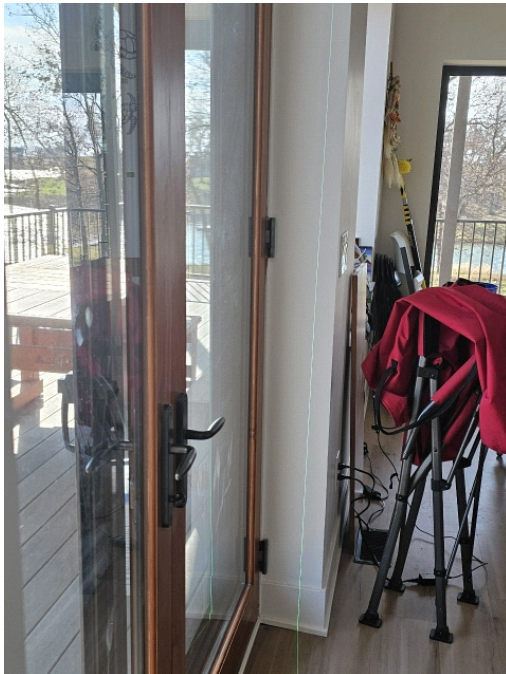
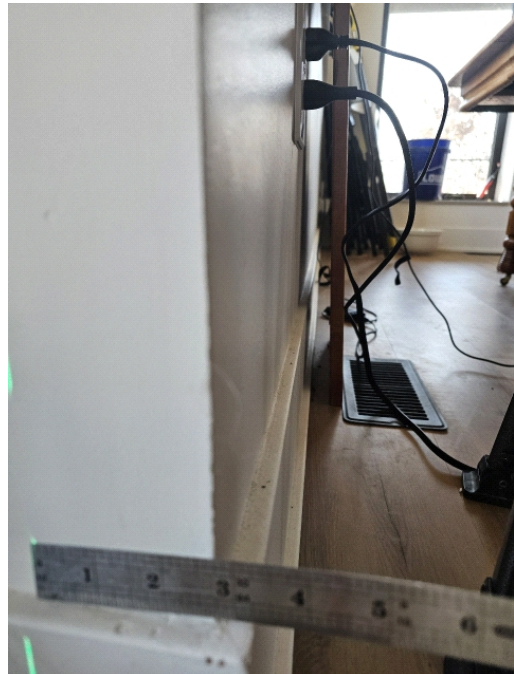
Back wall is out of plumb,
approximately two and three
quarter inches from top to bottom.

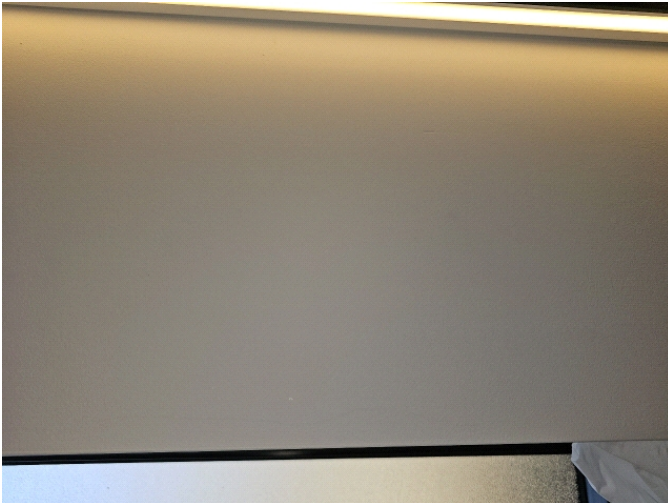
Drywall finish poor workmanship.

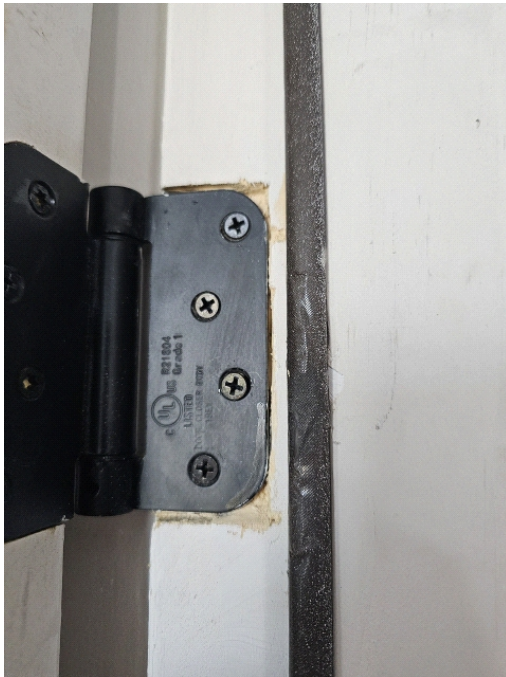
Builder's idea of how to adjust door. Door was not set properly, which required some adjustment. So the builder hacks out the hinge pocket in an attempt to adjust the door.

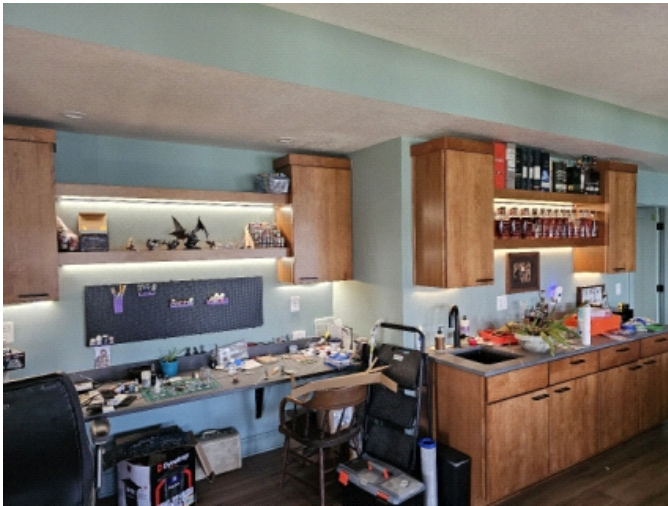
Two different colored undercabinet lights used.

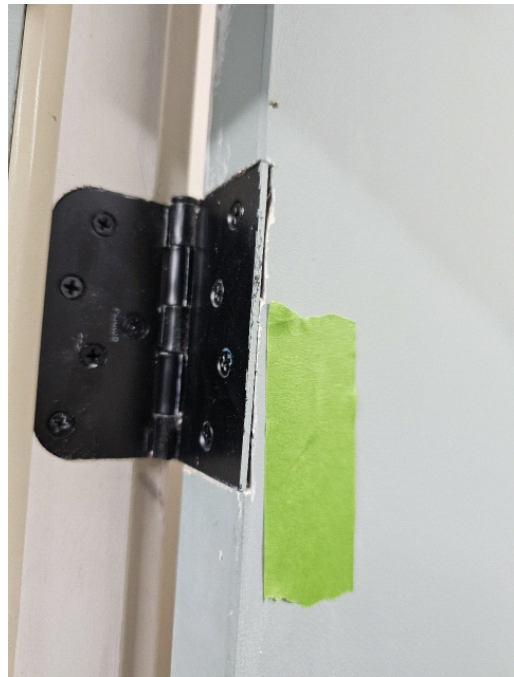
Builder hacked out hinge pockets in an attempt to make adjustments to a door that is not correctly set plumb, level, and square.

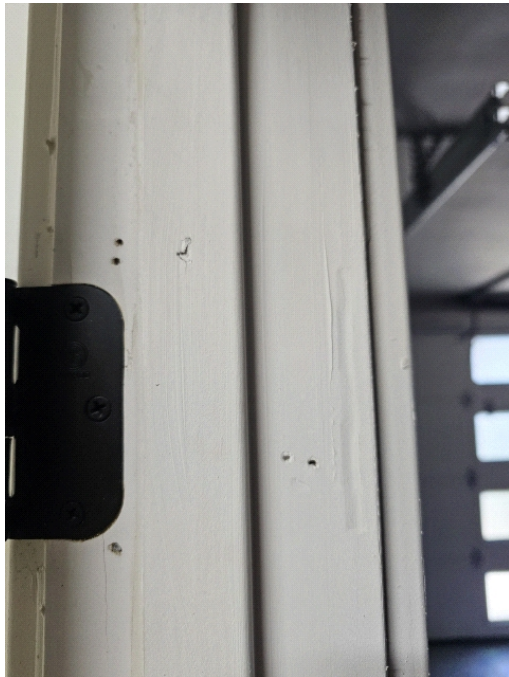
Nail holes in trim are not filled.

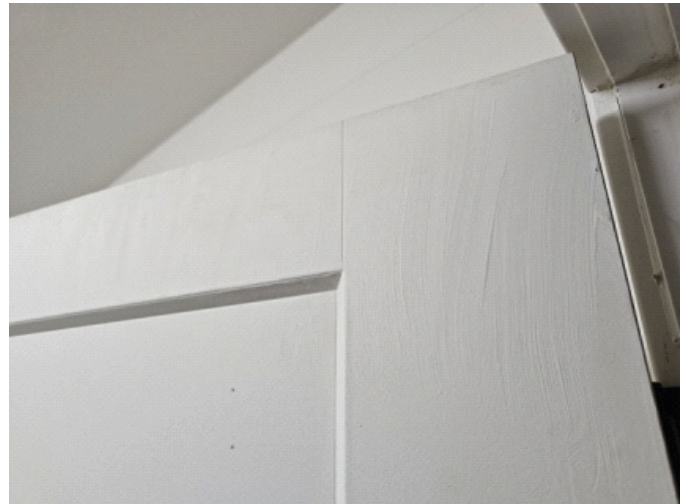
Sloppy brushstrokes in paint.

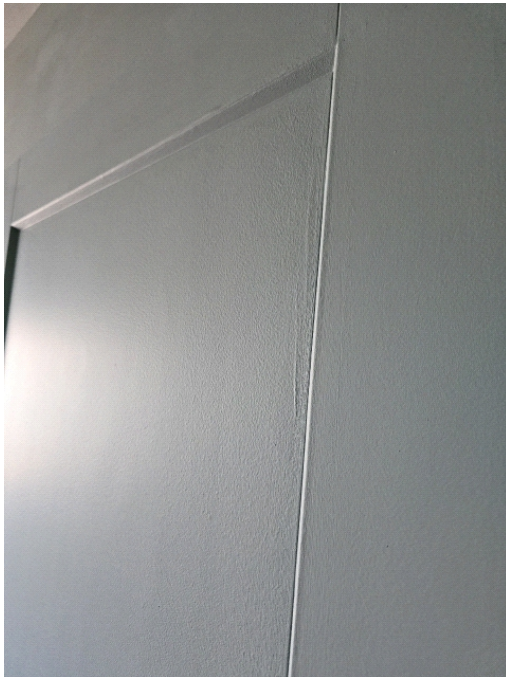
Brush strokes and textured finish on doors. Looks like doors were rolled rather than sprayed. Sloppy uneven non uniform finish on doors.

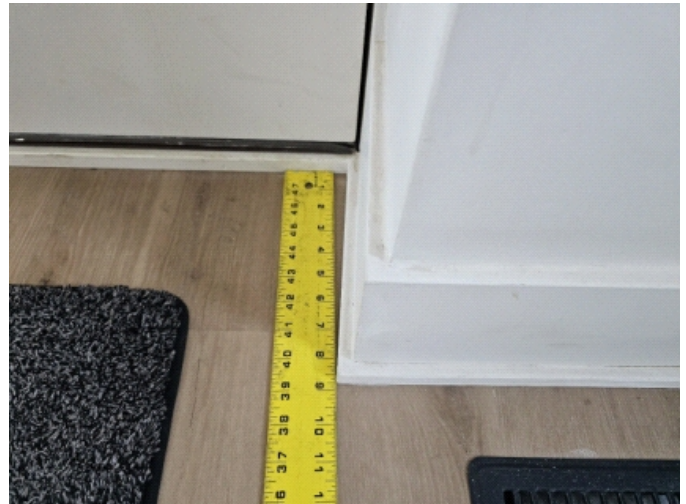
Return corners are out of square.

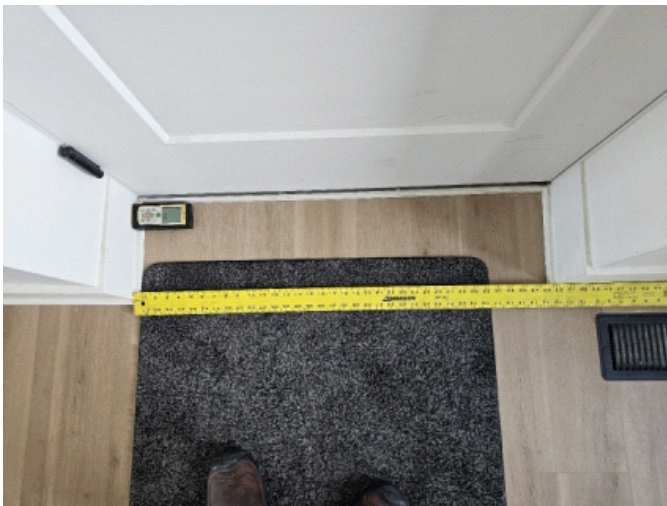
Measures 36 1/2". Back. 35 3/4" front.

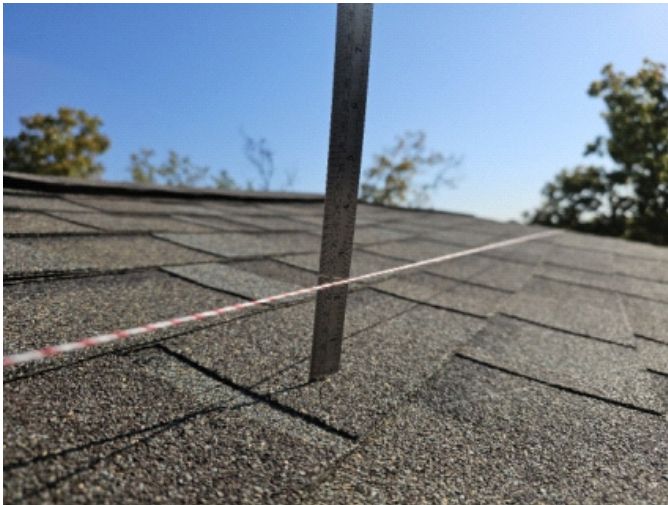
2.5" dip in roof measured.

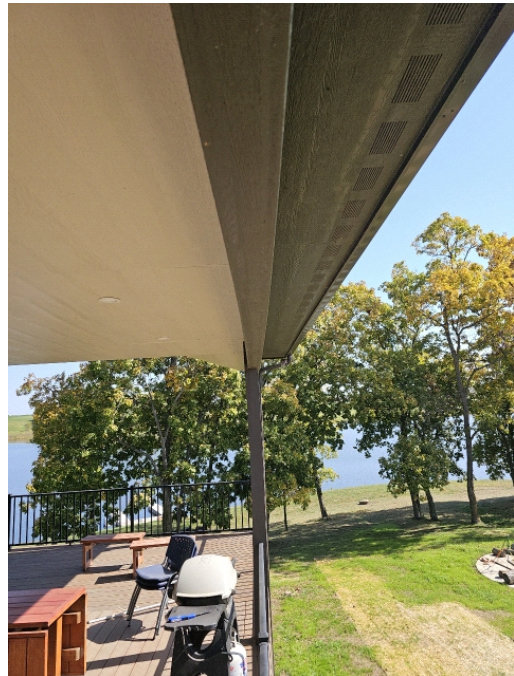
Beam bows outward at bottom over span. Beam rotates outward at bottom towards center.

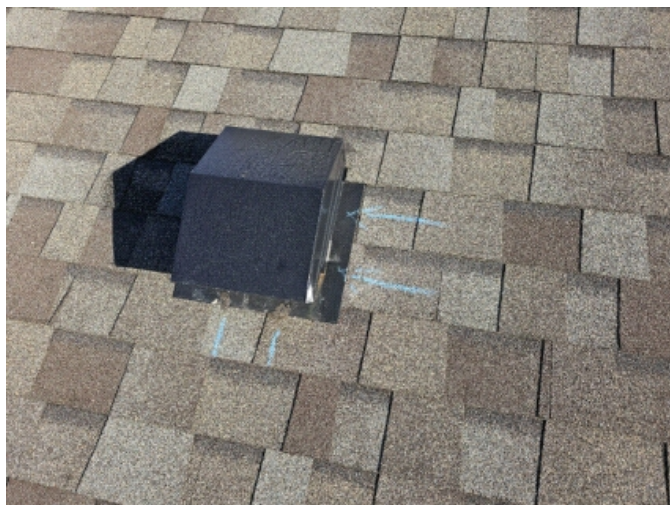
Shingles should lap onto hood at blue arrows. Hood should be nailed to the roof under shingles. Nails at bottom should not be there.

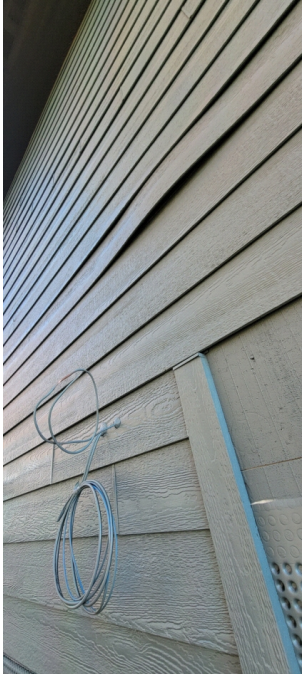
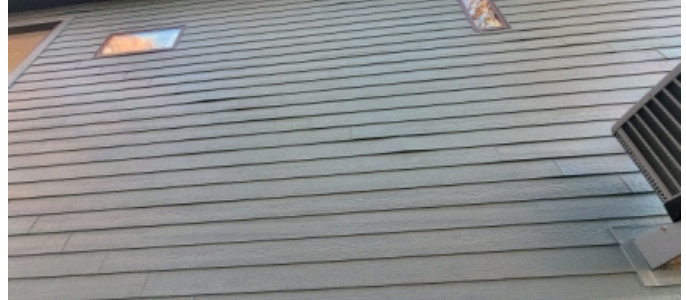
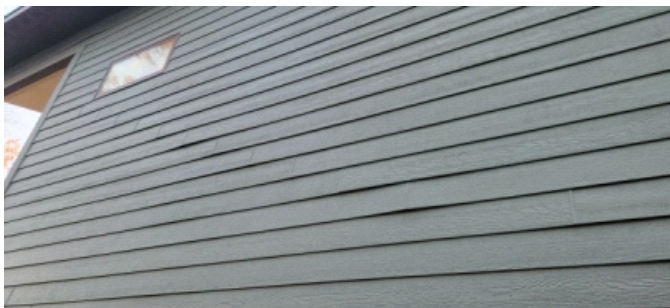
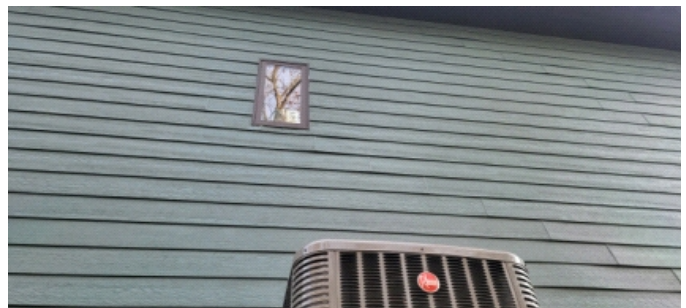
Siding is warping and bulging due to improper fastening.

The builder used nails.

LP specifies Min.#8stainless steel or equivalent, self drilling tapered head screw.
